Sub-Standard vessels in German ports 2014

ships name: M/V Curitiba
IMO number: 9078220
Call Sign: 3FIP4
MMSI number: 353614000
Ship type: Ro-Ro Cargo (Car carrier)
Gross Tonnage: 47367
Keel laying date: 10.02.1994

Detention port: Bremerhaven
Detention date: 31.03.2014
Detention Duration: 11 days

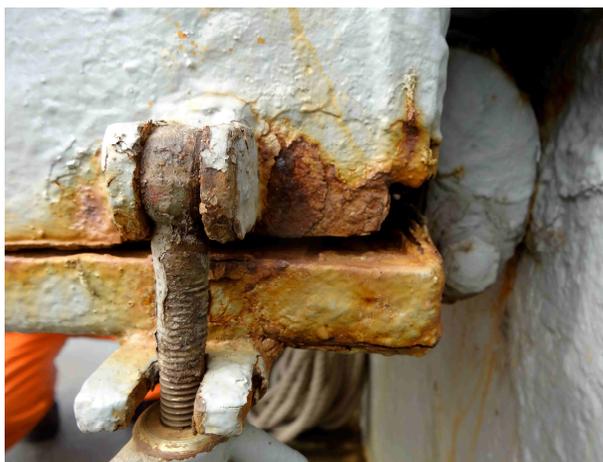
picture 1: rusted and holed fire flap

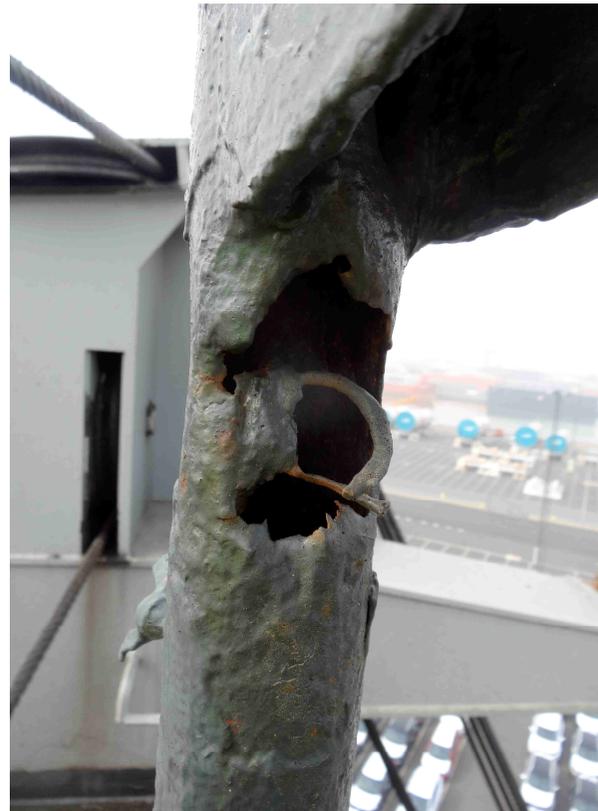
picture 2: foundation of floodlight found holed by rust

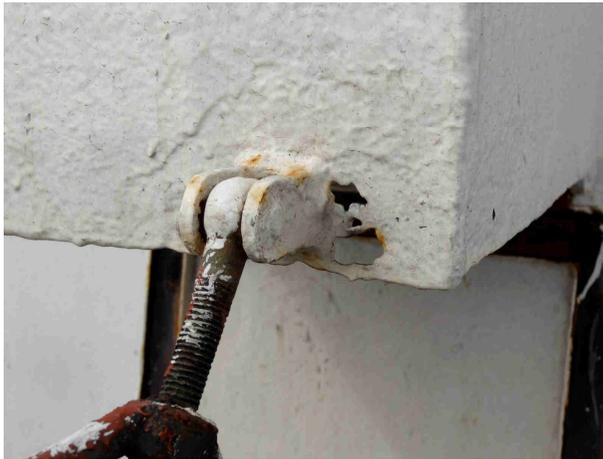
picture 3: even if closed not sealed fire flap

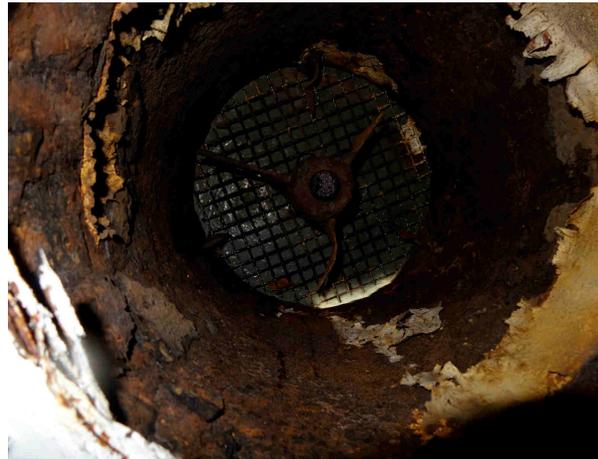
picture 5: ventilation pipes are showing from inside...

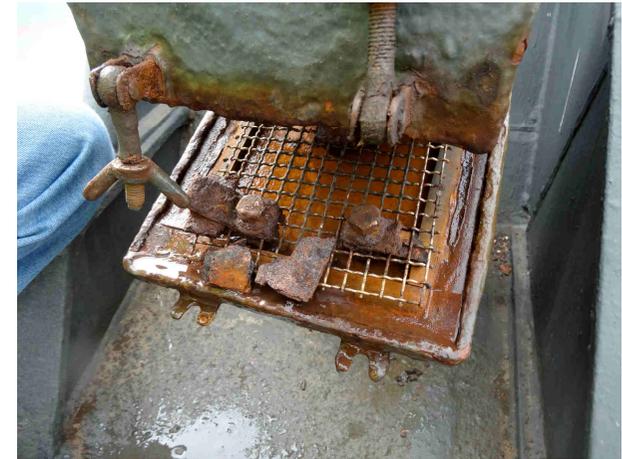
picture 7: some flaps were never opened before...

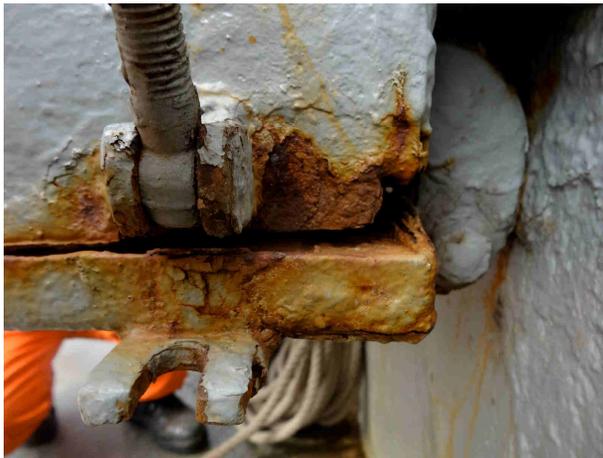
picture 4: so called "completely closed fire flap"

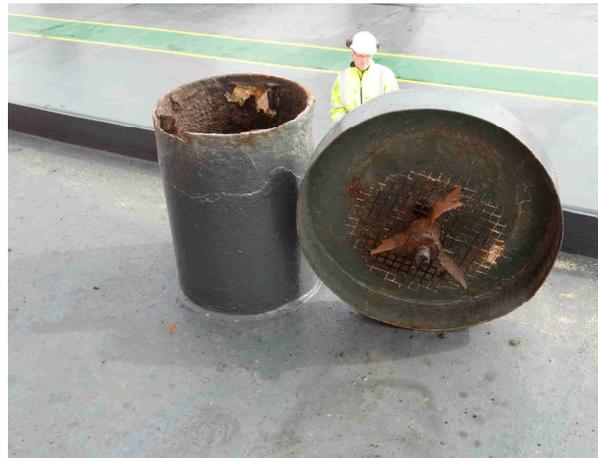
picture 6: and from outside destroyed foundations.

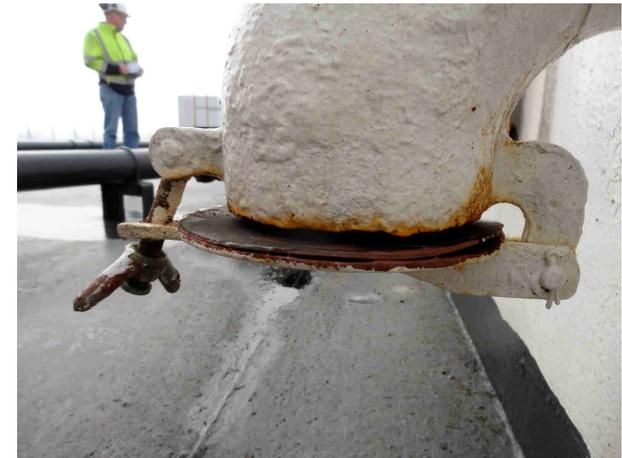
picture 8: ...some others never been closed properly

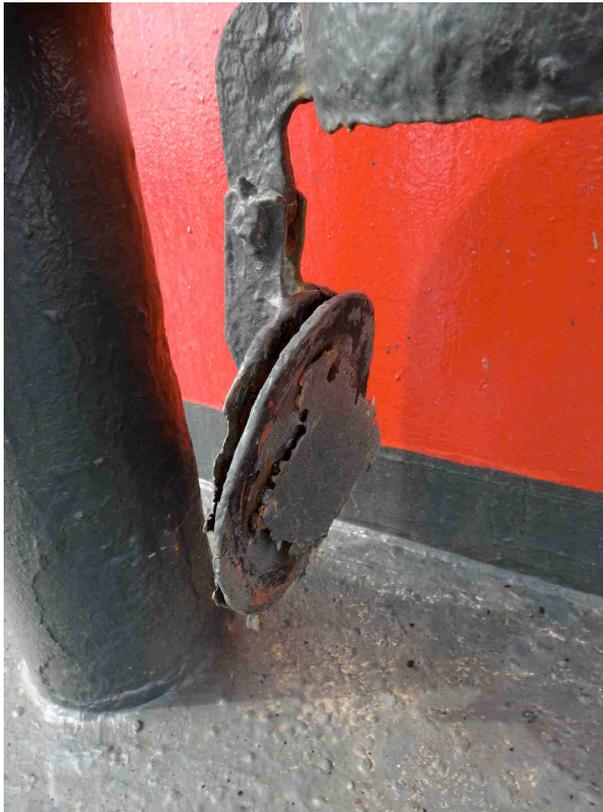
picture 9: nearly all flaps were found damaged

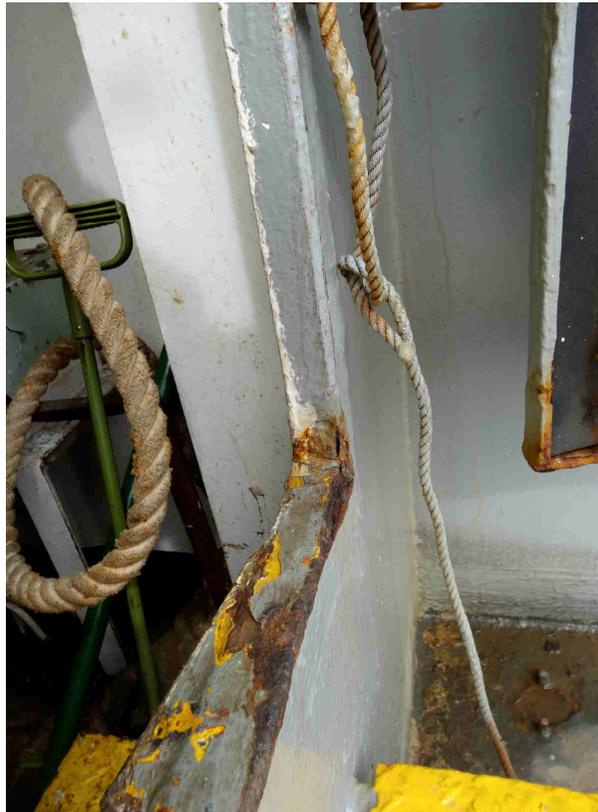
picture 10: also all entrances were heavy corroded

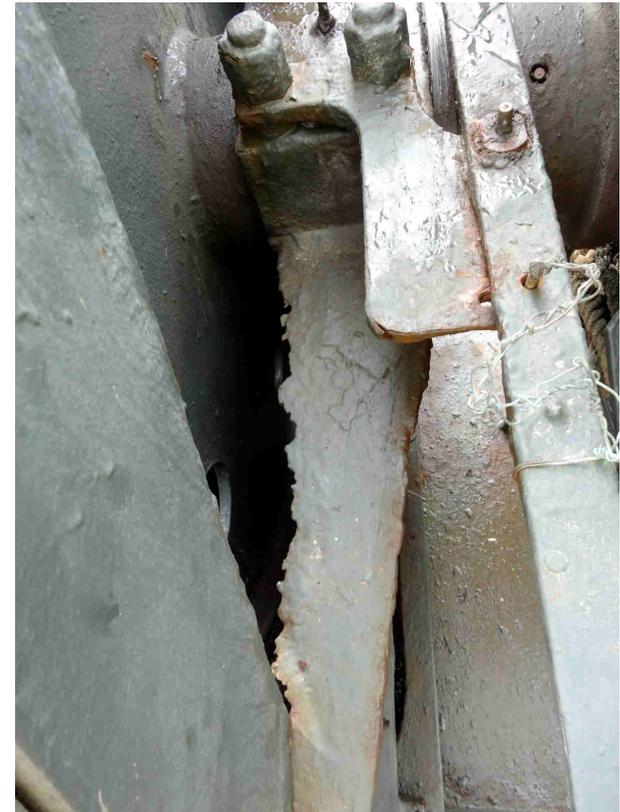
picture 11: foundation for winches had gone rotten

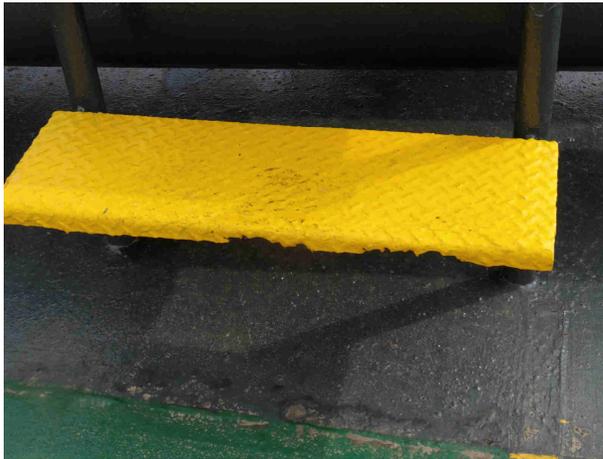
picture 12: steps and platforms were eroded...

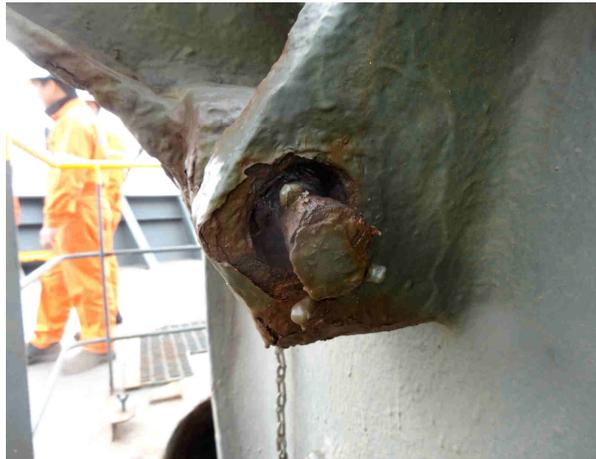
picture 14: bolts and bearings on winches worn out

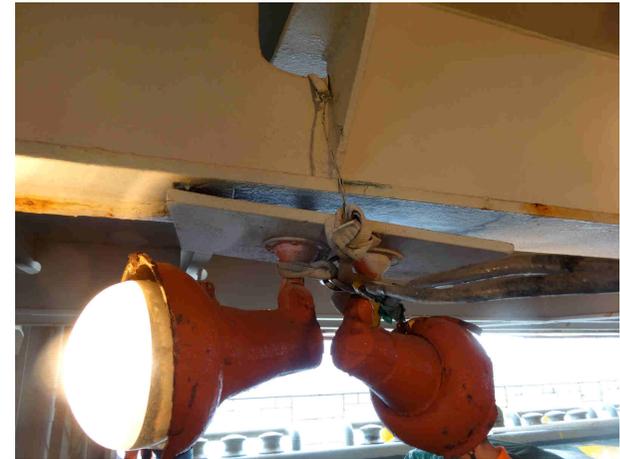
picture 16: historically grown electrical installations

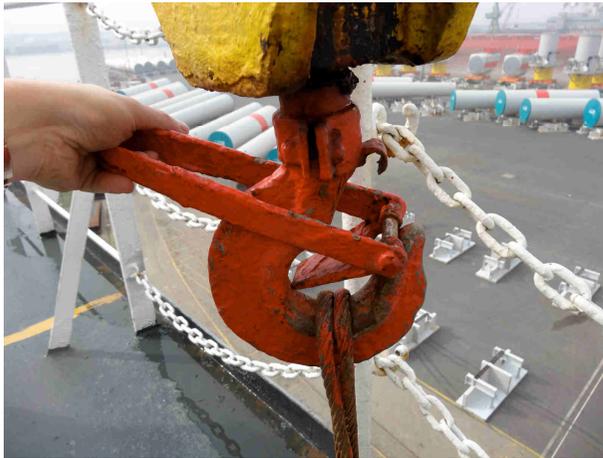
picture 13: ...safety clips on hooks destroyed

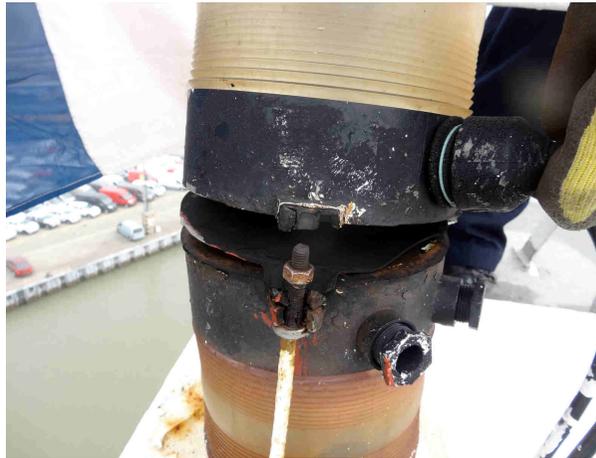
picture 15: navigational lights kept in position by hope

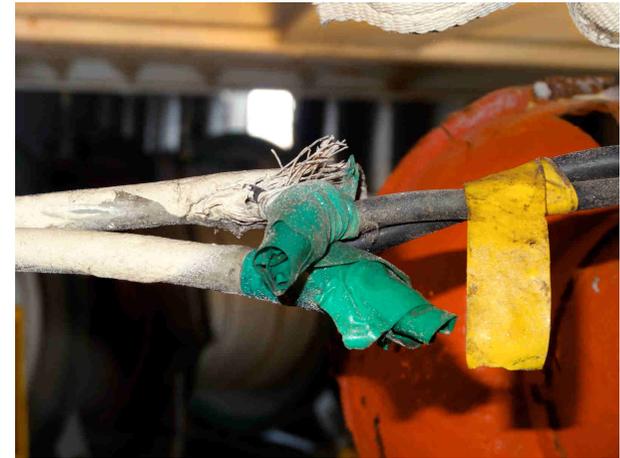
picture 17: self made professional electric installations

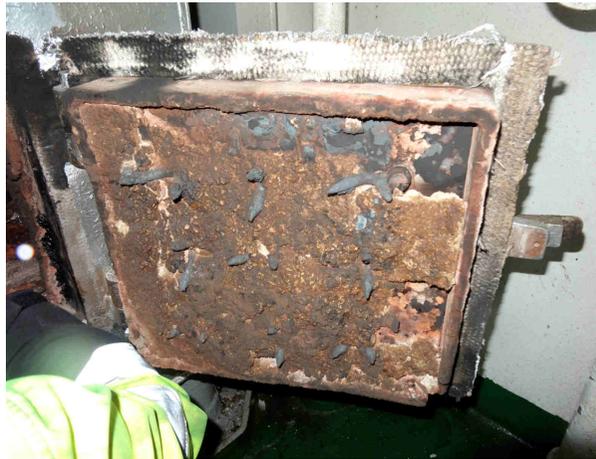
picture 18: damaged incinerator door

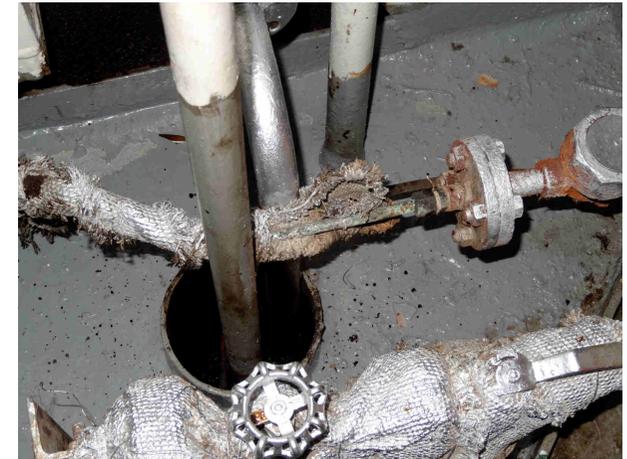
picture 20: damaged heat insulation on pipes

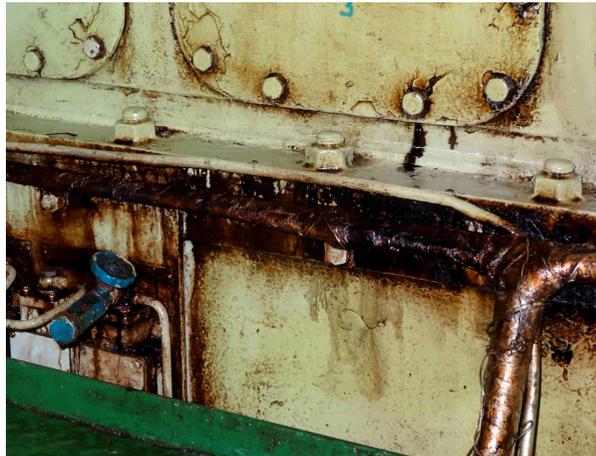
picture 19: insulations wetted through oil

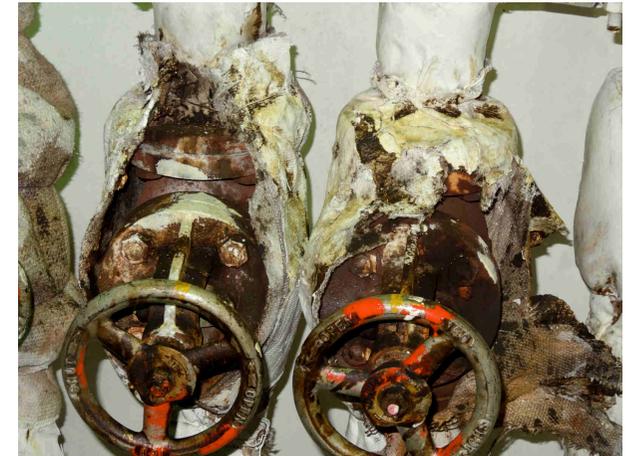
picture 21: combined: damaged and wetted through oil

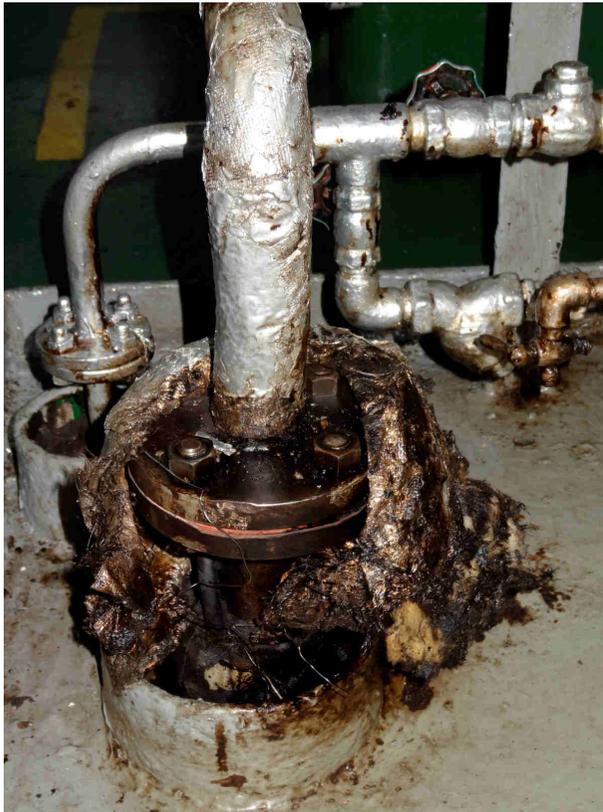
picture 22: again a combination of damaged insulation and insulation wetted through oil

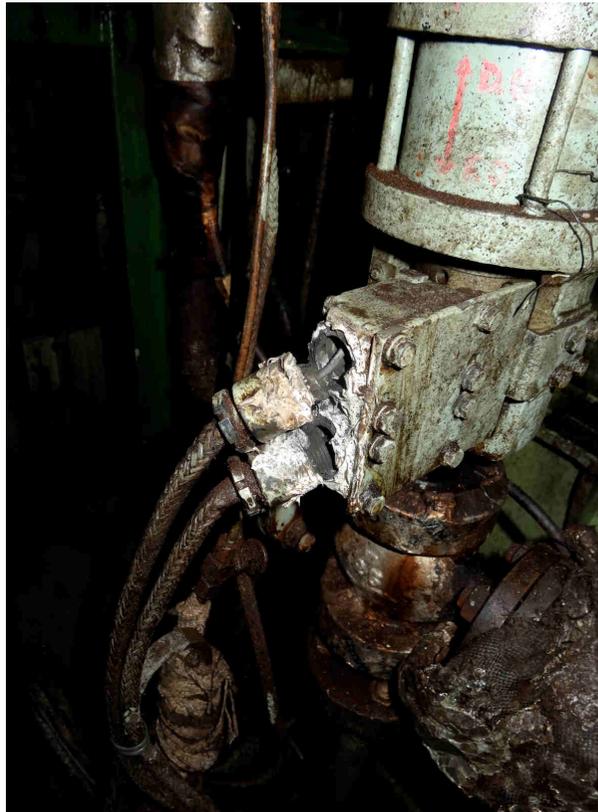
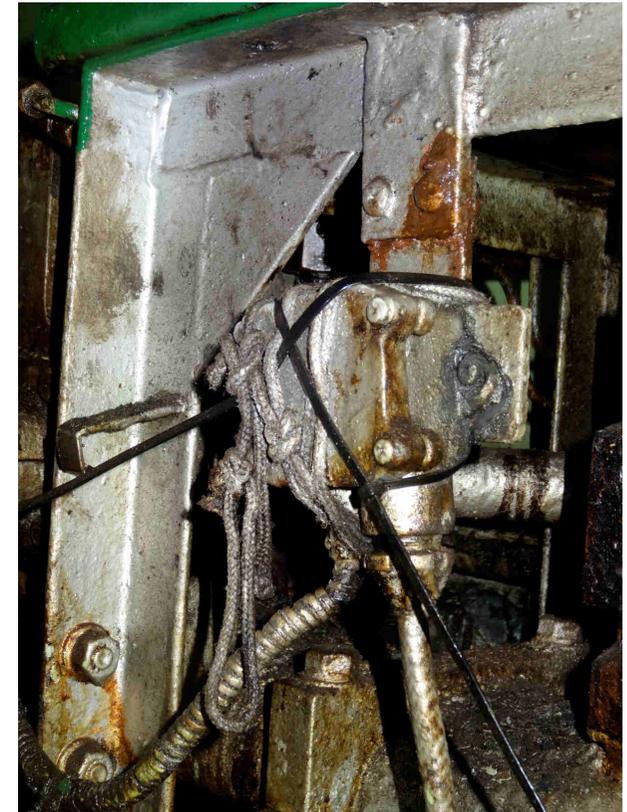
picture 23 and 24: also in engine room the electrical installations were found on same safety level like on deck

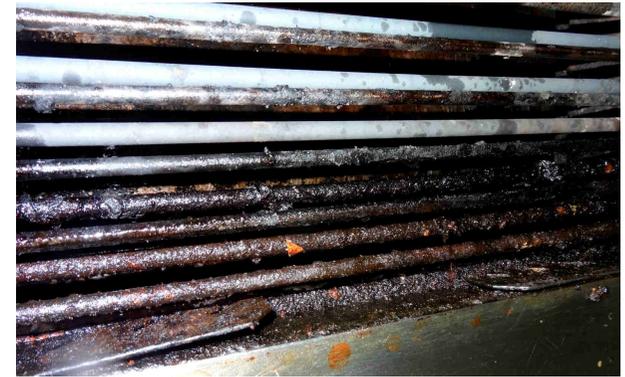
picture 26: old burned something on the grill

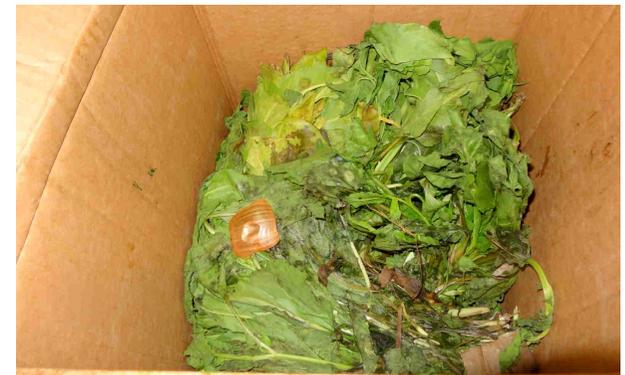
picture 27: foodstuff from provision room

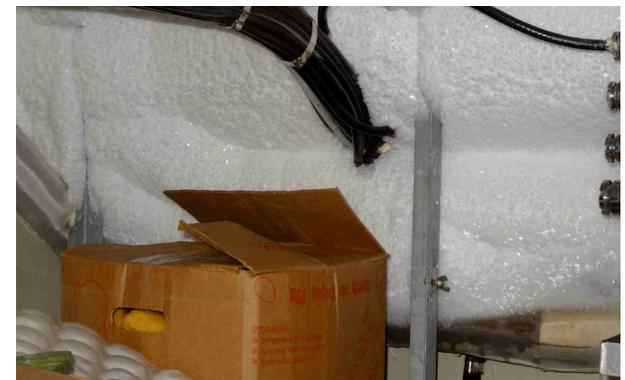
picture 28: lemons and cables enclosed in condensed ice
