Sub-Standard vessels in German ports 2014

ships name: M/V NORDIC BOTHNIA
IMO number: 9079157
Call Sign: 3EVU9
MMSI number: 352212000
Ship type: Bulk Carrier
Gross Tonnage: 27078
Keel laying date: 23.09.1994

Detention port: Nordenham
Detention date: 04.09.2014
Detention Duration: 8 days

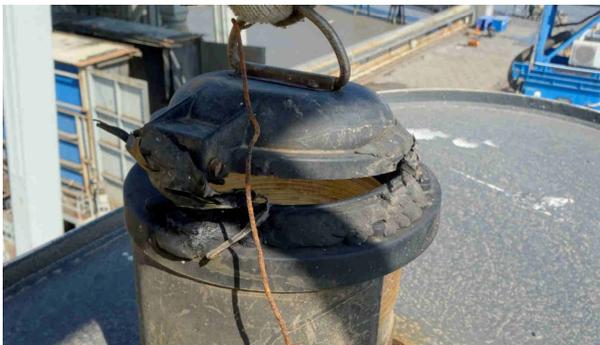
picture 1: damaged toplight, fixed by wire

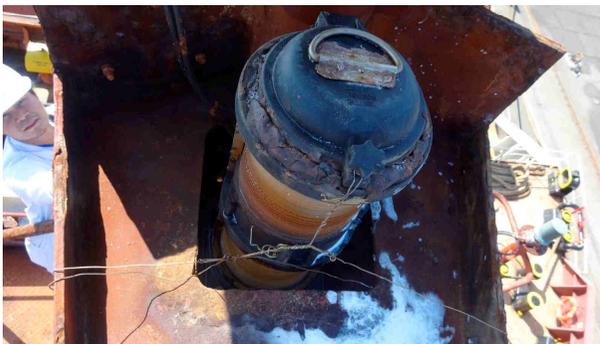
picture 2: second toplight, more wires necessary

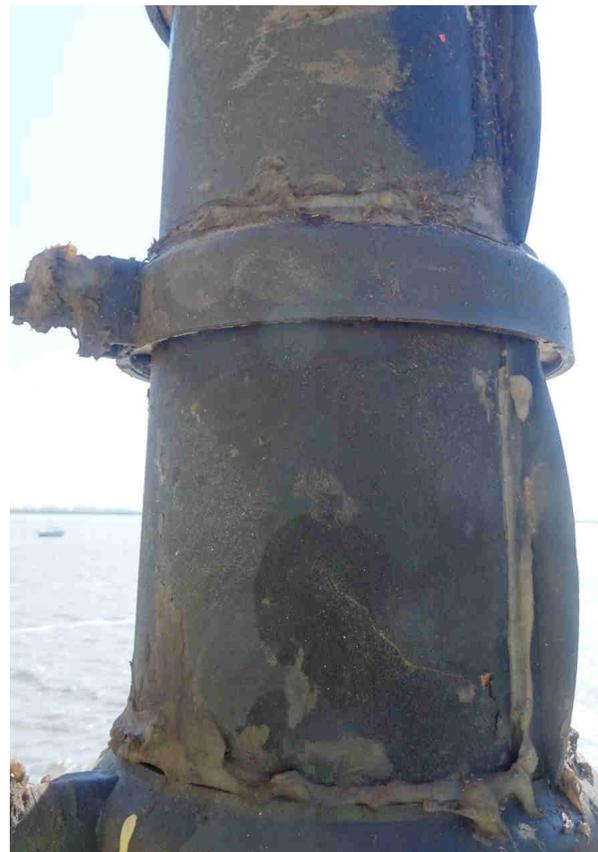
picture 3: sternlights, without wires but with silikon

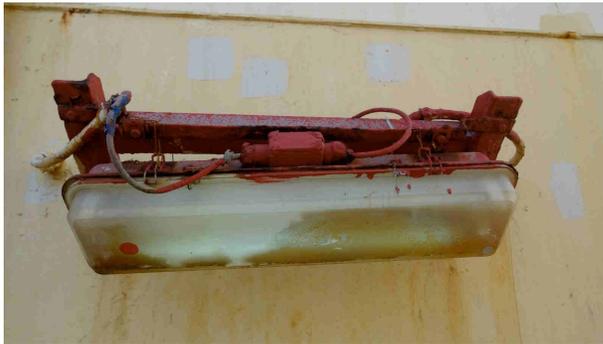
picture 4: damaged emergency light

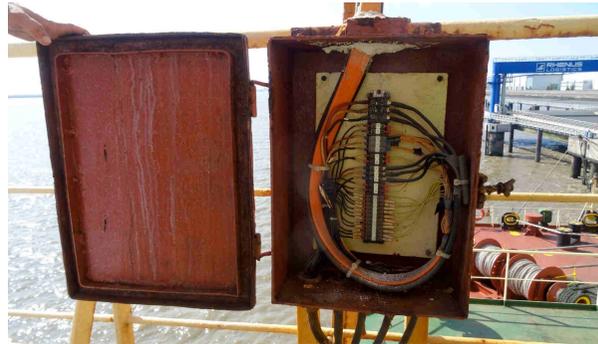
picture 7: unsafe electric installations

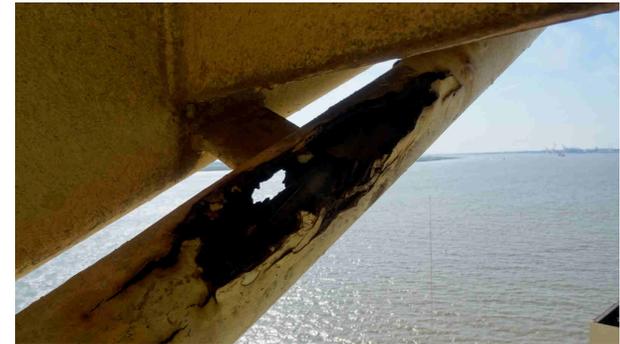
picture 10: rusted pipes

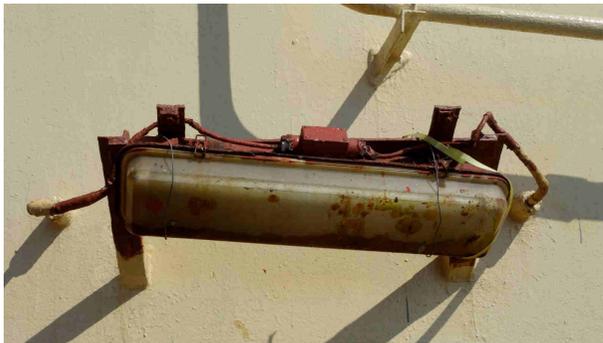
picture 5: nearly all lights on deck were found similar

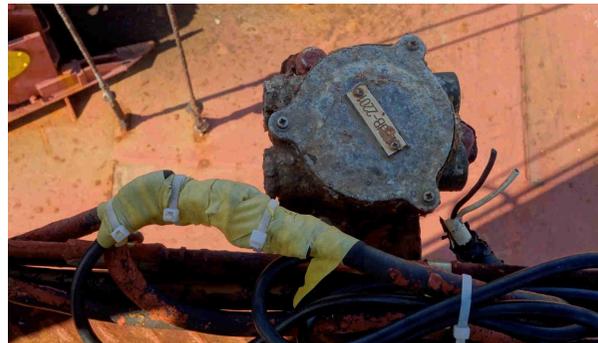
picture 8: self made connections.

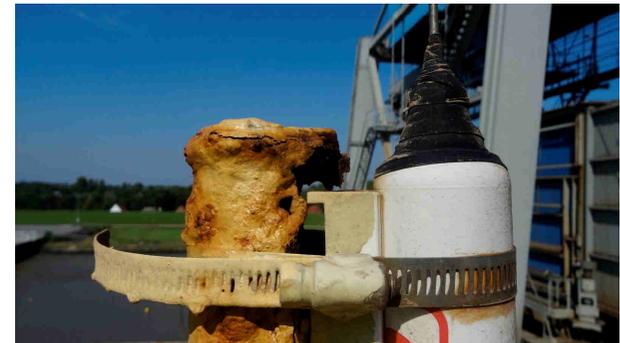
picture 11: rusted foundations

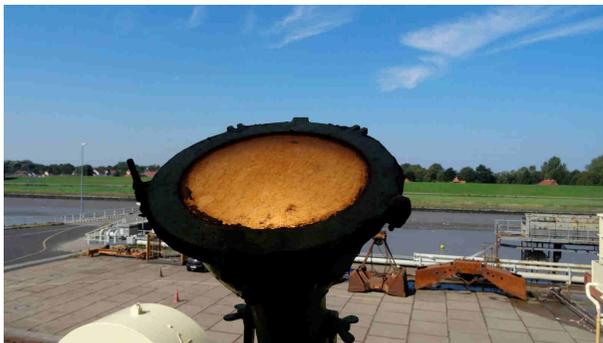
picture 6: in poor condition also this flood light

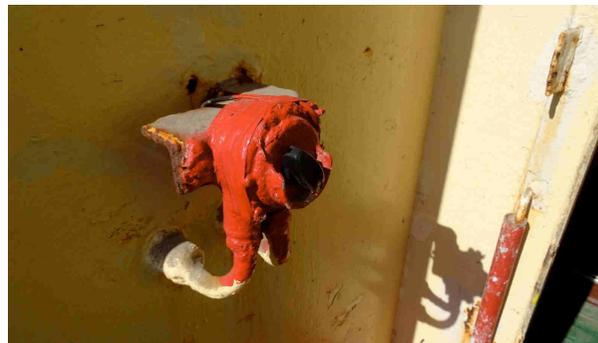
picture 9: switch, repaired by tape and some cable

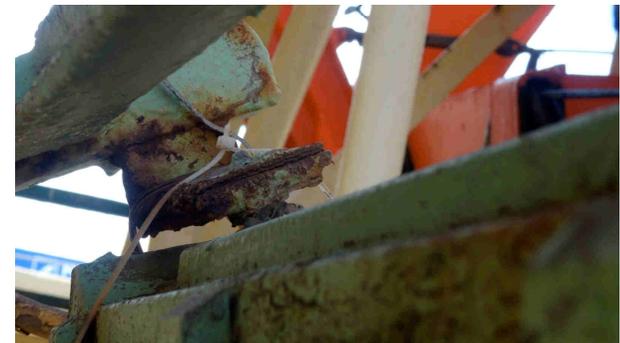
picture 12: rusted and broken holder fixed by straps

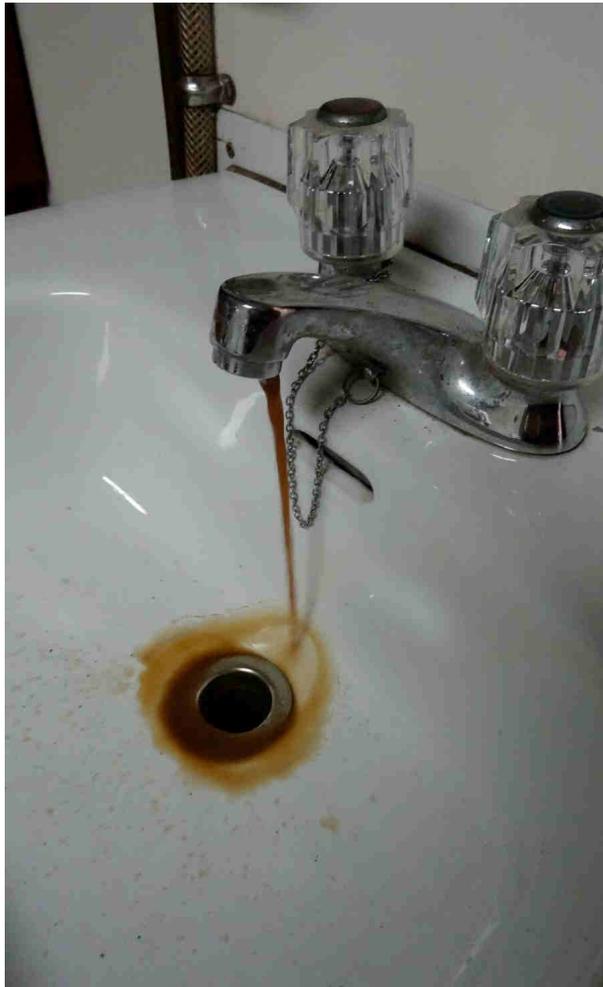
picture 13: fresh water in ship hospital

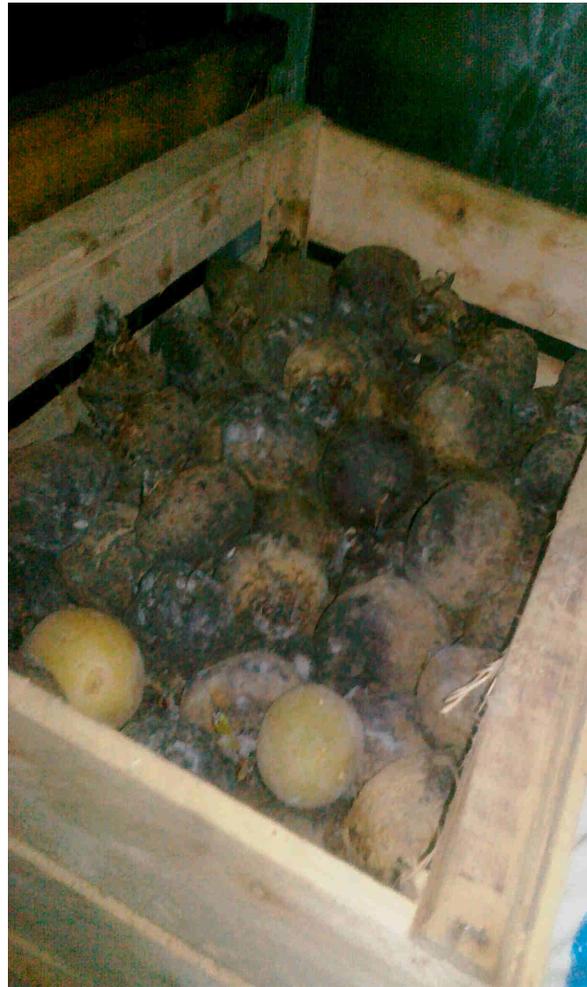
picture 14: vegetables in provision store

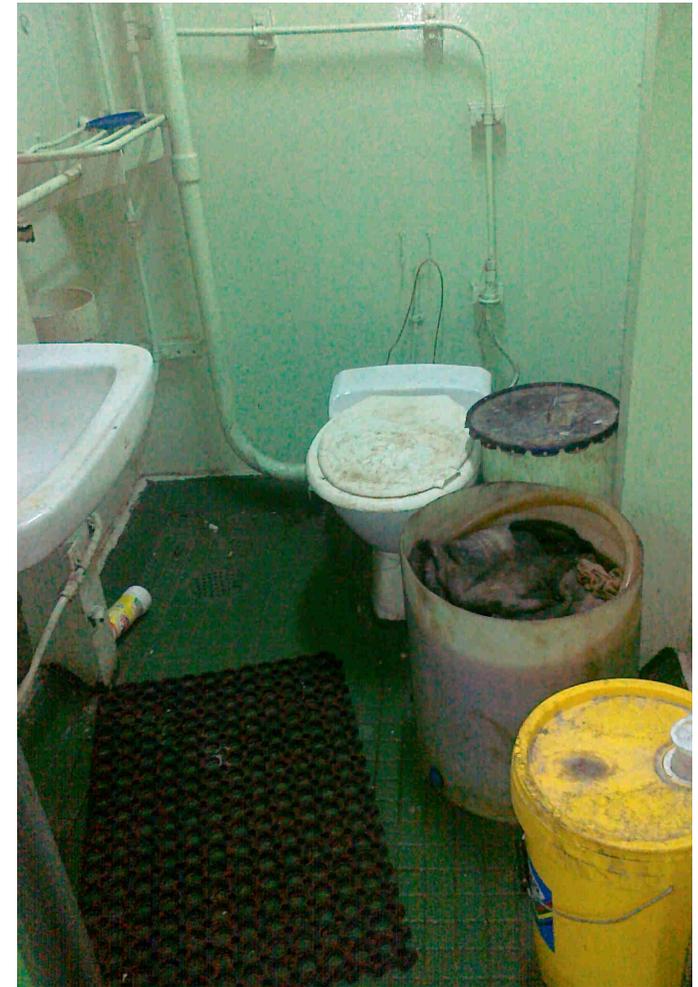
picture 15: condition of public toilets

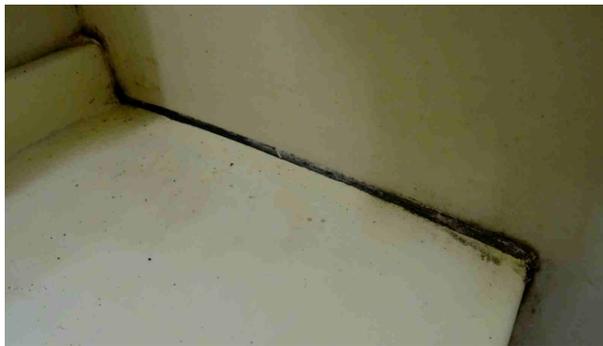
picture 16: crew cabins showing mould in all corners

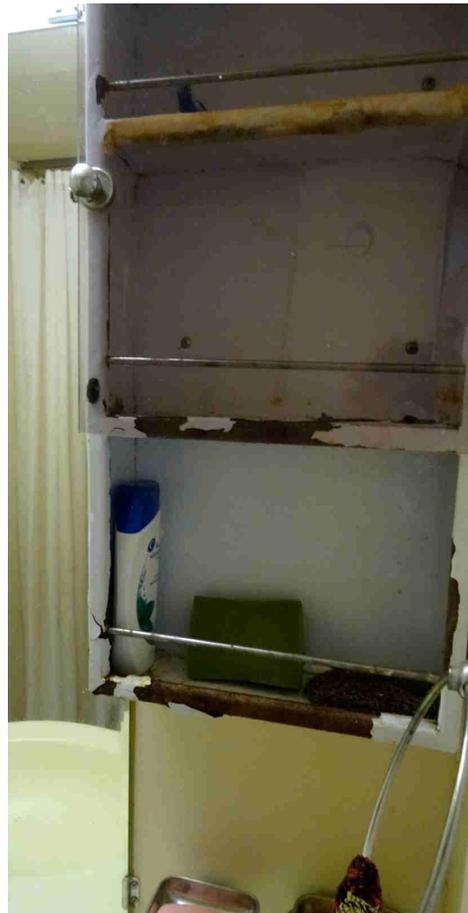
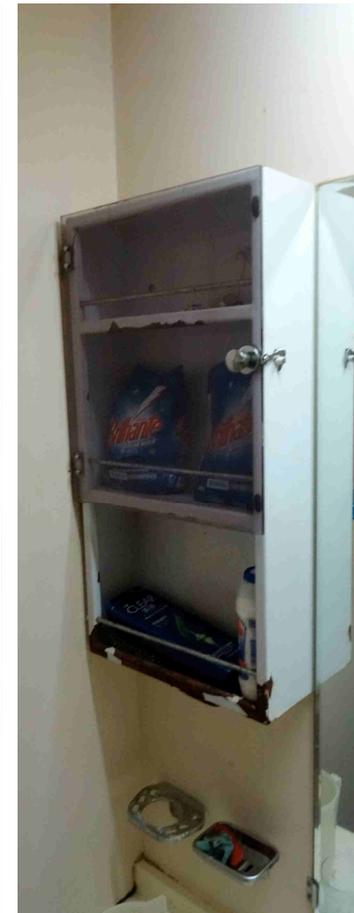
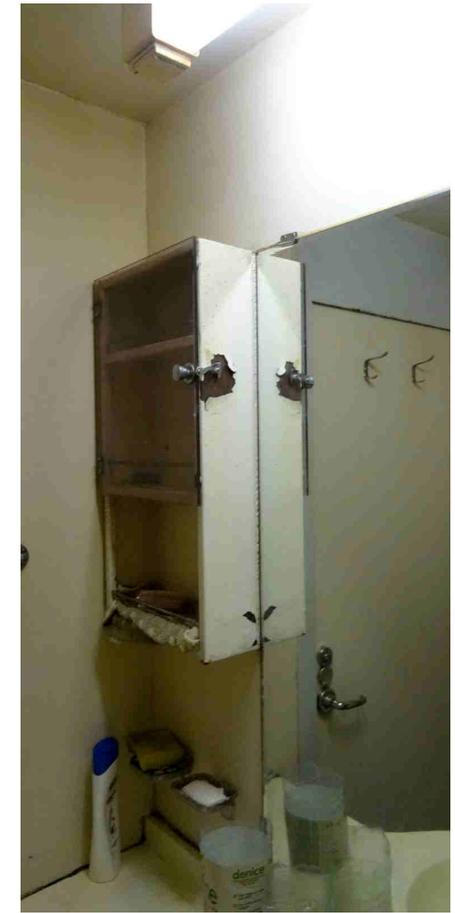
picture 17-19: in crew cabins all racks rusted and/or damaged; mould in all corners

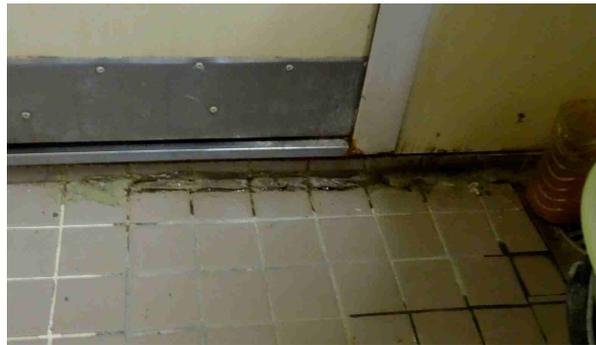
The flagged floors in crew cabins were found dent so there were openings between the tiles. When using showers some water was going in the space between.

picture 20: damaged tiles with some mould

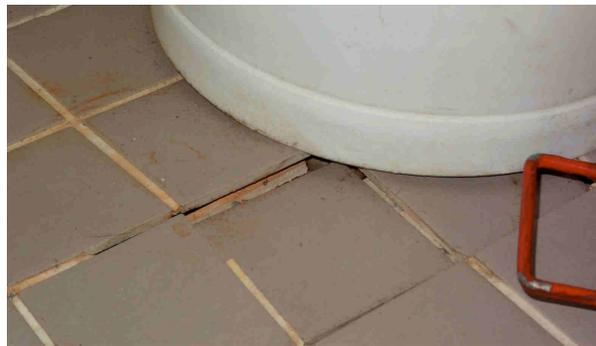
picture 21: water from showering gone in this spaces..

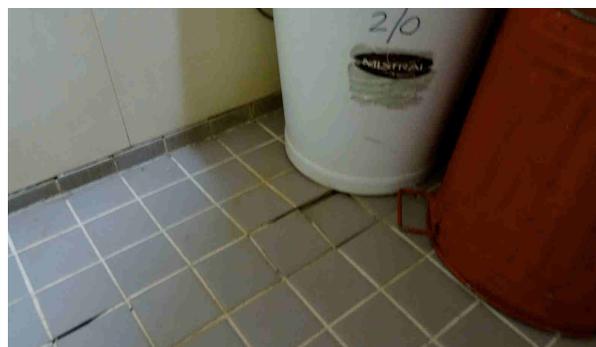
If walking in the washing rooms from the movement a black liquid of old stagnant water was pressed through the openings like an artesian well. This effect was increased by missing shower curtains, so more water could go into the bottom.

picture 22: when moving on floor stagnant water pressed out like on an artesian well

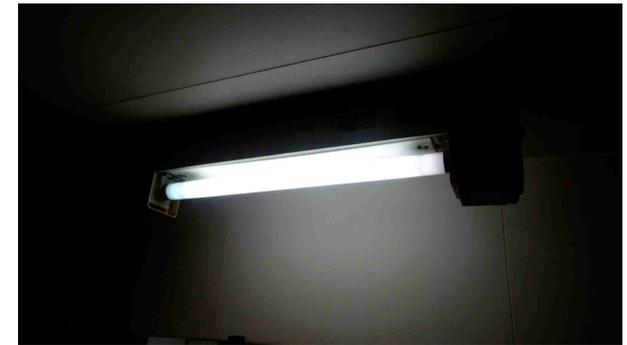
Additional the light covers in the bathrooms were damaged or missing, so danger of electric accidents.

picture 23: missing covers on light - electrical unsafe

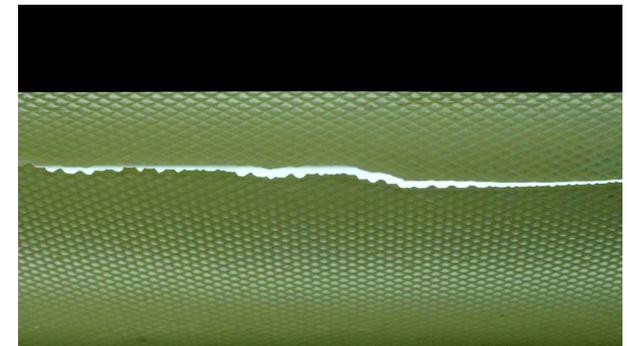
picture 24: if not missing then damaged covers found

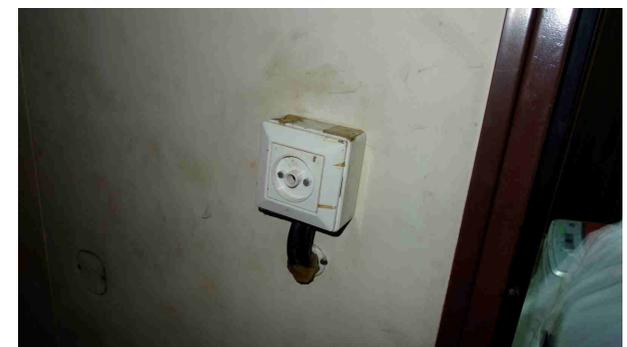
picture 25: damaged light switch

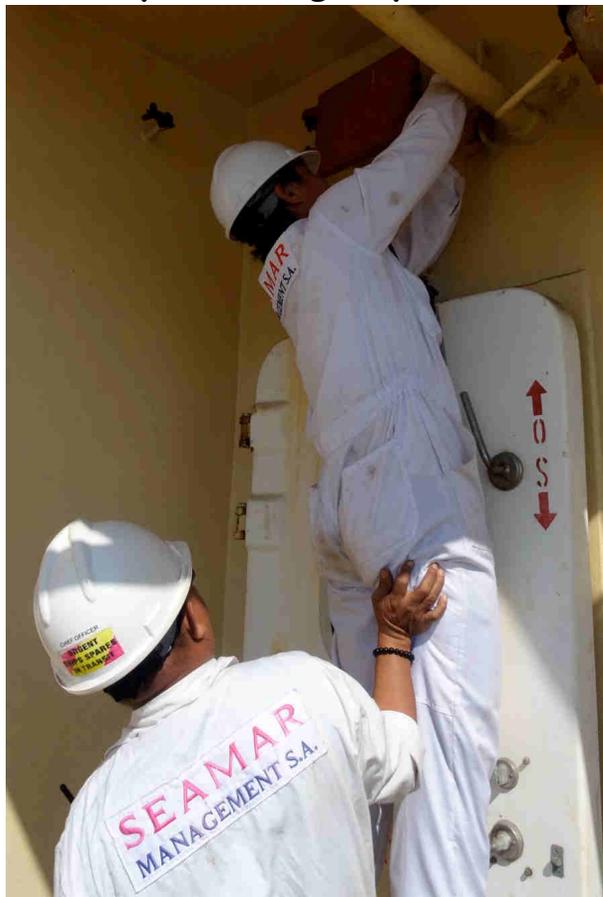
picture 26: for normal flaps just ~~one~~ two

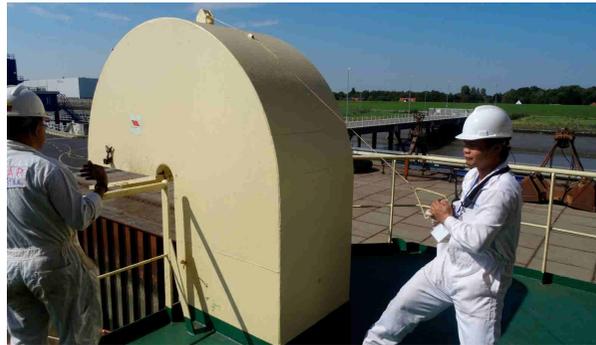
picture 27: for big flaps principally only one crewmember

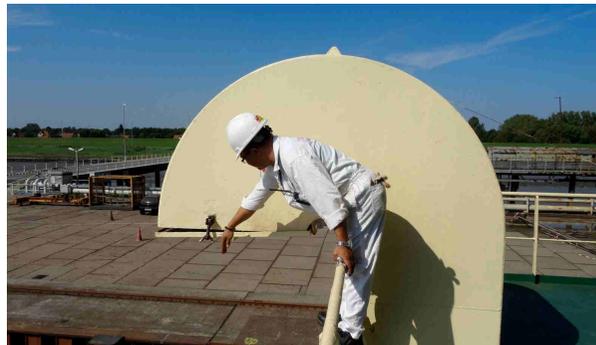
picture 28: ..with one assistant for locking left side

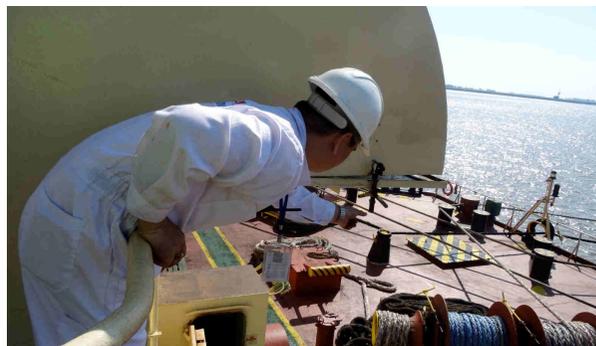
picture 29: ..and one additional for the right side lock

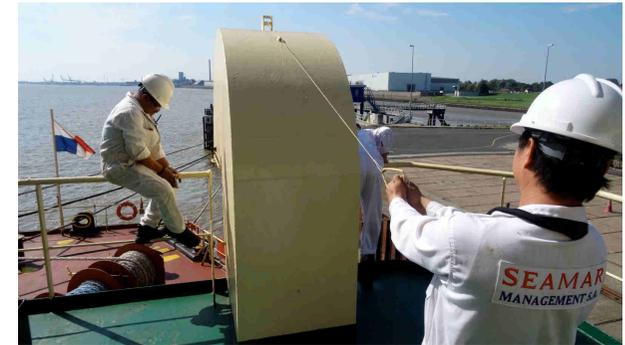
picture 30: together you need one strong crewmember for closing and keeping...

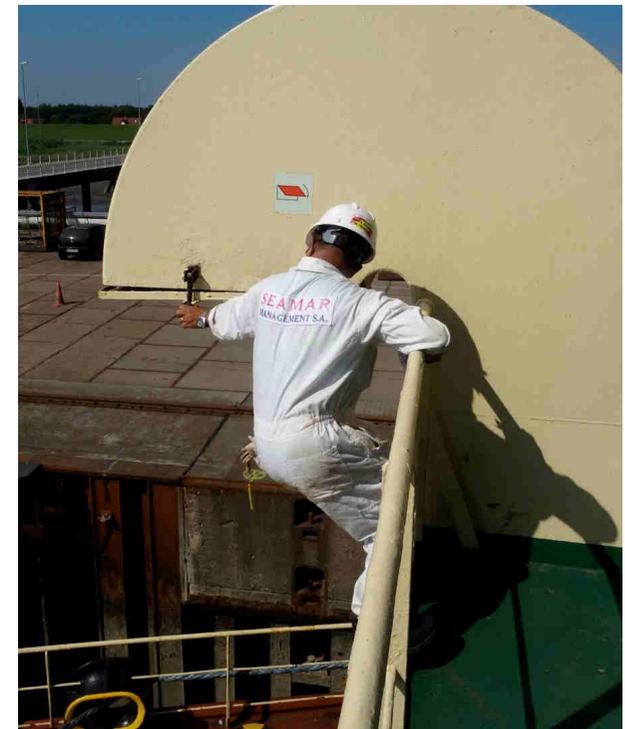
picture 31: ..and two former circus balancing actors for locking the flap - all together three persons necessary

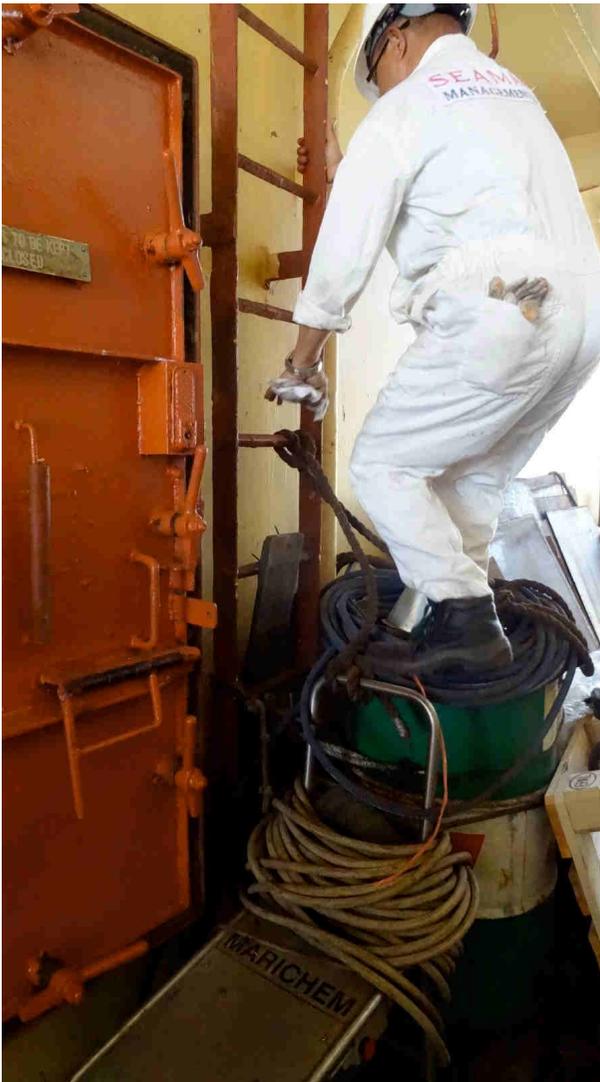
picture 32: crew artistic abilities were also shown on tasks like "using a ladder"

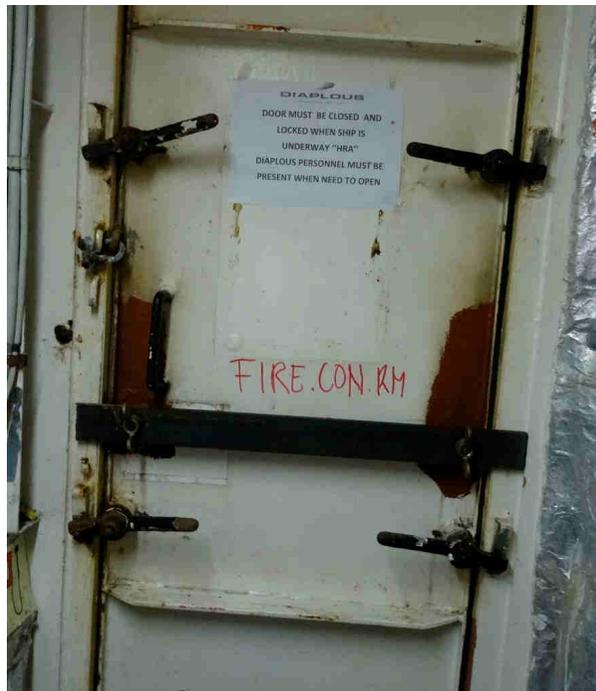
picture 33: Entrance to fire station secured from inside, so in case of fire not possible to reach equipment
