# UNITED STATES COAST GUARD

## MARINE SAFETY LESSONS LEARNED

Lessons Learned 01-19

### **Avoid delays and keep your ship on schedule!** **Does your BilgMon 488 Bilge Alarm / Oil Content Meter operate properly?**

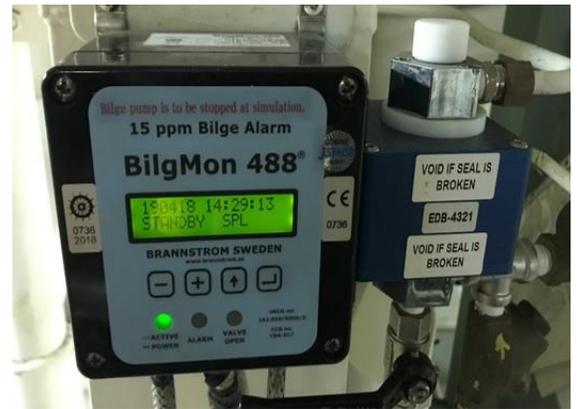
Recently, Marine Safety Detachment (MSD) Port Canaveral Port State Control Officers (PSCOs) identified MARPOL deficiencies related to the 15-ppm Bilge Alarm system of the Oily Water Separators (OWS) onboard four separate ships. They discovered that the entries in the Oil Record Book (ORB) did not correspond to the Bilge Alarm Data being displayed by the bilge alarm / oil content meter. The 15-ppm Bilge Alarm is required to record date, time, alarm status and the operating status of the 15-ppm Bilge Separator. The recording device should also store this data for at least eighteen months and be able to display or print a protocol for official system inspections as required by IMO Resolution MEPC.107(49), REVISED GUIDELINES AND SPECIFICATIONS FOR POLLUTION PREVENTION EQUIPMENT FOR MACHINERY SPACES OF SHIPS. In each case, PSCOs issued a deficiency on the Port State Control Report of Inspection (Form B) requiring that each vessel needed to verify the validity of the entries in the Bilge Alarm data log against the entries in the ORB. The deficiencies found were required to be rectified to the satisfaction of Recognized Organization, Flag Administration, and the U.S. Coast Guard prior to the vessels' departure from port.

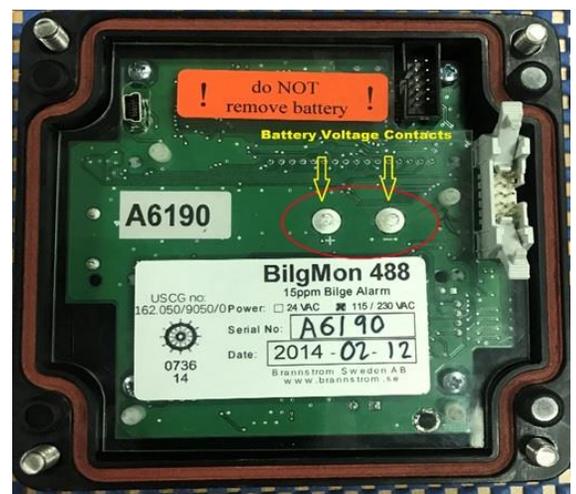
The specific monitor in these cases was the BilgMon 488 model manufactured by Brannstrom, a Swedish company. The older model, BilgMon 488 shown on the right, has a battery that is not replaceable by the crew inserted behind the circuit board of the Bilge Alarm. The purpose of the battery is to maintain the stored data and Real Time Clock (RTC) when the unit is disconnected from a power supply. The circuit board contains two contact points which provide the ability to measure the battery voltage. In all four cases, the battery voltage was extremely low and failed to provide the required 2.5 volts necessary to maintain the stored data without error. As a result, when the data was viewed on the LCD screen it was scrambled and inaccurate. The operator's manual for this model clearly states that, under no circumstances should the battery be removed. Furthermore, a red warning sticker is affixed to the circuit board as pictured above. Attempting to remove the battery in this circumstance may cause an unrecoverable error, failure and data loss. A manufacturer's representative indicated that the battery was originally designed to last the lifetime of the device and that if the RTC stops due to a power supply

failure combined with a low back-up battery voltage, the unit is locked down and the display reads "RTC check: FAILED." [Click here for the applicable manual.](#)<sup>1</sup>

- Remind vessel engineers to routinely review the stored data available through the LCD display ensuring that the data matches the information recorded in the ORB and actual OWS operations.
- Maintain awareness that Port State Control Officers performing MARPOL examinations will verify that the BilgMon 488 is recording data properly and is aligned with the ORB entries. **Avoid potential departure delays.**

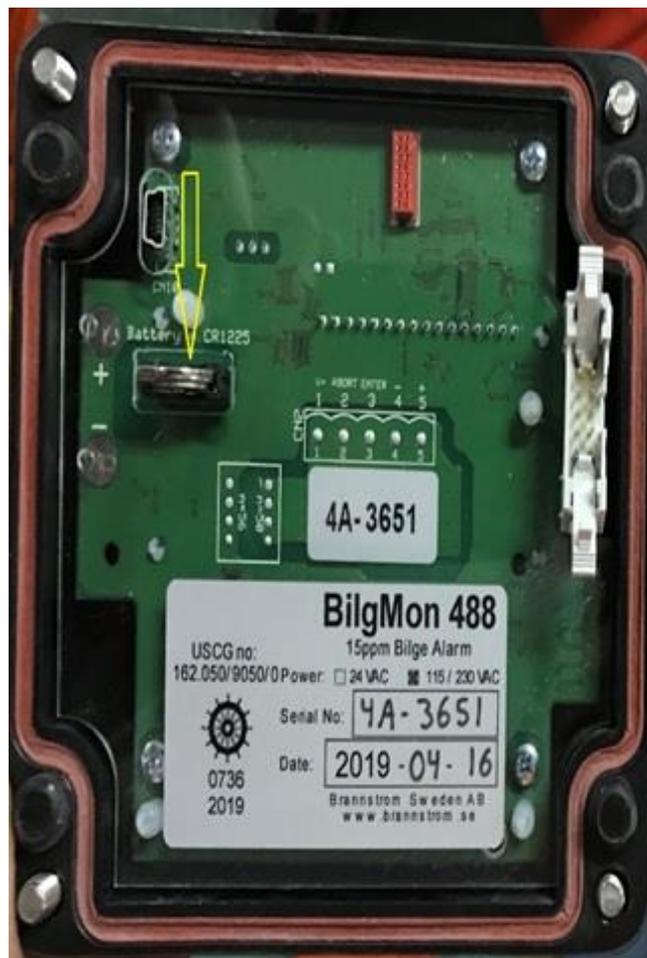
The newer model BilgMon 488 is equipped with a replaceable battery shown on the right below the yellow arrow. As a result, when the battery weakens the unit display will read "Batterylow: 0.5V Replace battery." The battery can then be safely removed because it utilizes a capacitor that ensures enough energy to maintain the stored data for several hours. [Click here for the applicable manual.](#)<sup>2</sup>
