Sub-Standard vessels in German ports 2016

Ship name: INDEPENDENCE II
IMO no.: 9070448
Flag: United States
Ship type: Car carrier
MMSI: 367318000
Call sign: WGAX
Gross tonnage: 55598
Keel laying date: 02.12.1993

Port of detention: Bremerhaven (Germany)
Detention date: 05.02.2016
Duration of detention: 5 days

The inspection revealed 22 deficiencies of which 12 were considered as ground for detention (3 RO related) and 18 as ISM-related.

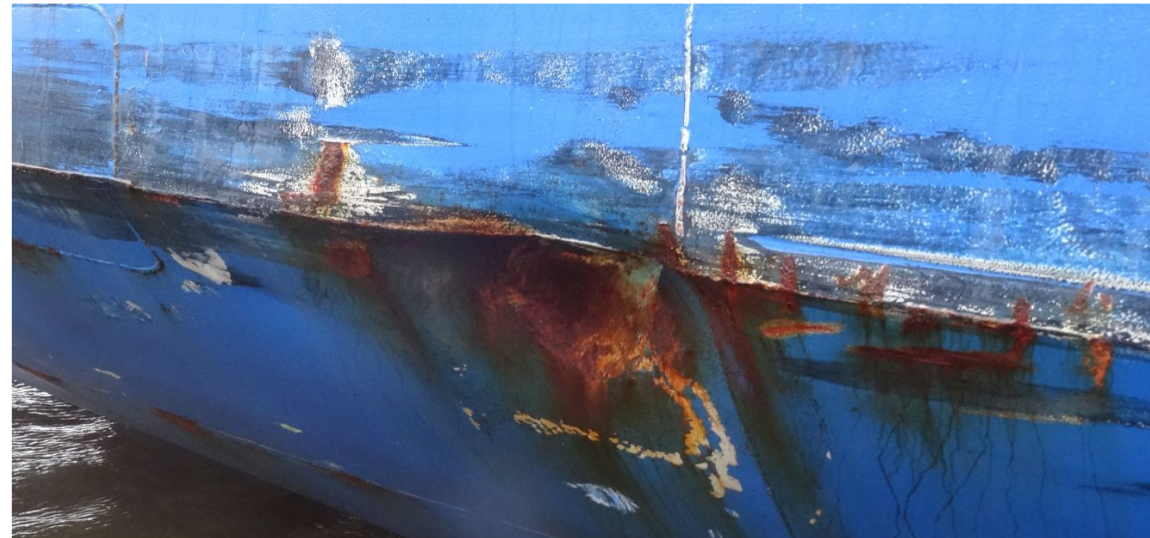
Picture 1 - bents on the outside hull, aft part

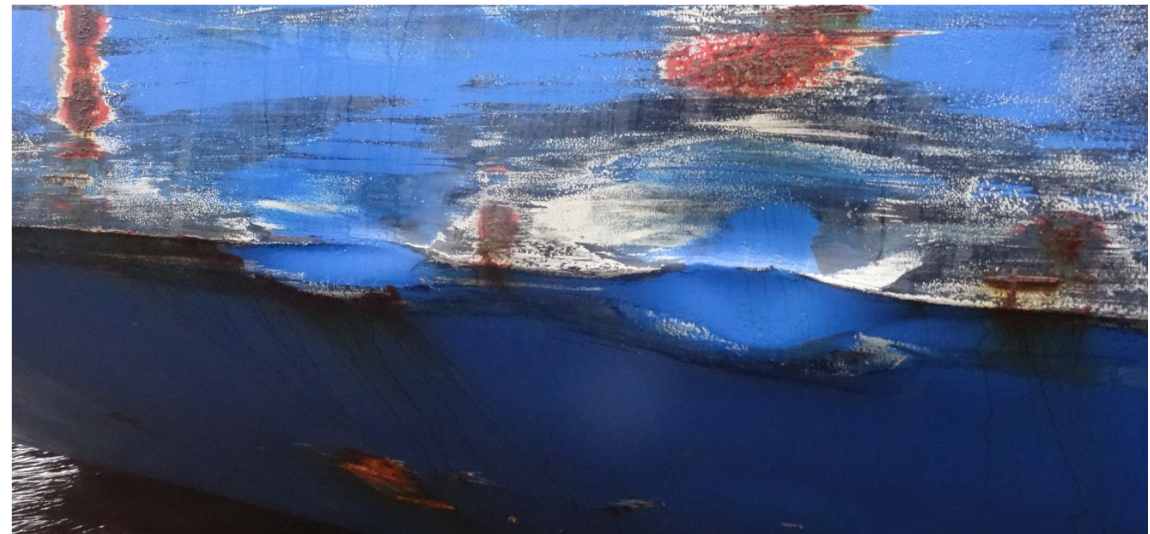
Picture 2 - bents on the outside hull, aft part

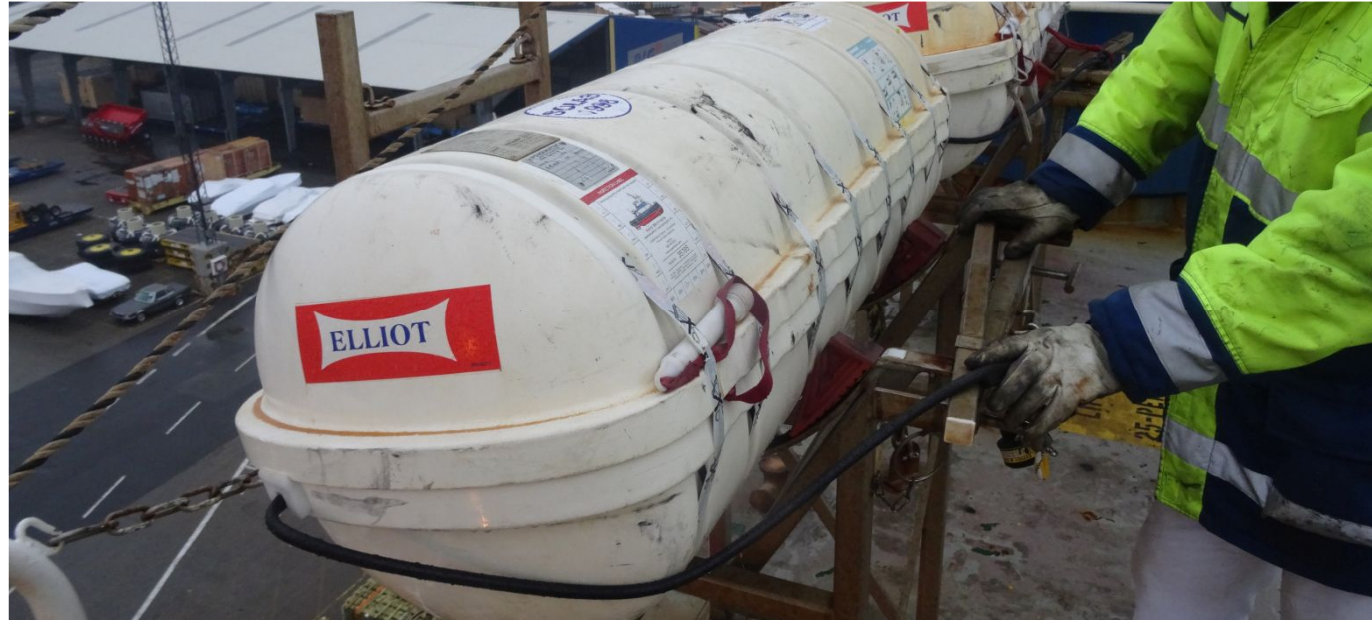
Picture 3 - liferafts only stored on board by painter line on weak link

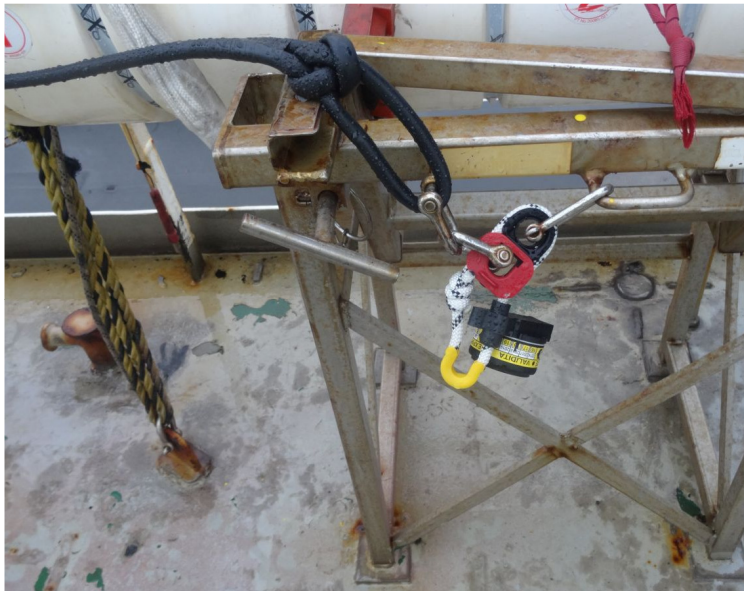
Picture 4 - not connected hydrostatic release unit

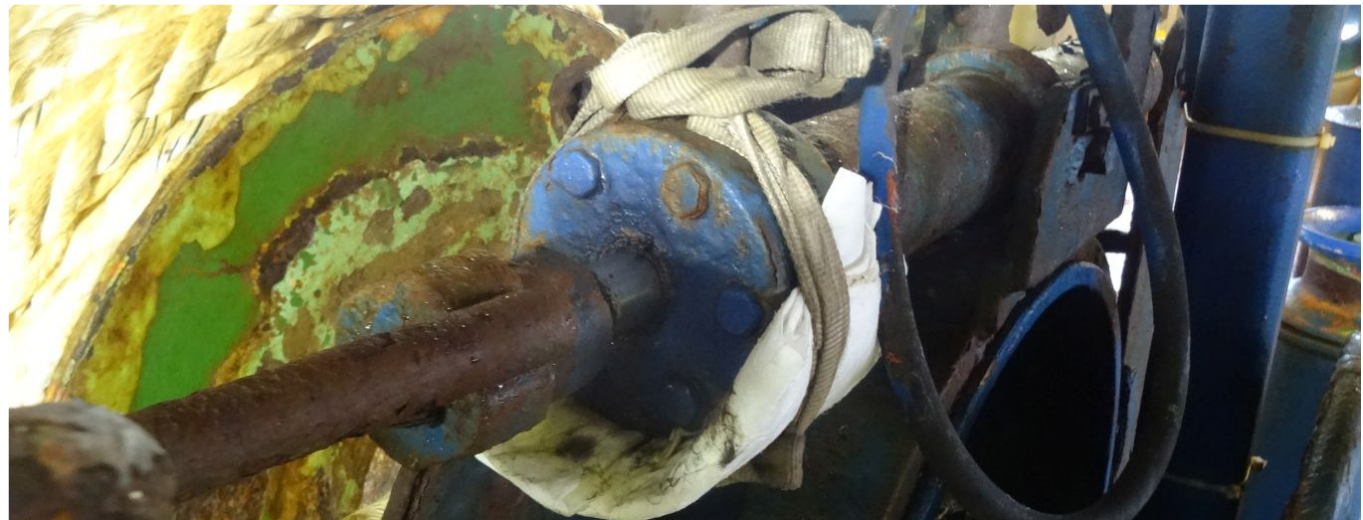
Picture 5 - known oil leakages on mooring winches found "temporary" repaired

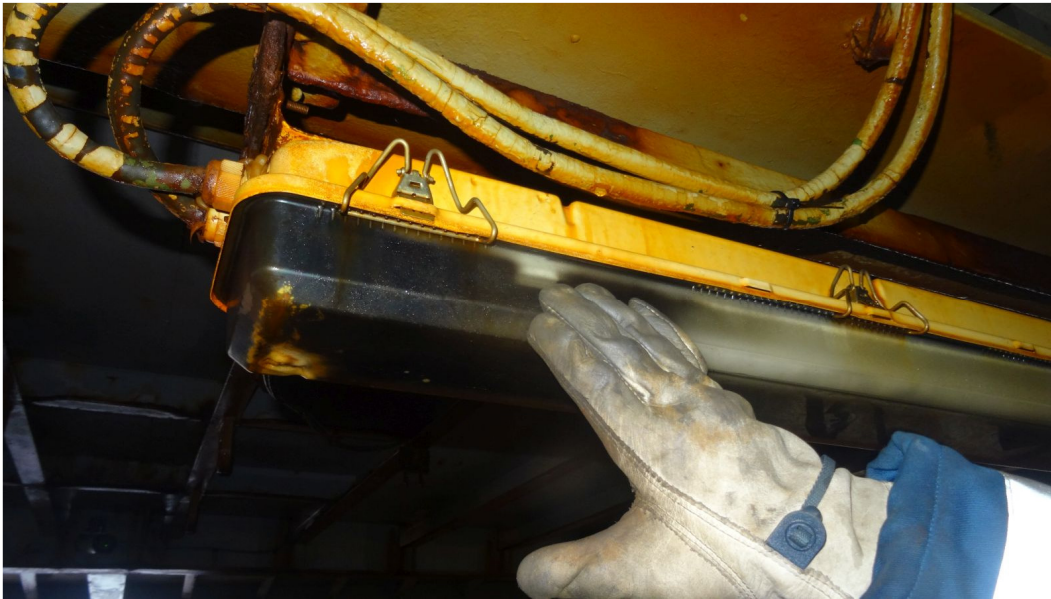
Picture 6 - when switching on, the lights on pilot station caught fire...

Special highlight on this inspection had been the pilot station. When the PSCO asked for switching on the lights, a firework starts: Sparklings from shortcuts observed on the lights and two cases caught on fire.

The effective fire fighting was highly appreciated, but notwithstanding that a deficiency for "unsafe electrical installation" was added to the report.

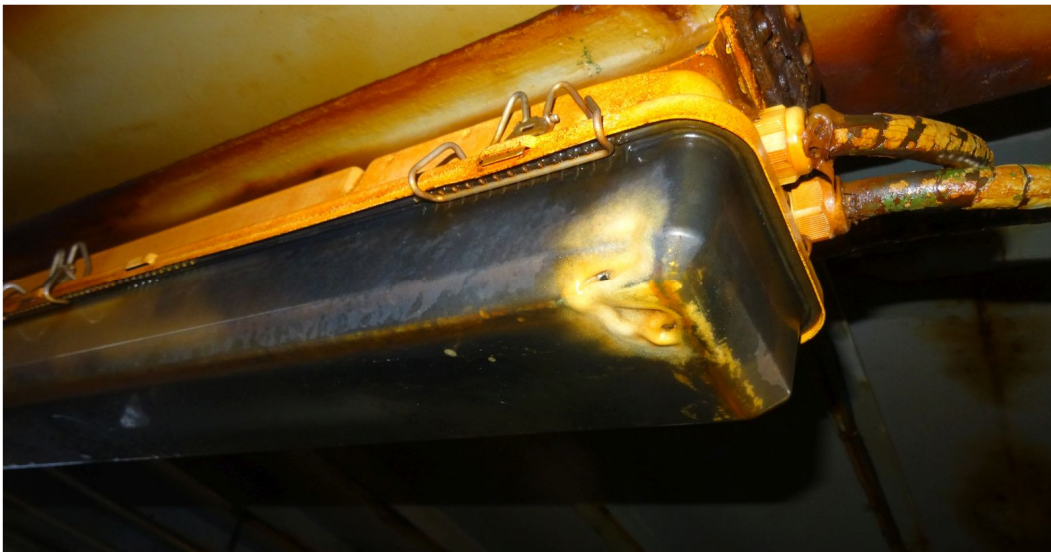
Picture 7 - ...which was fortunately killed immediately by water inside the light case

The heating of the fire melted the plastic case what causes water inside the lamp to flow to the burning side of the case.

This water killed the fire quickly, so no further damage observed.

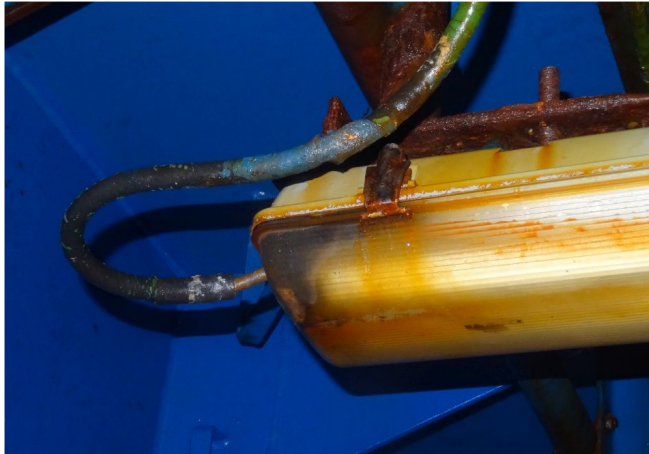
Picture 8 - several lights found in bad condition...

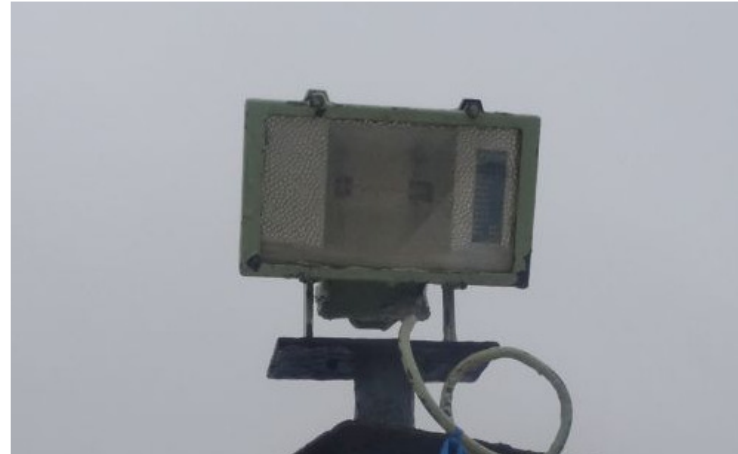
Picture 9 - ... or just not working ...

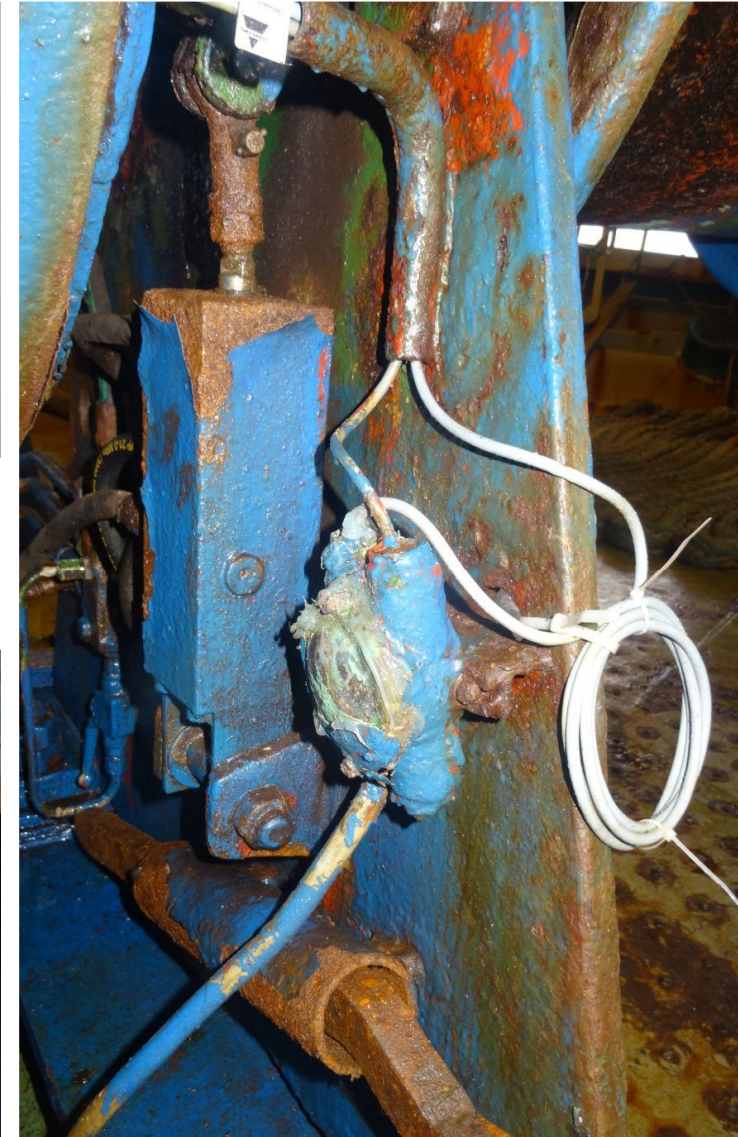
Picture 12 - ... general in poor condition

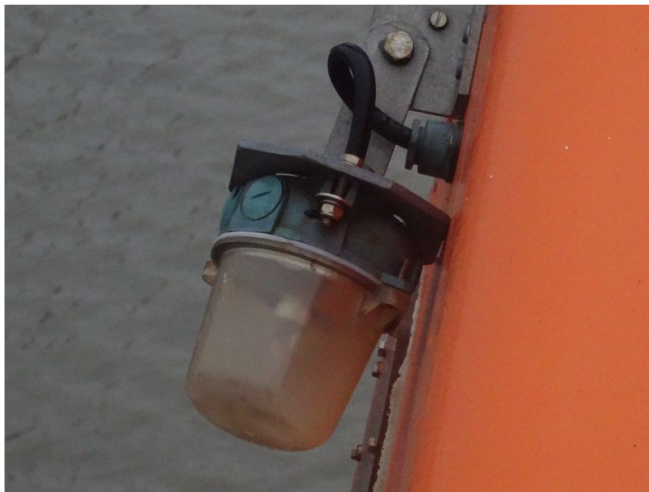
Picture 10 - ... including FFB Navigation light

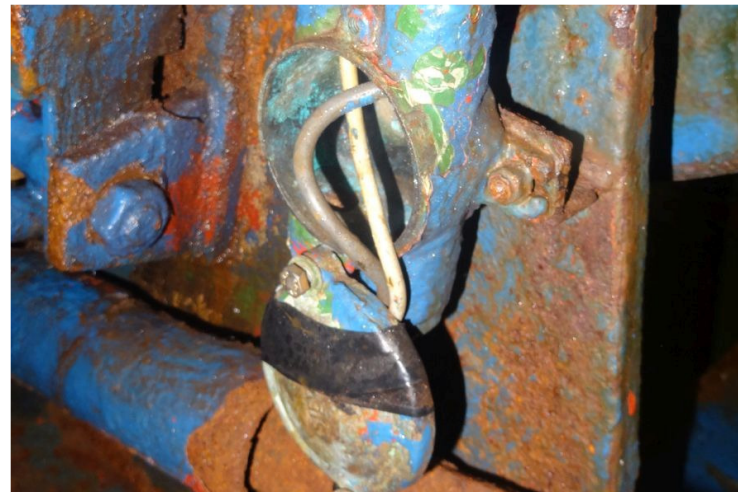
Picture 11 - electric installations on deck ...

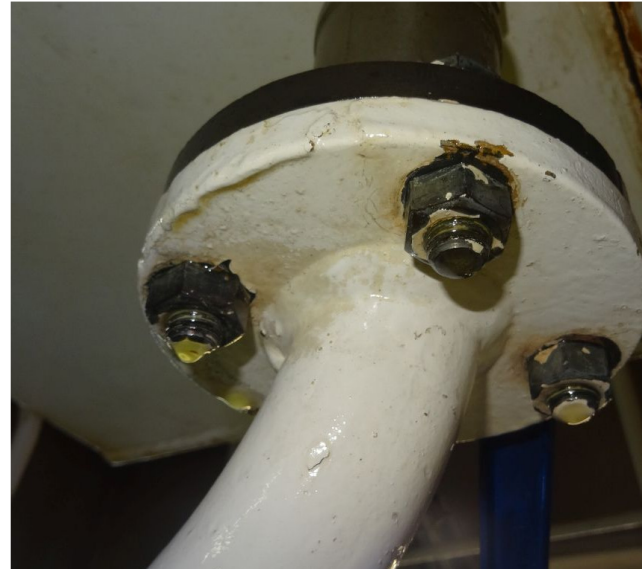
Picture 13 - everywhere small oil leakages

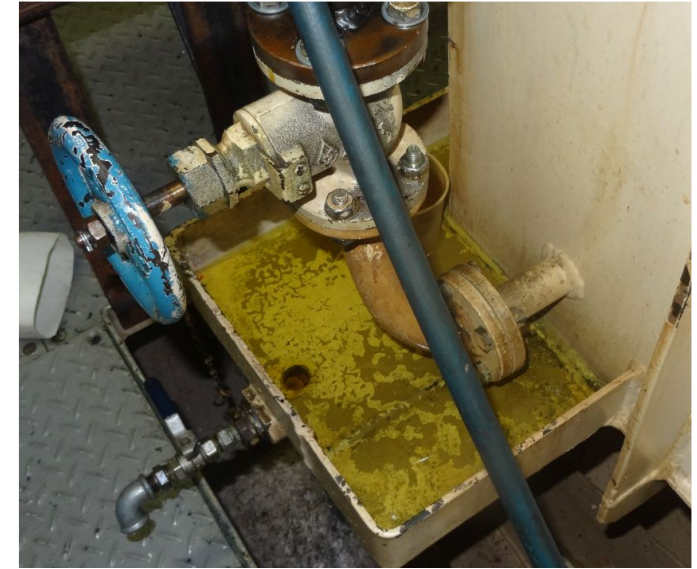
Picture 14 - areas full of spoiled oil

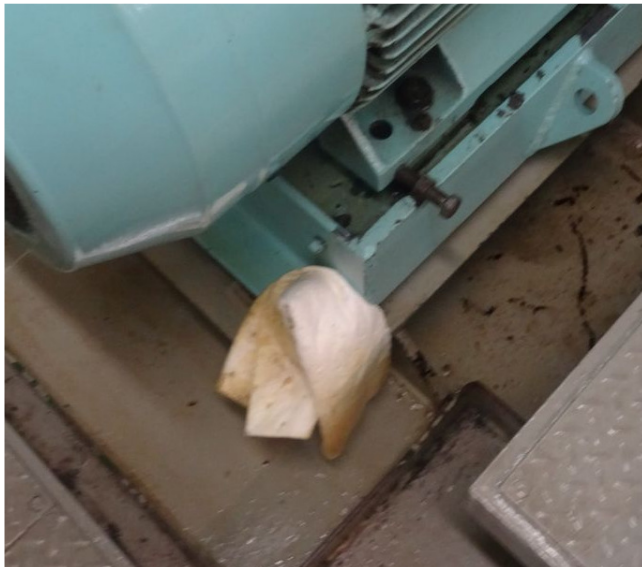
Picture 15 - oil soaked rags on several places

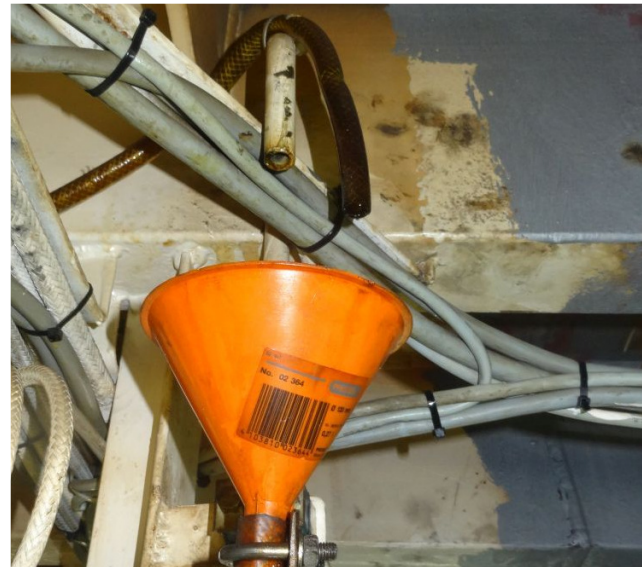
Picture 16 - self-made rubber hose constructions...

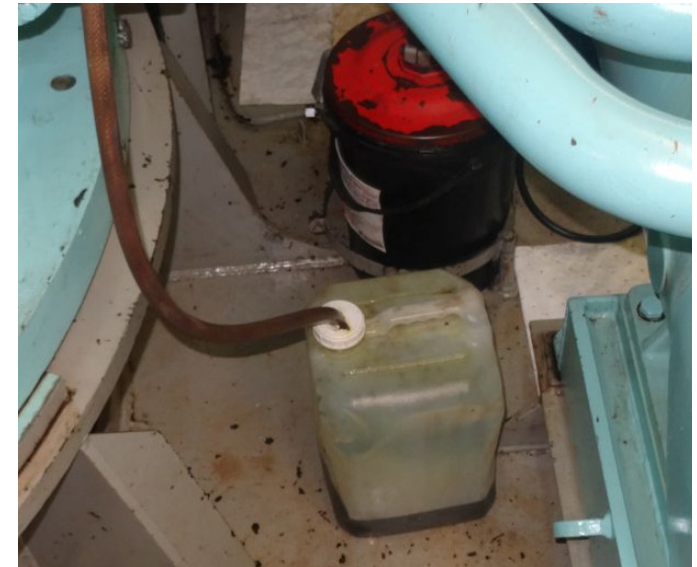
Picture 17 - ... with plastic collection jars ...

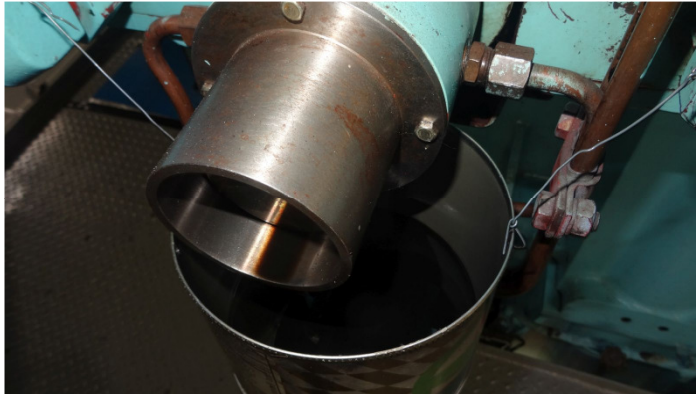
Picture 18 - ... or collection buckets full of oil

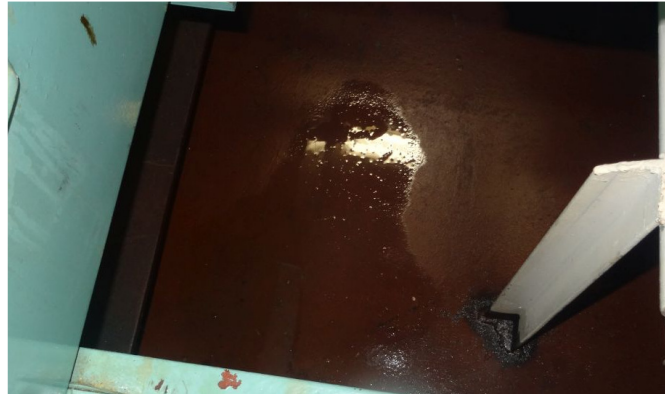
Picture 19 - fuel leakage on emergency generator

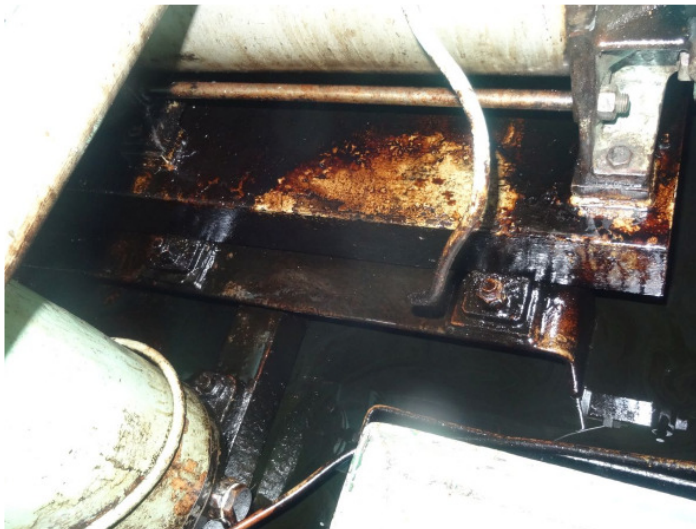
Picture 20 - HFO spill in engine room

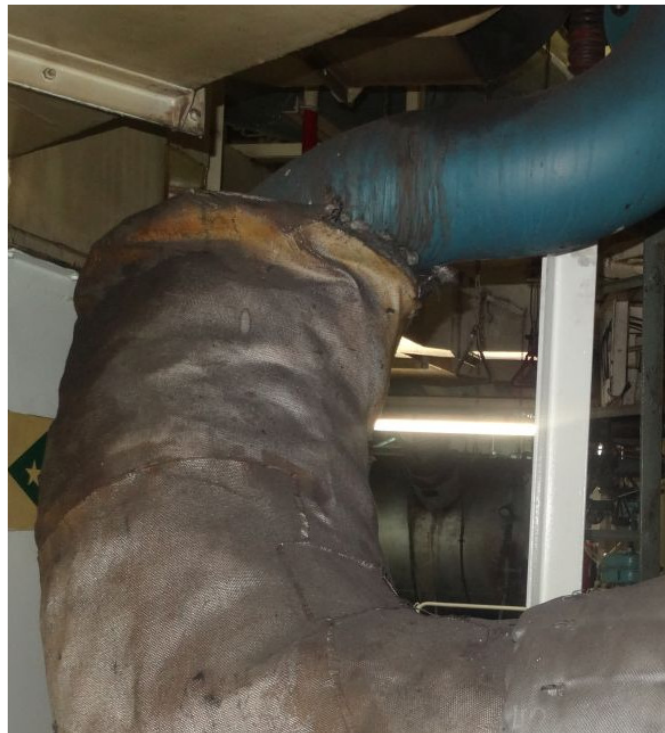
Picture 21 - missing insulation

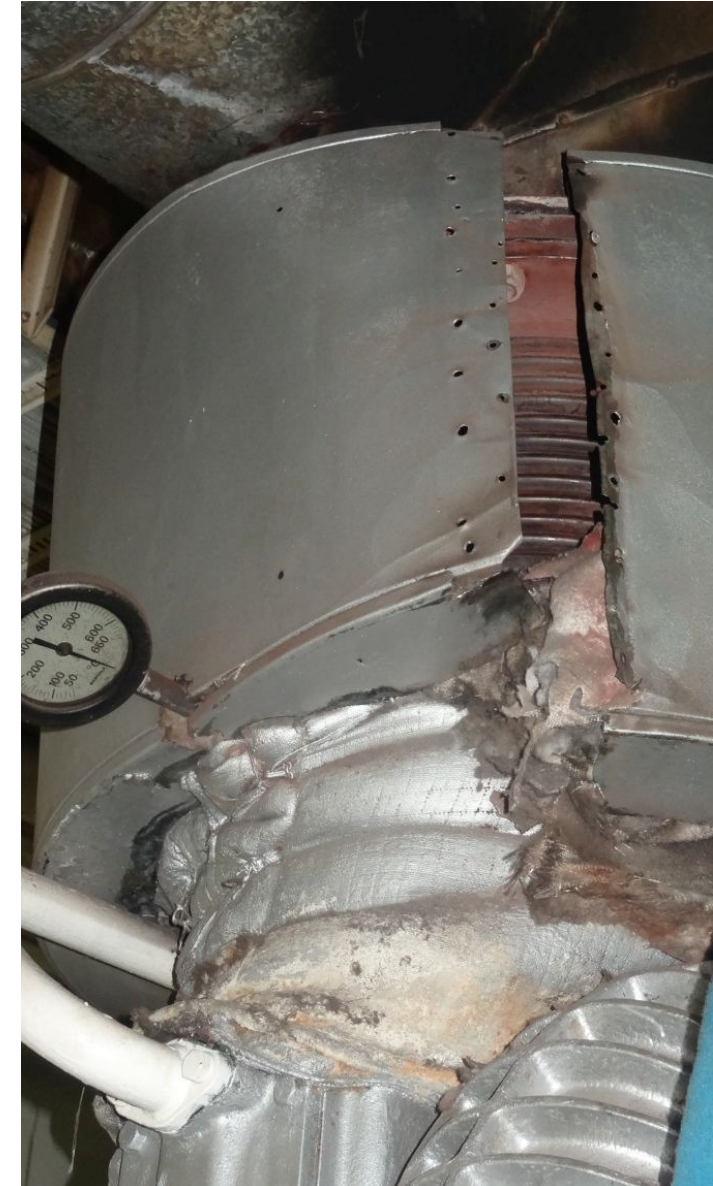
Picture 22 - damaged insulation

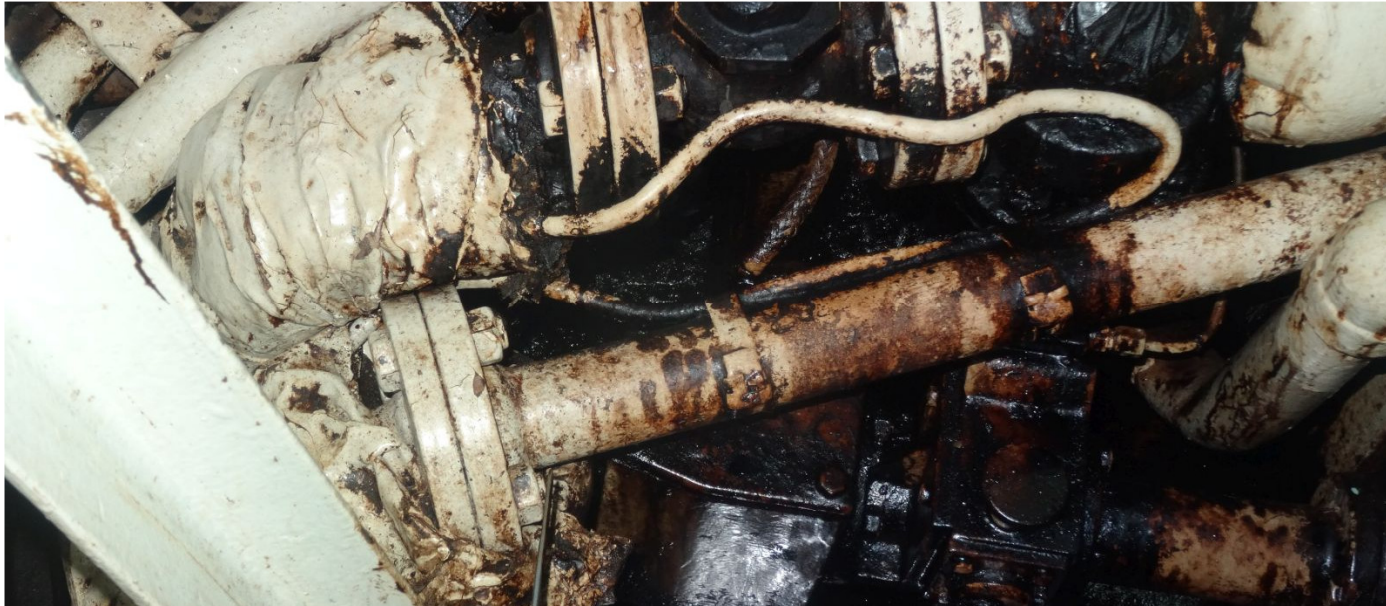
Picture 23 - insulation wetted through oil, insulation partly missing and HFO spill

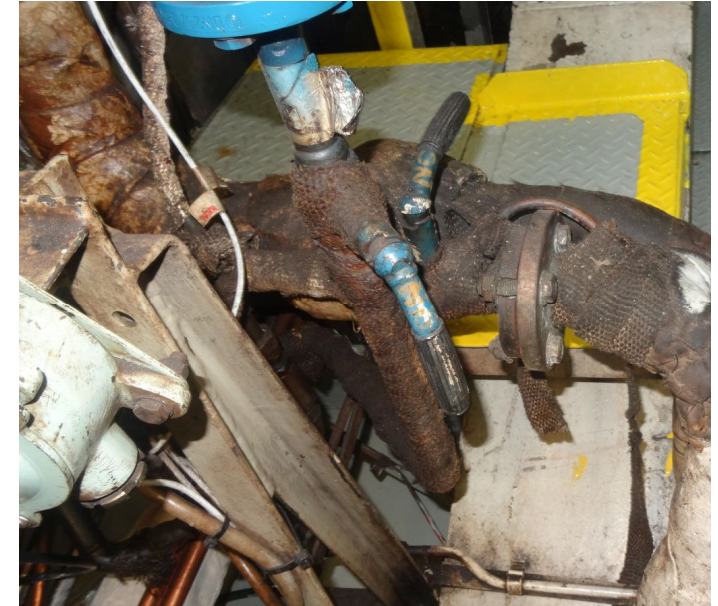
Picture 24 - insulation wetted through oil & damaged

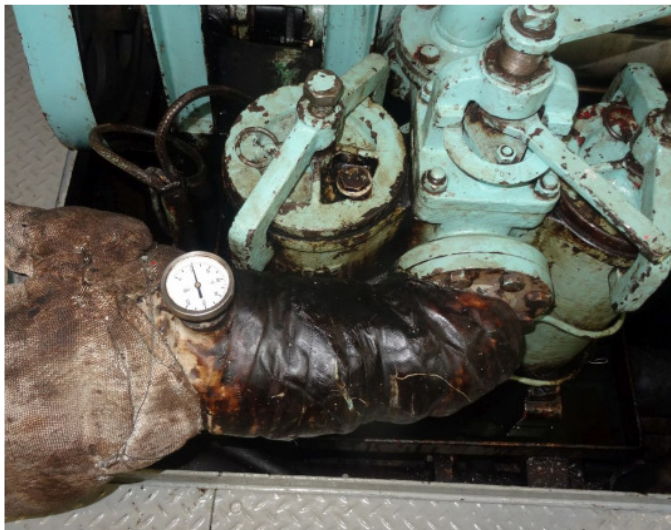
Picture 25 - insulation wetted through oil & damaged

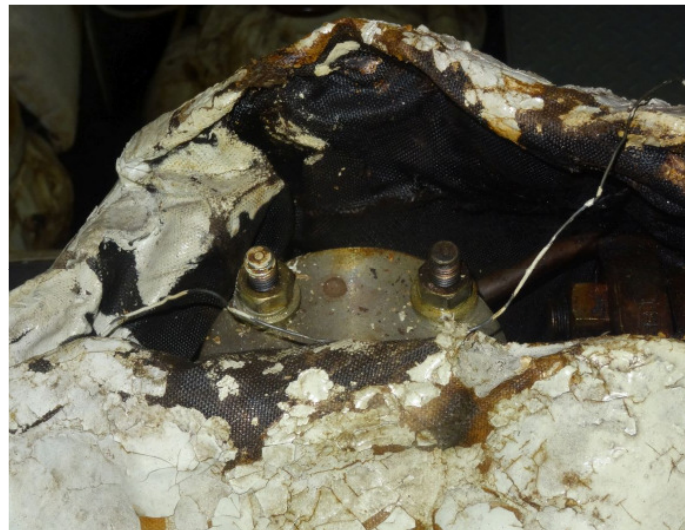
Picture 26 - insulation wetted through oil & damaged

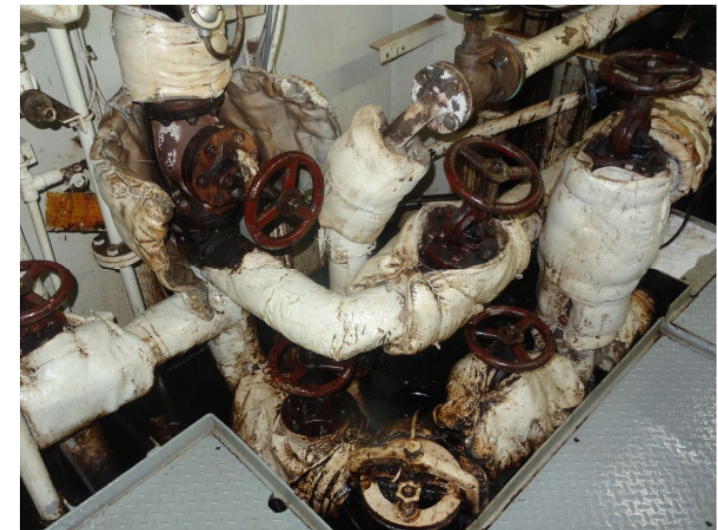
Picture 27 - insulation displaced

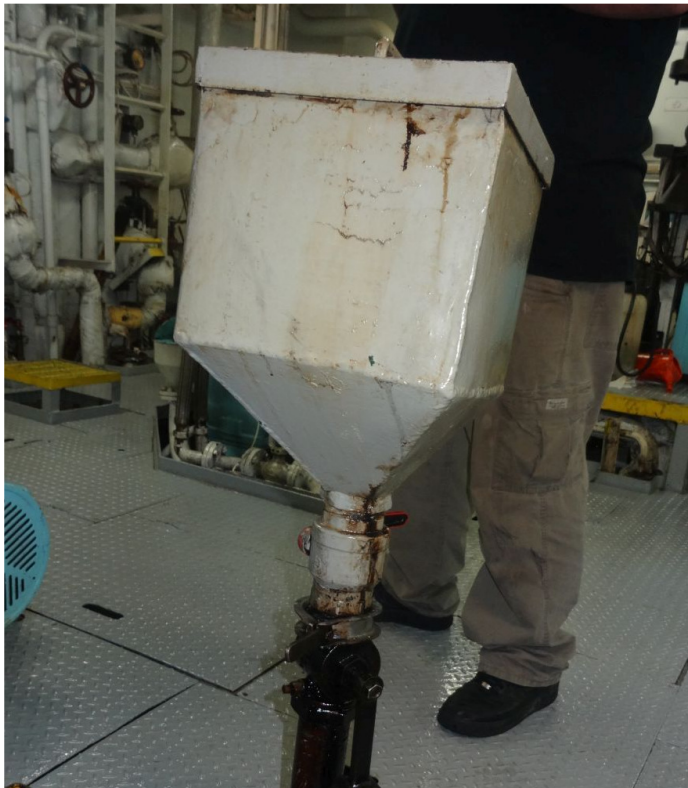
Picture 29 - modification on self-closing valves ...

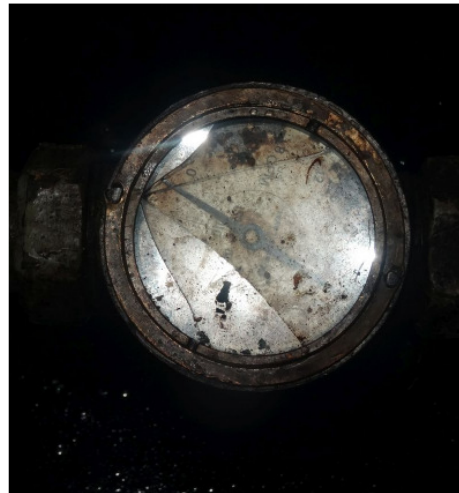
Picture 31

Pictures 31-33 - Several damaged gauges

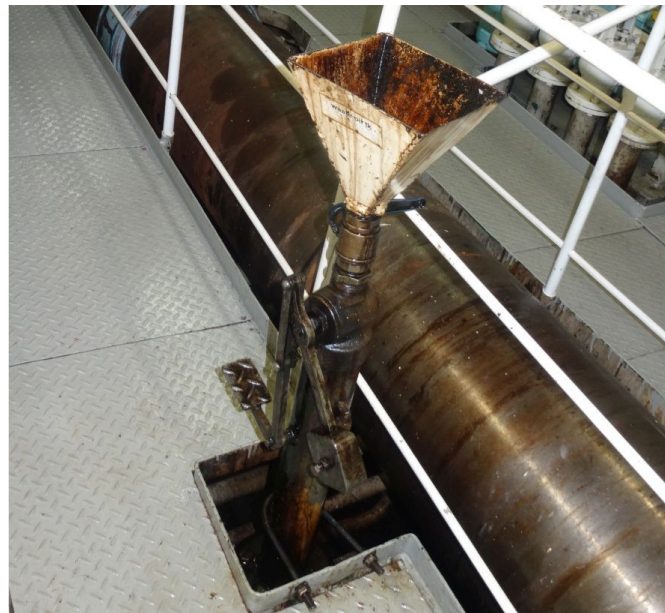
Picture 30 - ...which kept sounding pipes open

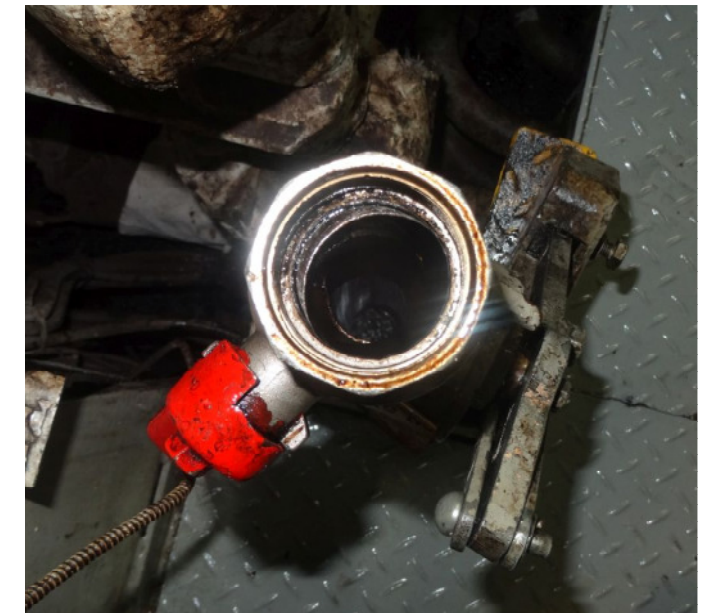
Picture 28 - damaged self-closing valve

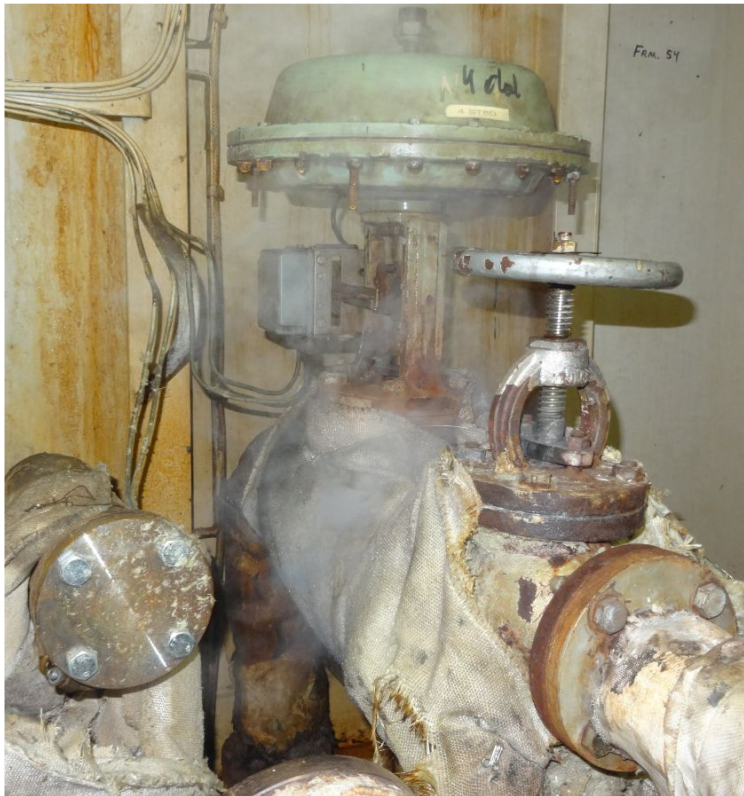
Picture 34 - steam leakage

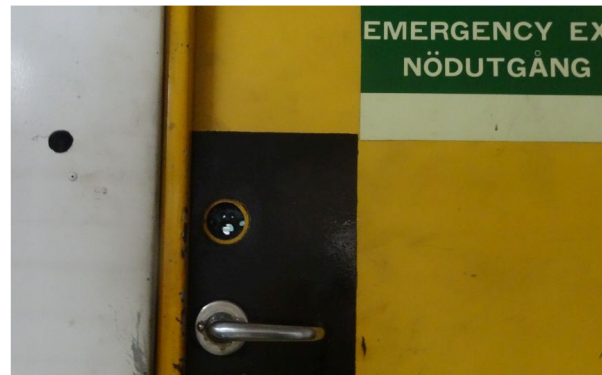
Picture 35 - holed frame, missing lock

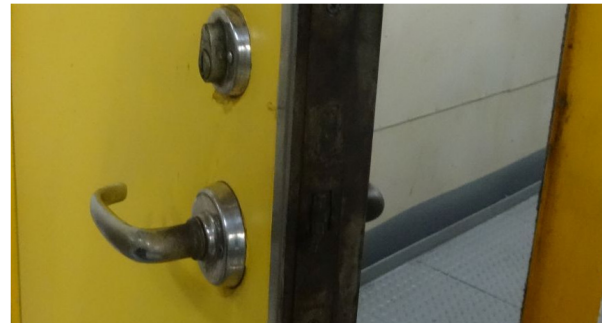
Picture 36 - stuck lock, not closing

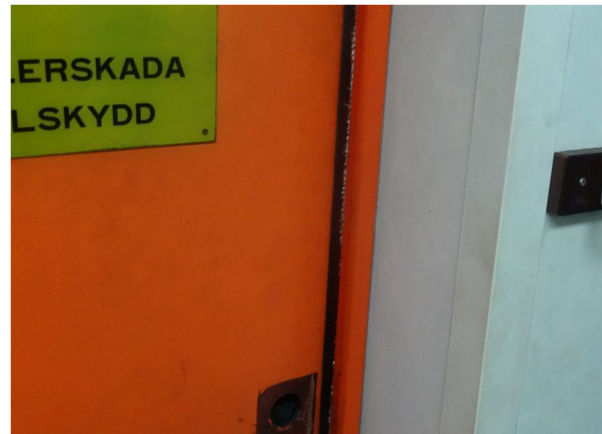
Picture 37 - door not closing, missing lock

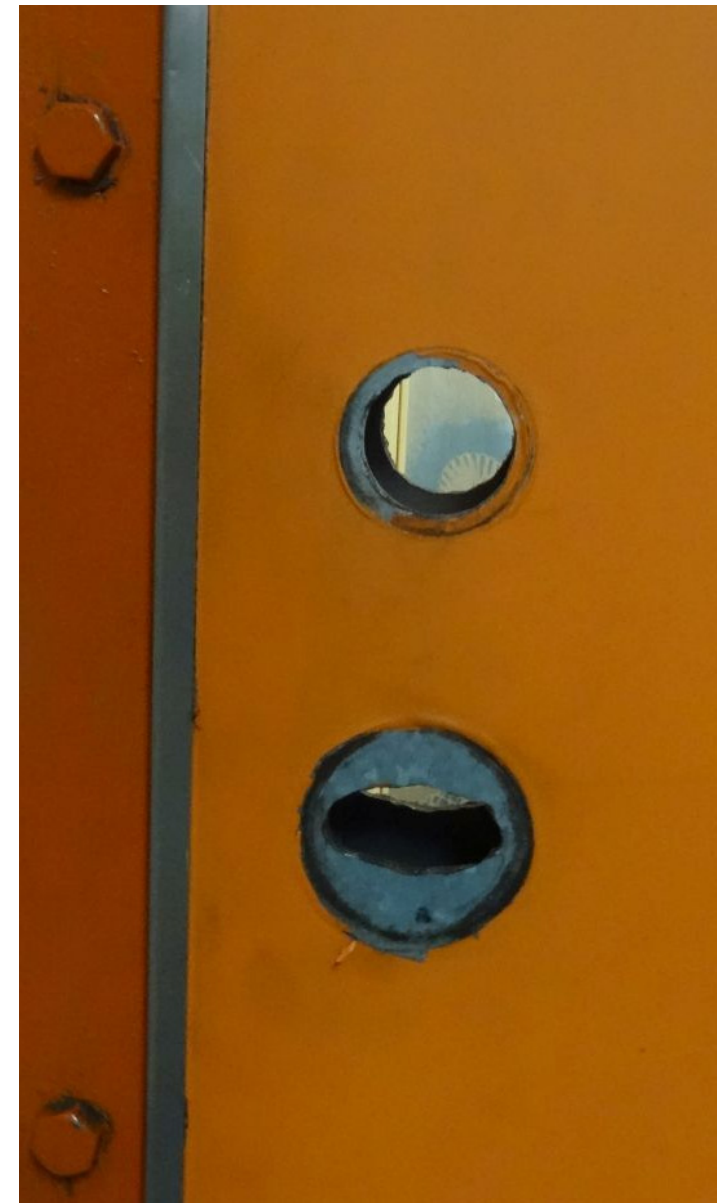
Picture 38 - missing lock and handle on firedoor
