Sub-Standard vessels in German ports 2016

Ship name: UNITED OCEAN
IMO no.: 9071052
Flag: Bolivia
Ship type: General Cargo
MMSI: 720927000
Call sign: CPB3038
Gross tonnage: 3806
Keel laying date: 03.02.1993

Port of detention: Bremen (Germany)
Detention date: 11.04.2016
Duration of detention: 50 days

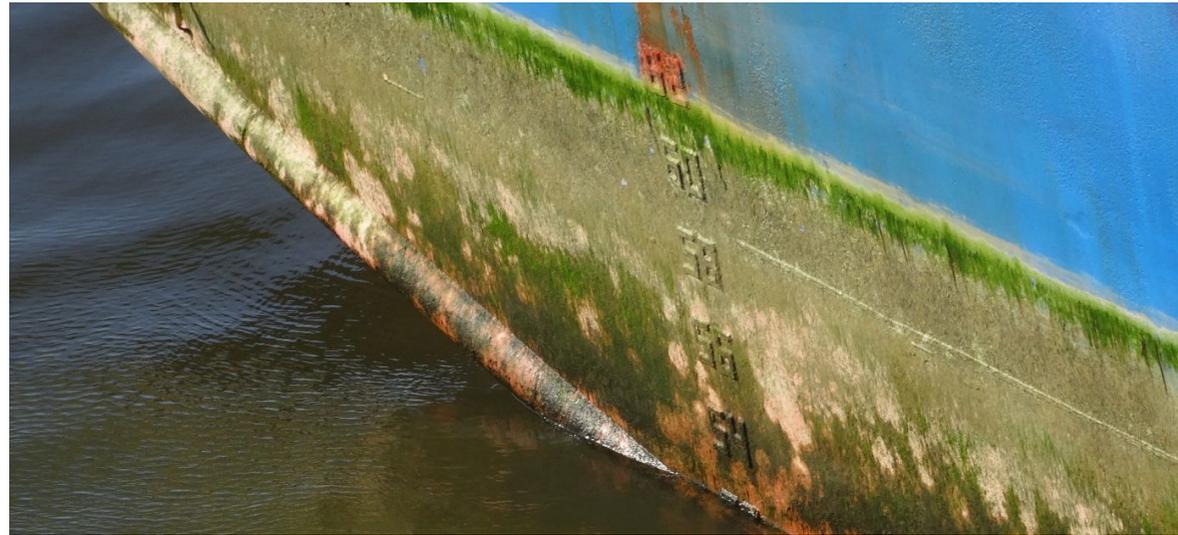
Picture 1 - first impression: not readable draft marks

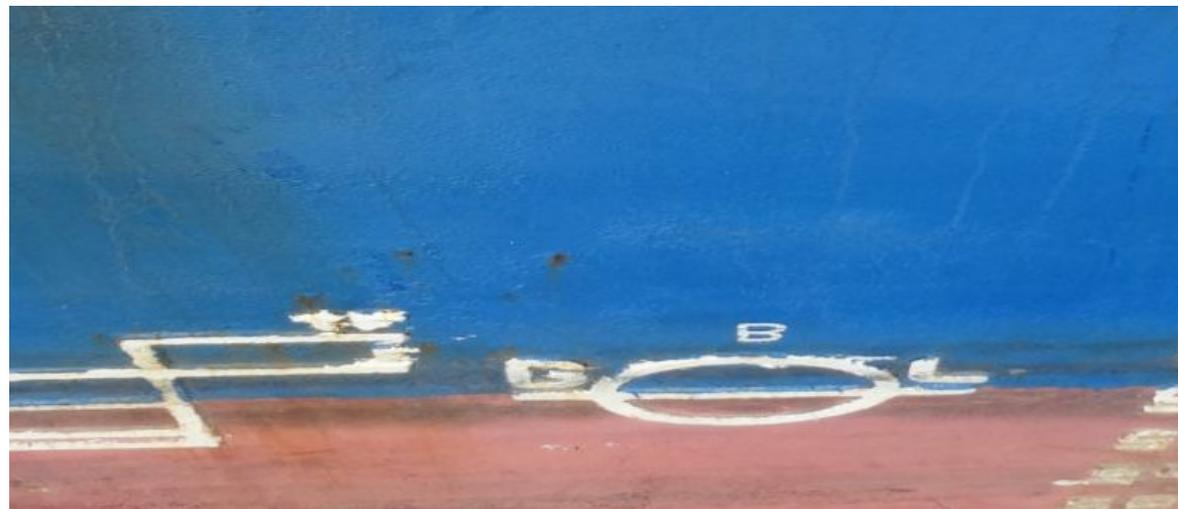
Picture 2 - freeboard marks readable but with wrong letters (GL has withdrawn certificates before)

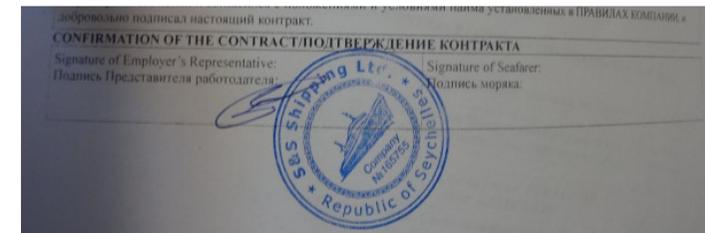
Picture 4 - SEAs signed by unknown Seychelles company, neither by MLC owner nor ISM company

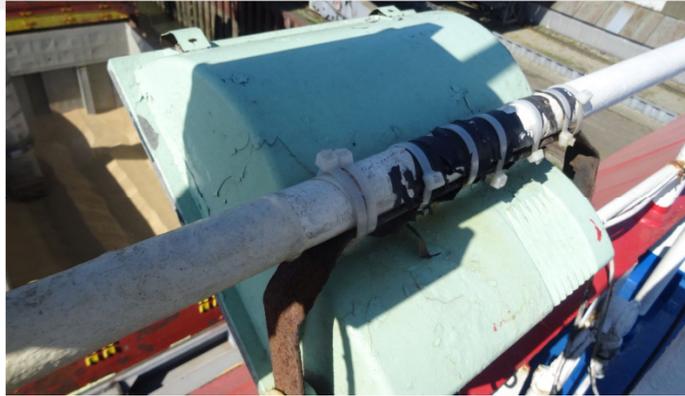
- **GMDSS battery charger showing error**
- **Flood lights on monkey deck fixed by plastic straps and tape only**
- **Signal and navigational lights not working or cases damaged**

Picture 6 - safe installation of flood lights

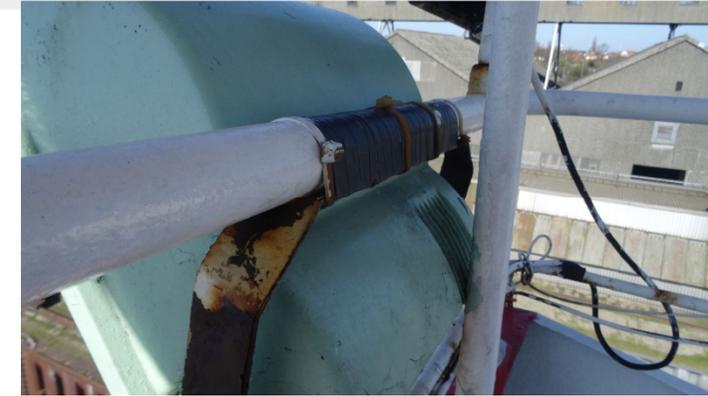
Picture 8 - safe installation of flood lights

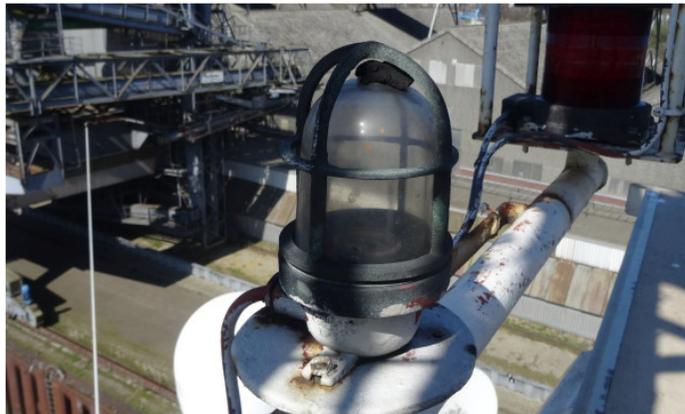
Picture 8 - not working signal lights

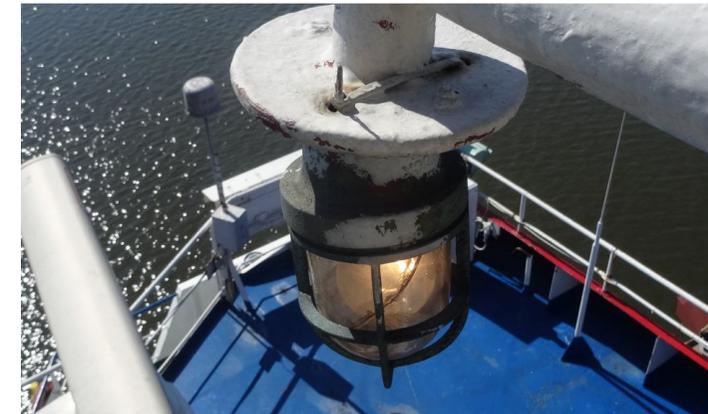
Picture 9 - light case broken, fixed by plastic strap

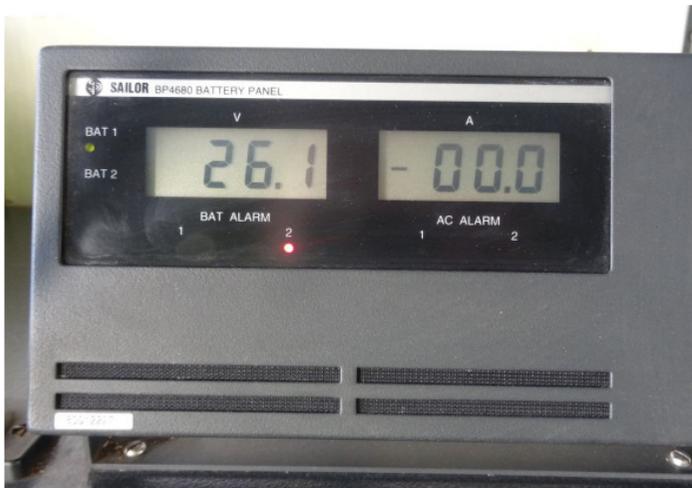
Picture 10 - GMDSS battery charger showing error

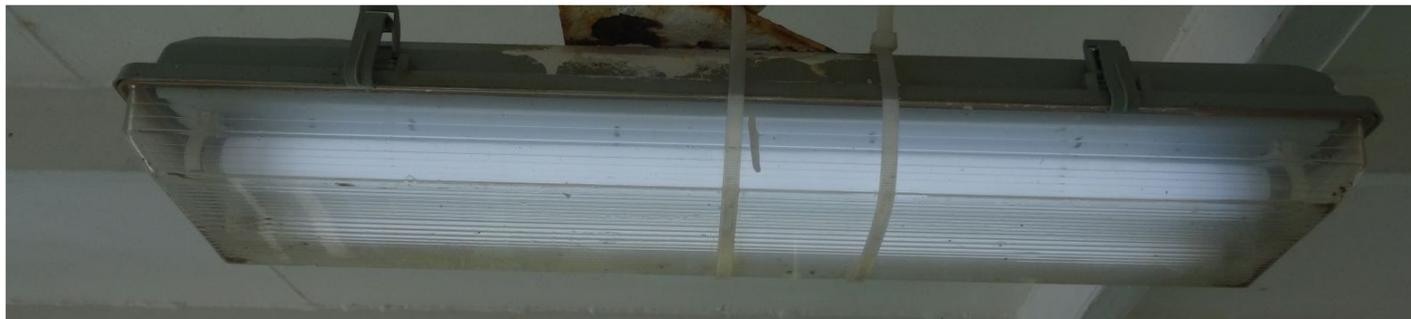
Picture 11 - generally the use of plastic straps seems to be preferred method of repairing on board

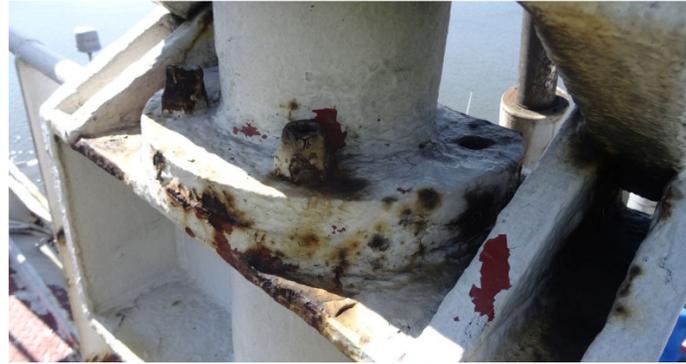
Picture 12 - missing or rusted bolts for mast basement

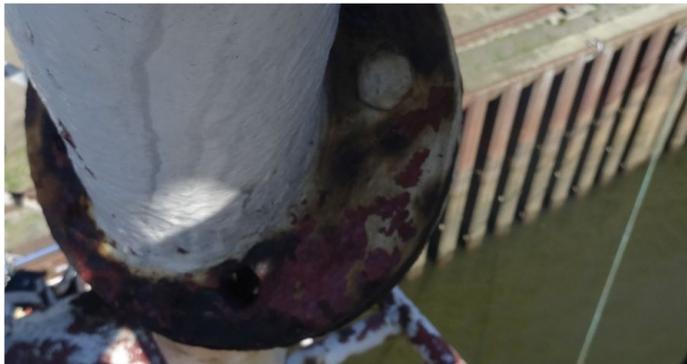
Picture 13 - missing bolts for mast connection

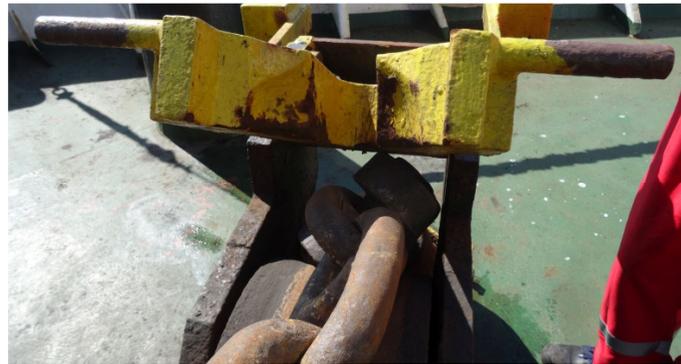
Picture 14 - both anchor stopper misplaced

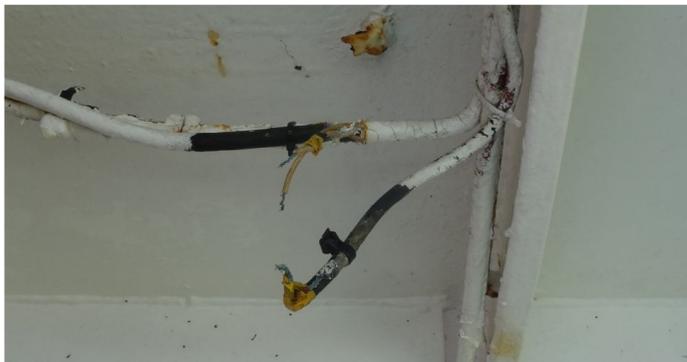
Picture 15 - unsafe electric installations

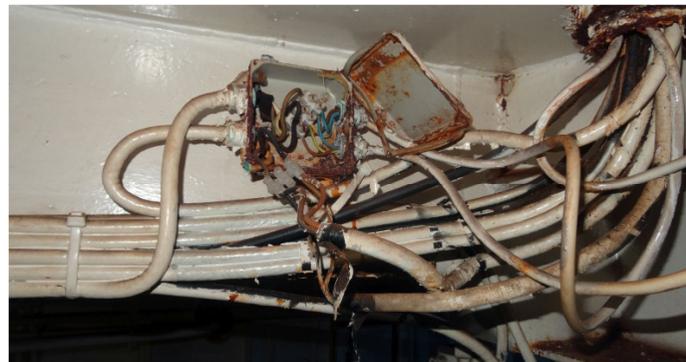
Picture 16 - unsafe electric installations

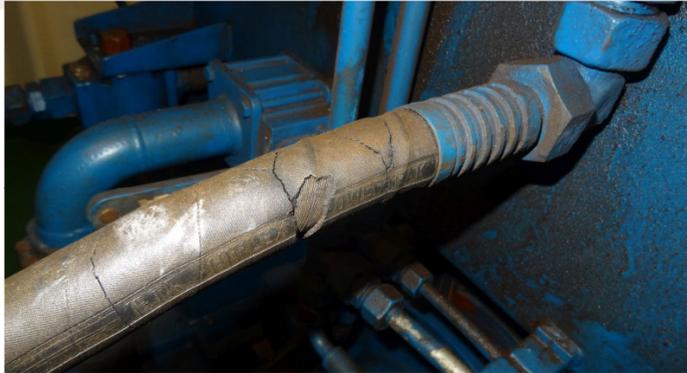
Picture 13 - damaged hydraulic hoses

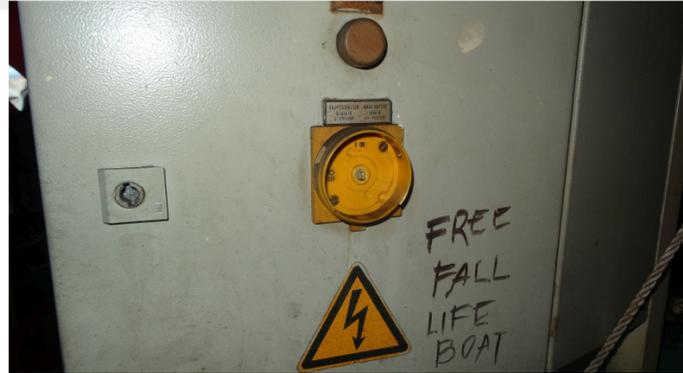
Picture 14 - damaged electric installations

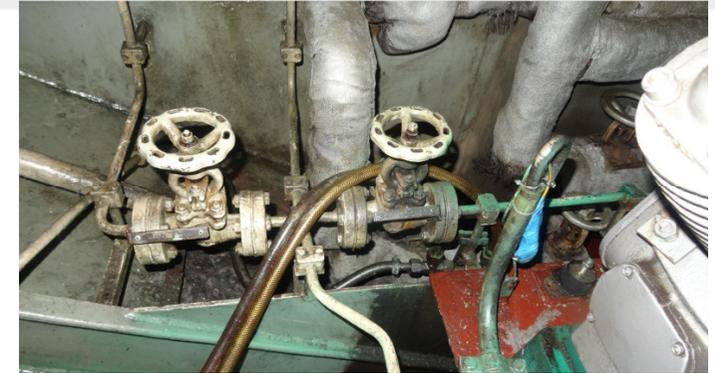
Picture 15 - self made rubber hose installations

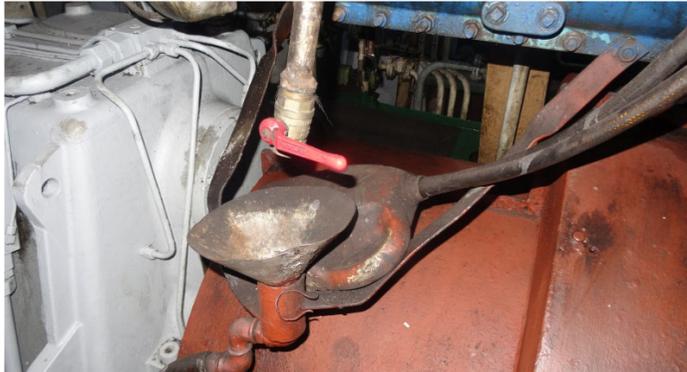
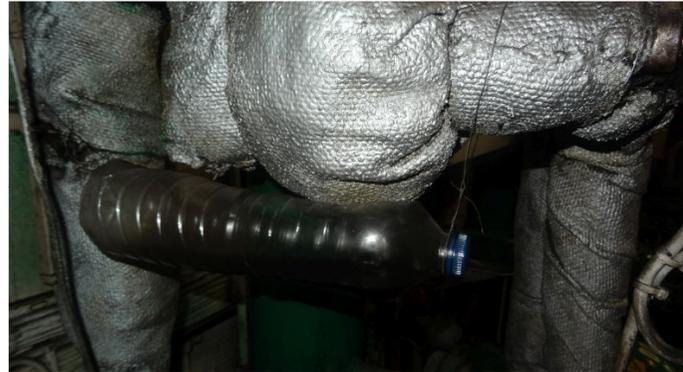
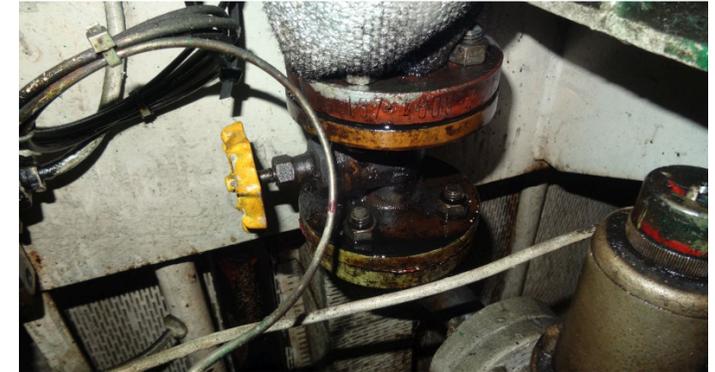
Picture 16 - self made collectors for fuel and...

Picture 17 - ...self made oil collector ...

Picture 18 - ...for several minor leakages

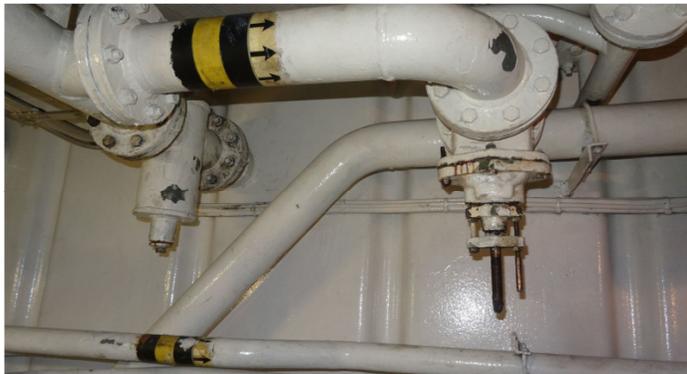
Picture 19 - missing handles for valves

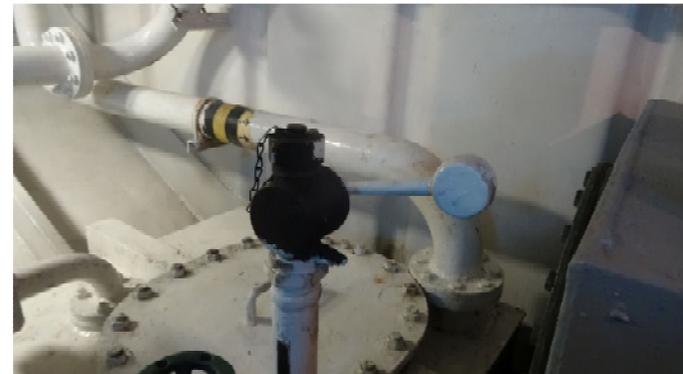
Picture 20 - not closing self-closing devices

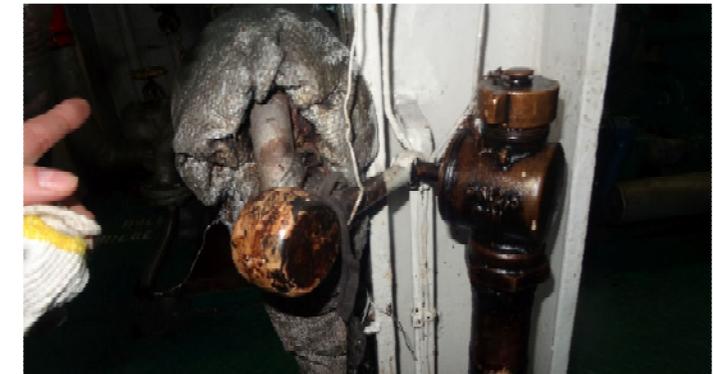
Picture 21 - missing insulation, not closing valve

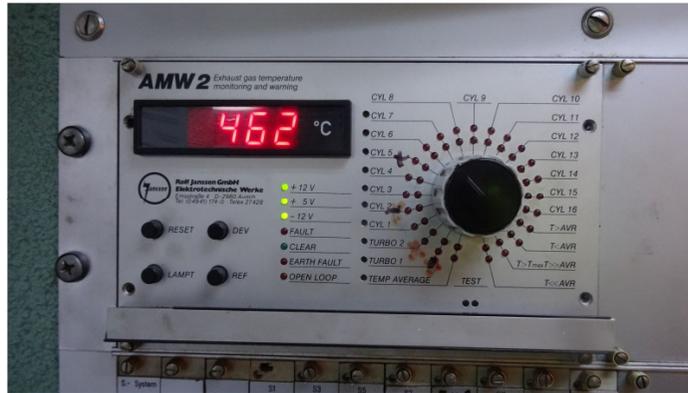
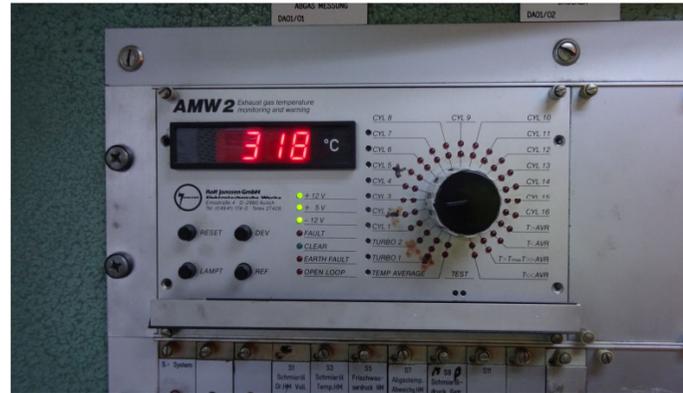
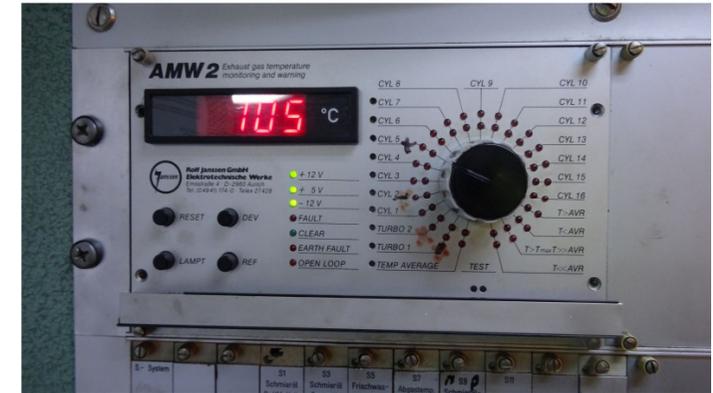
Picture 22- variation on cylinder temperatures are

Picture 23 - clear indication for problems on the

Picture 24 - sensors or with the main engine
