Sub-Standard vessels in German ports 2017

Ship name:	MISTRAL
IMO no.:	9045651
Flag:	Turkey
Ship type:	General Cargo
MMSI:	271000615
Call sign:	TCCH
Gross tonnage:	5469
Ship length:	125.99m
Keel laying date:	11.06.1988
Flag state:	Turkey
Classification society:	Nippon Kaiji Kyokai / Turk Lloyd
Recognized Organization:	Turk Lloyd
ISM Company:	Bora Denizcilik IMO no. 1205958
Port of detention:	Hamburg (Germany)
Detention date:	25.07.2017
Duration of detention:	35 days

MISTRAL

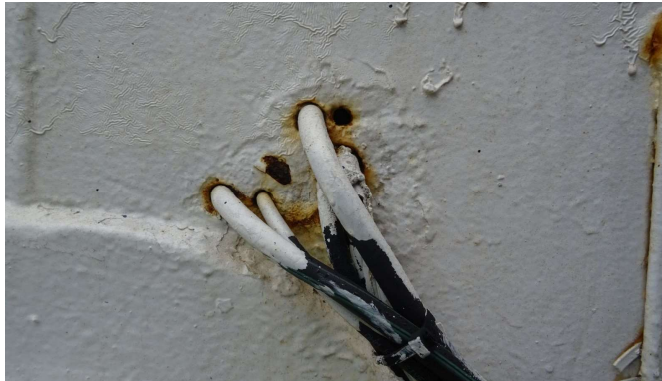
- Historically grown cable installations, damaged fire resistant walls or divisions

Picture 1 – self-made cable penetrations

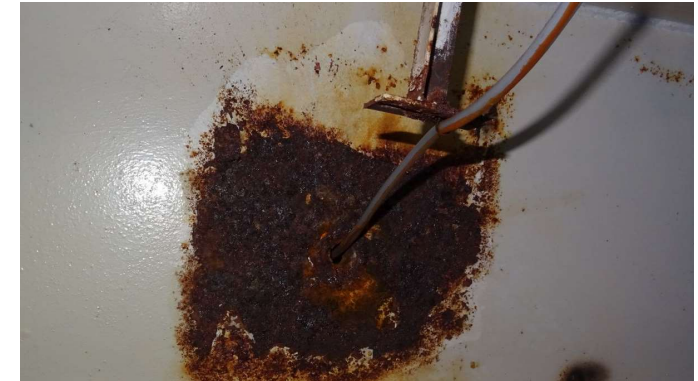
Picture 2 – self-made cable penetrations

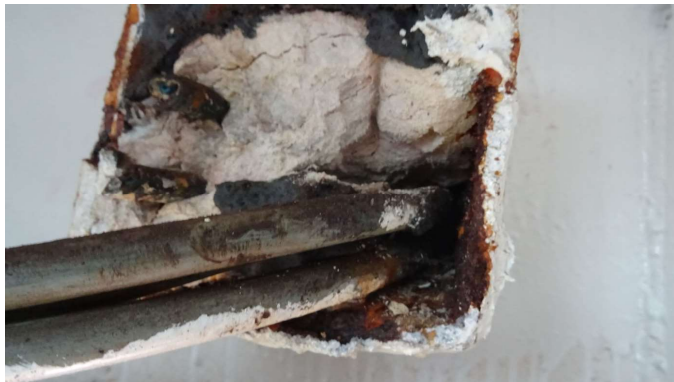
Picture 3 – self-made cable penetrations

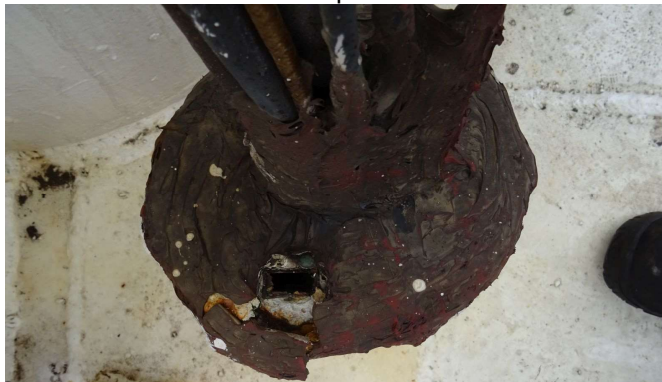
Picture 4 – self-made cable penetrations

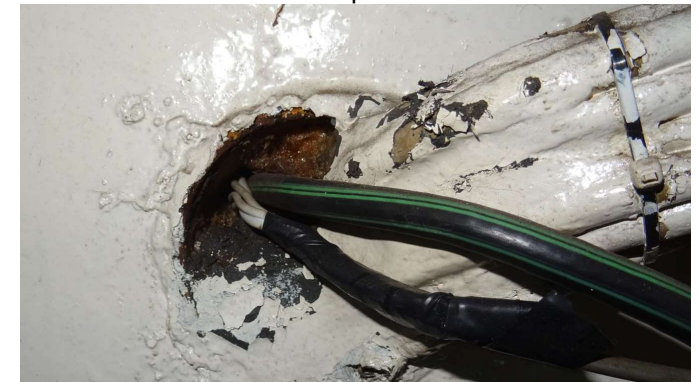
Picture 5 – self-made cable penetrations

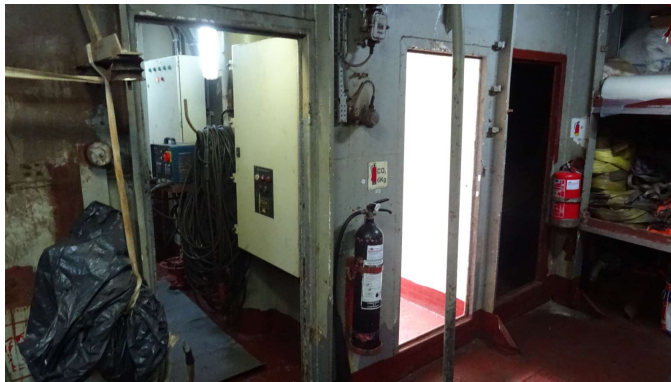
Picture 6 – three missing fire doors

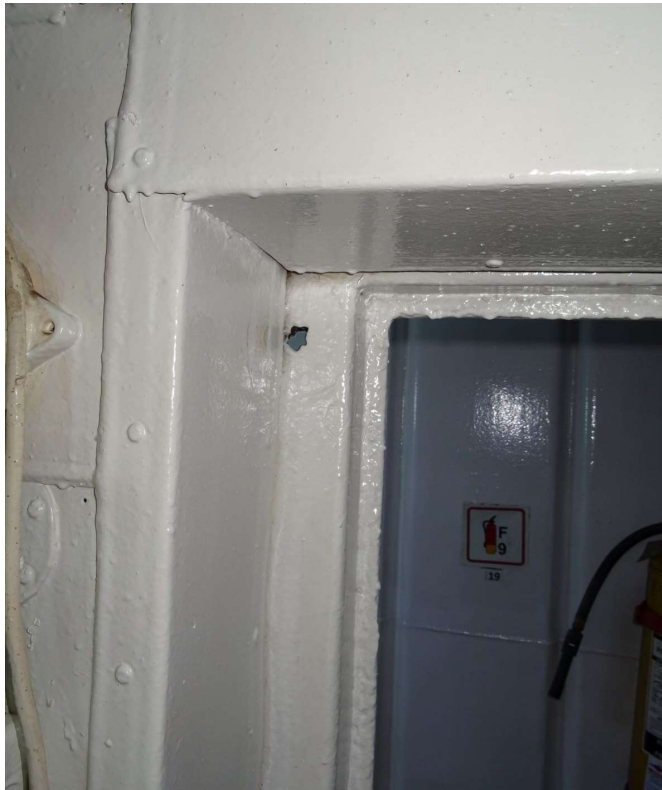
Picture 7 fire door frame holed by rust

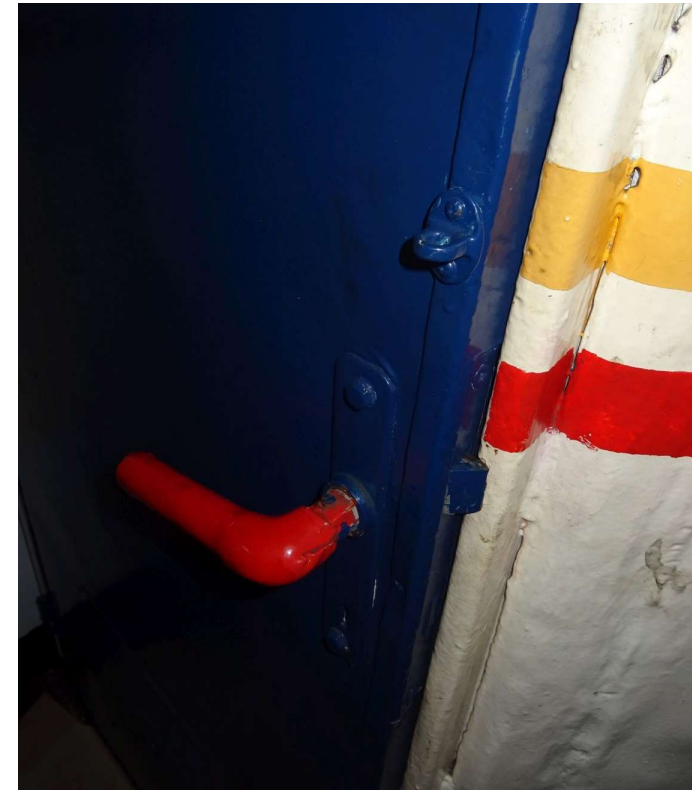
Picture 8 – incorrect installed door closure on fire door

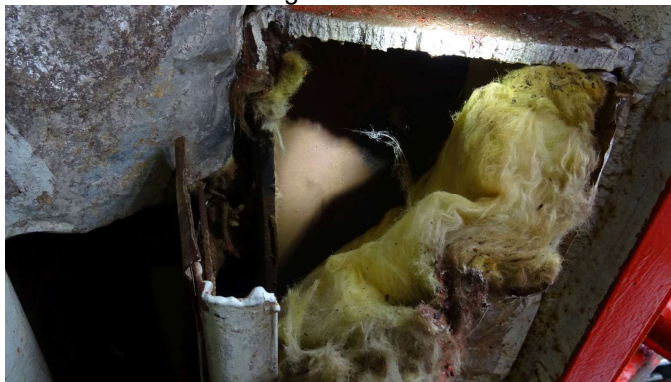
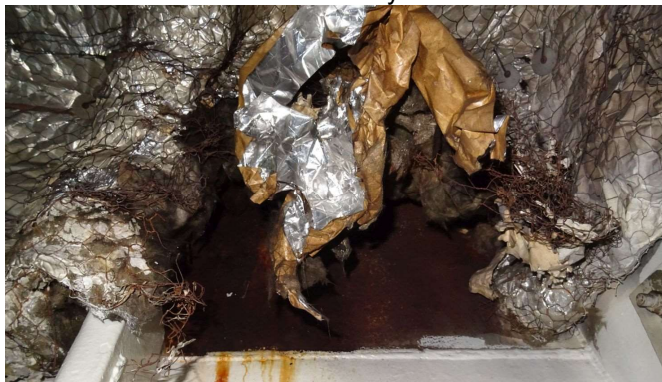
Picture 9 – The fire insulation of A60 boundaries...

Picture 10 – ...found damaged in various spaces

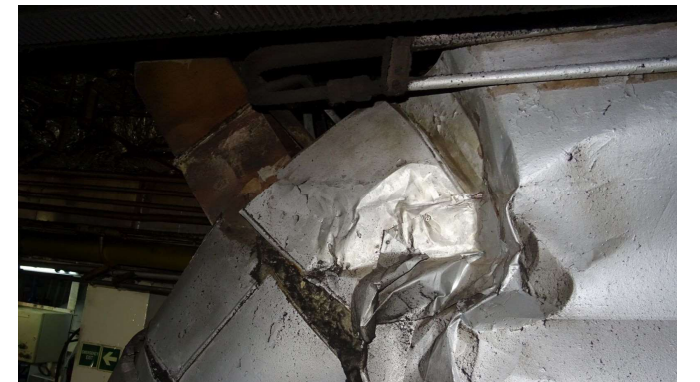
Picture 11 – damaged insulation on exhaust pipe

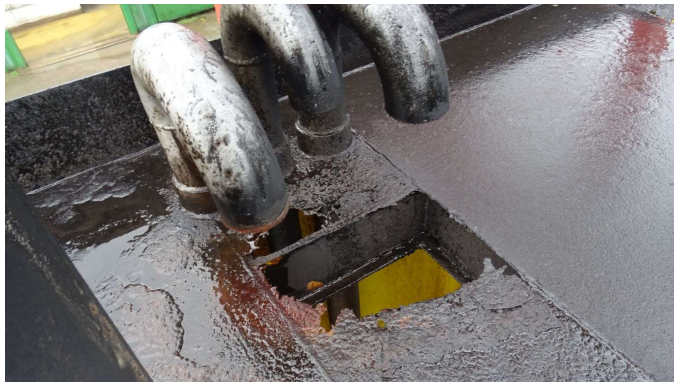
Picture 12 – platform deck holed by rust

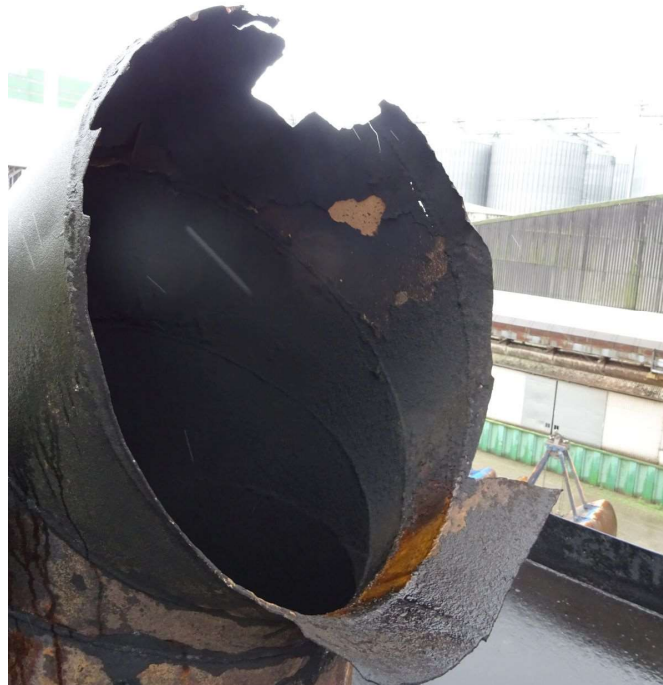
Picture 13 – funnel end rusted away

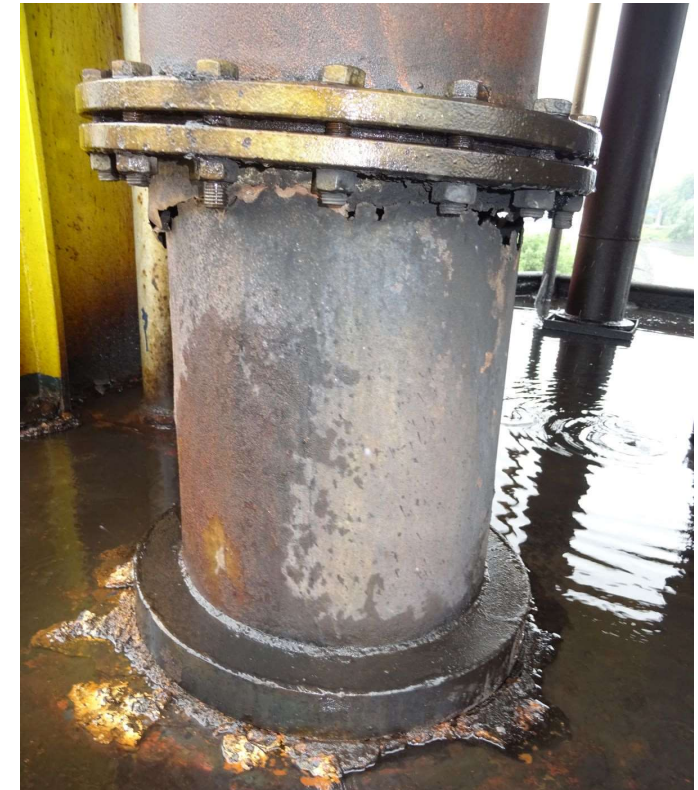
Picture 14 – rusted foundation of exhaust pipe

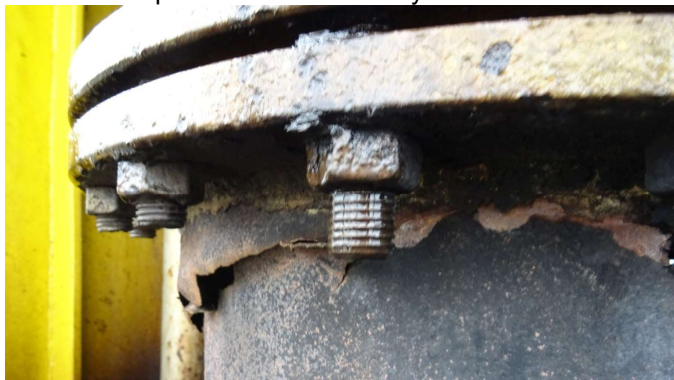
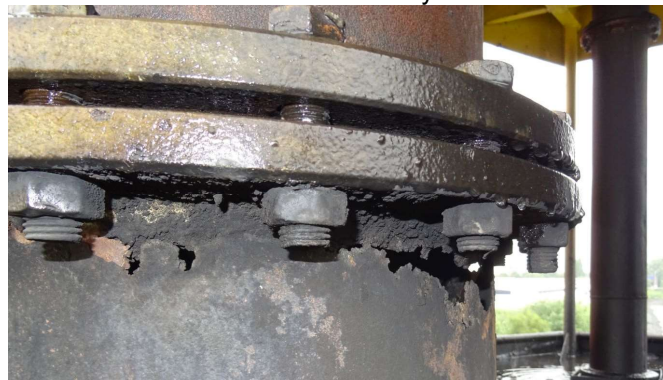
Picture 15 – the exhaust pipe found rusted through...

Picture 16 – ...and collapsed due to its own weight

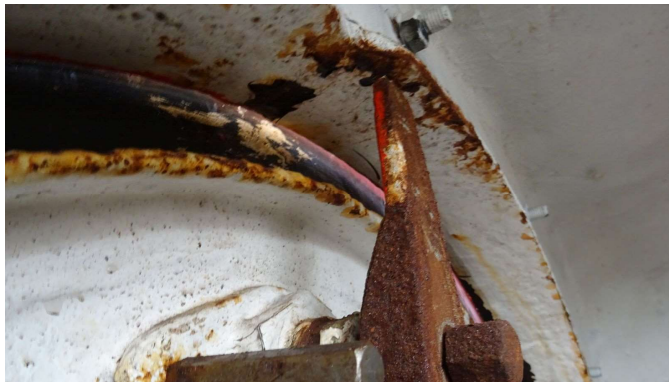
Picture 17 – not closing sash lock

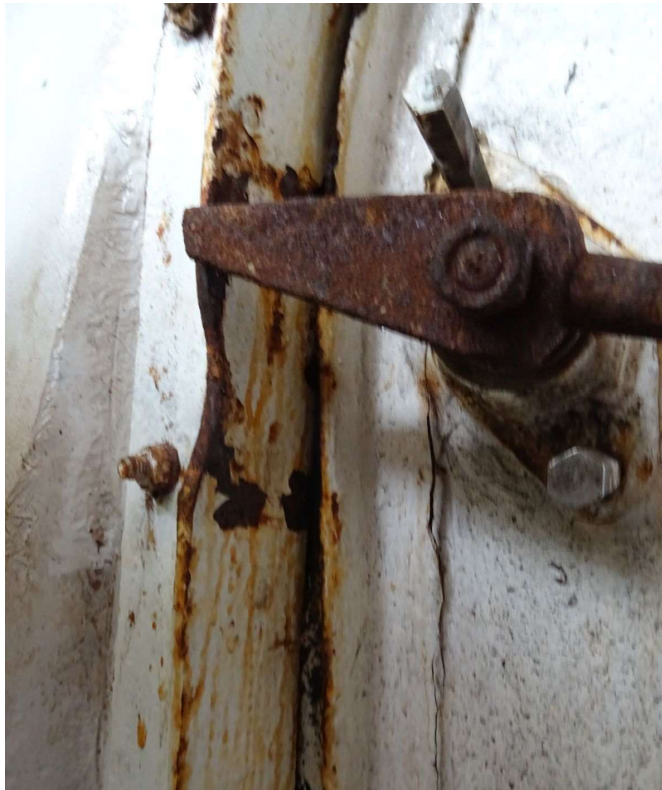
Picture 18 – damaged frame on outside door

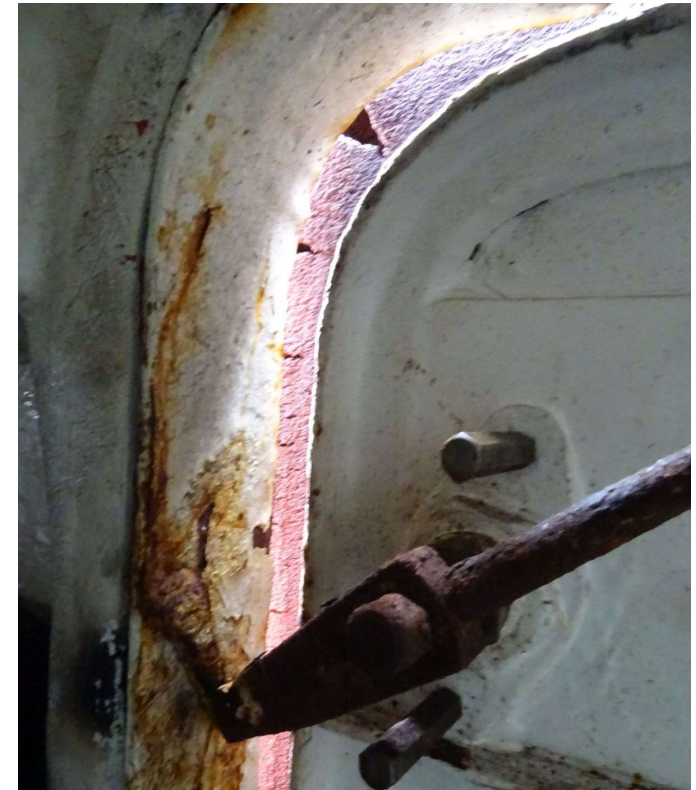
Picture 19 – not possible to close the door

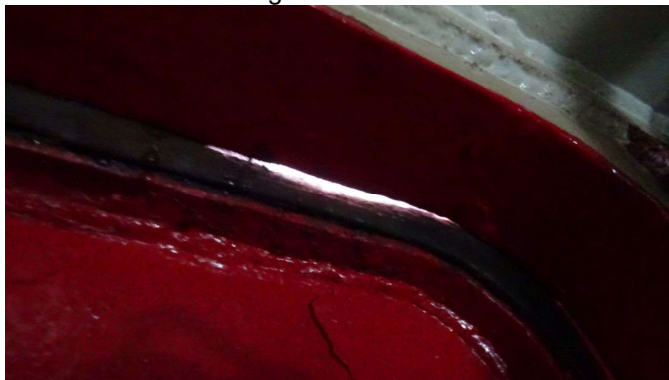
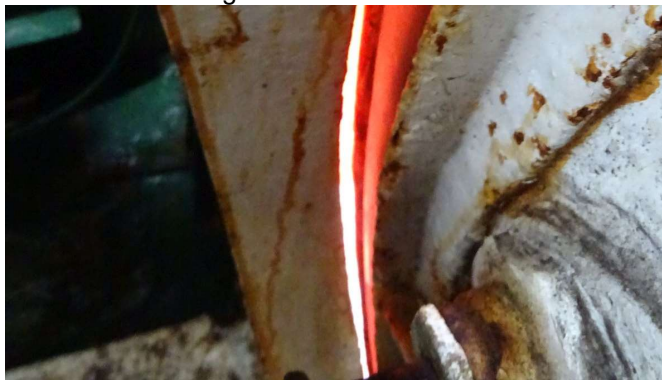
Picture 20 – Even if sash locks found working...

Picture 21 – ...still the doors are not closing tightly

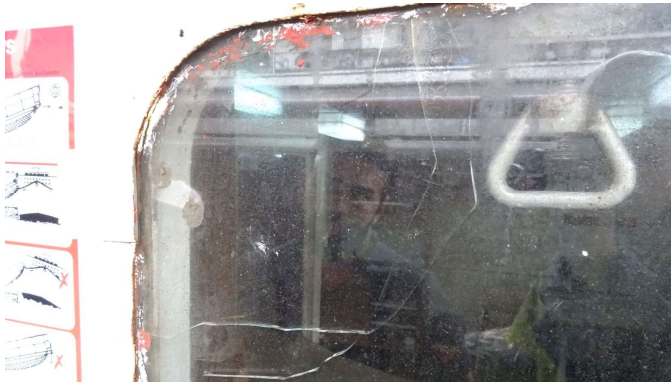
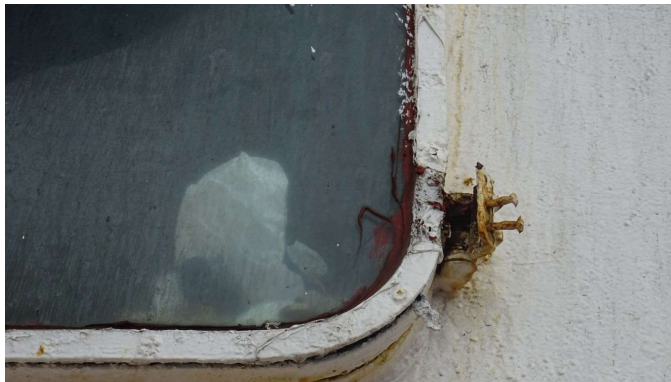
Picture 22 – almost all windows found in...

Picture 23 – ...different stages of disintegration

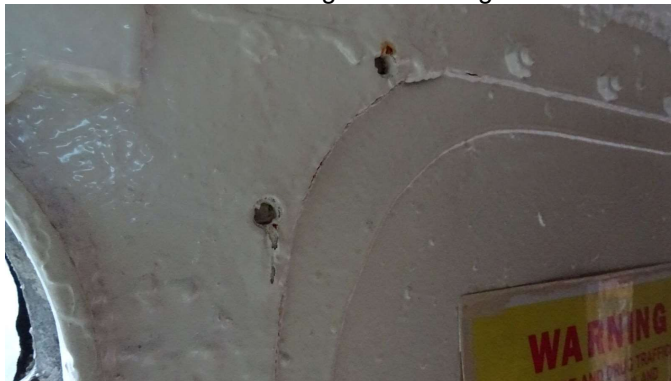
Picture 26 – destroyed windows replaced by wood...

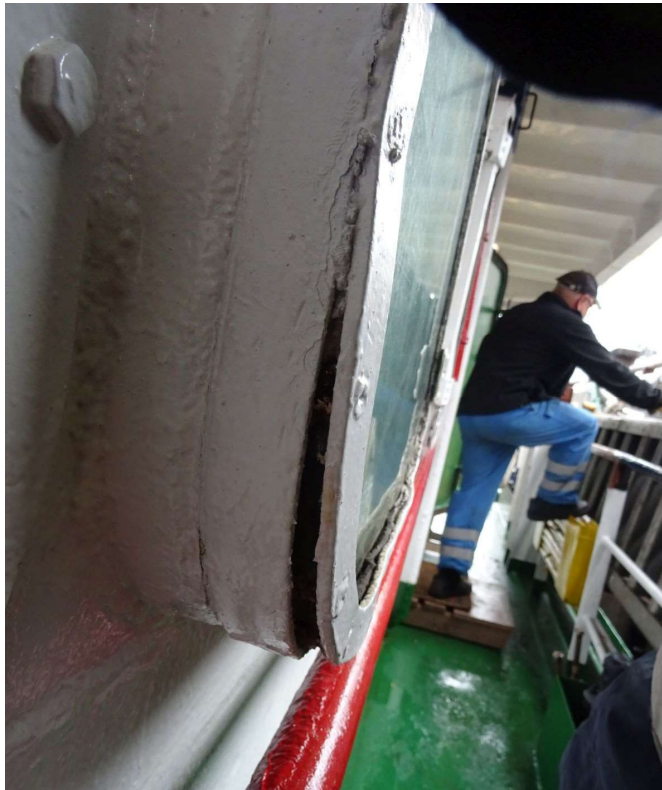
Picture 24 – window frame rusted and buckled

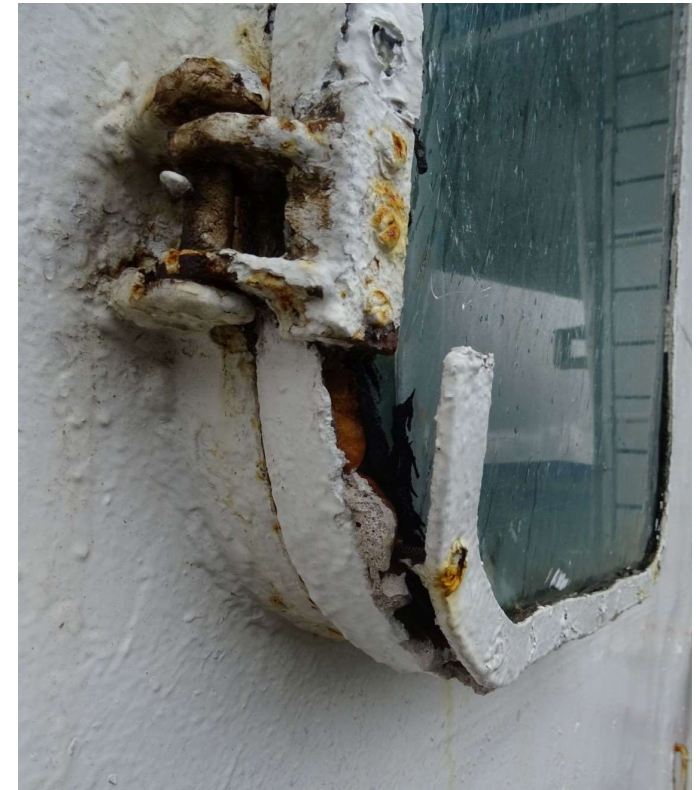
Picture 25 – ongoing disintegration on window frame

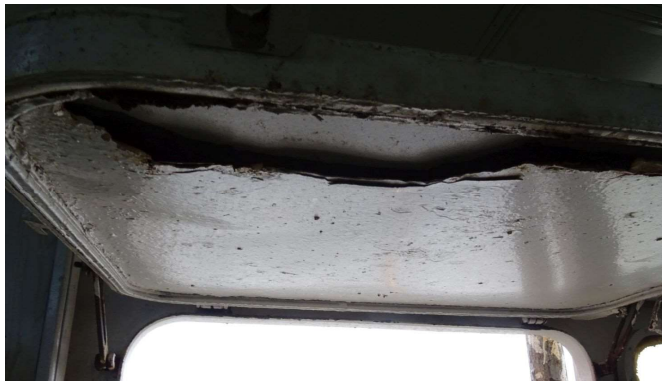
Picture 27 – ...obviously done a long time ago

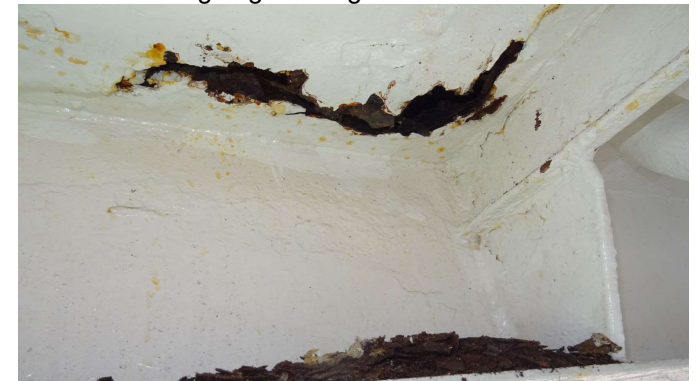
Picture 28 – successfully worked around by hammer

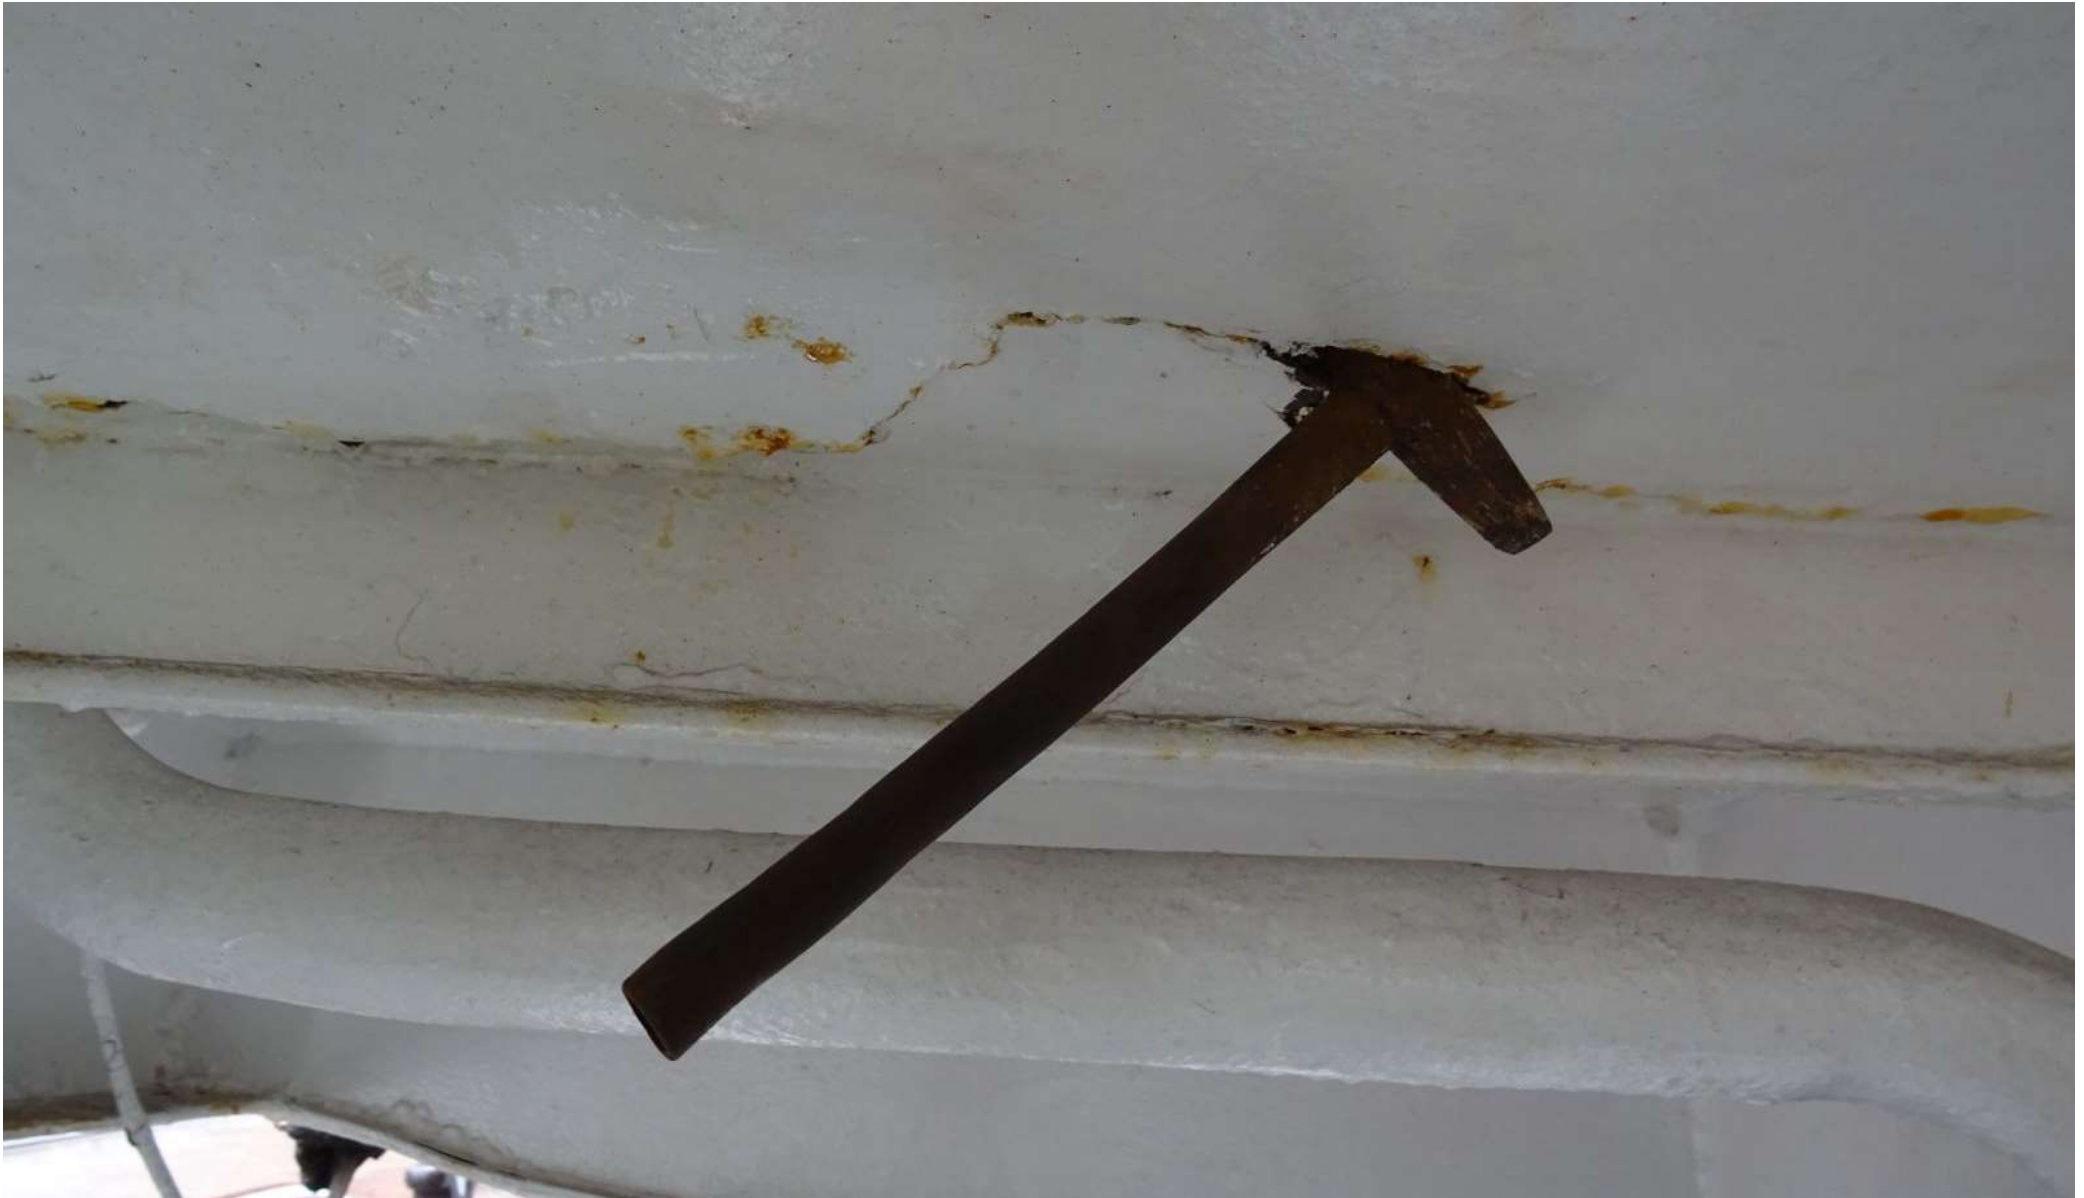
Picture 29 – testing integrity of the steel by chipping – as result severe corrosion damages were identified

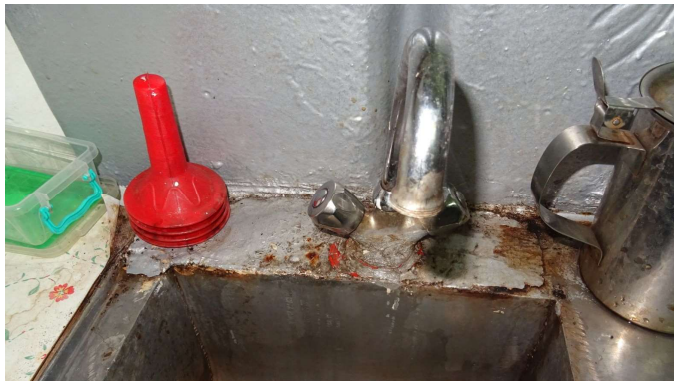
Picture 30 – self repaired washbasin

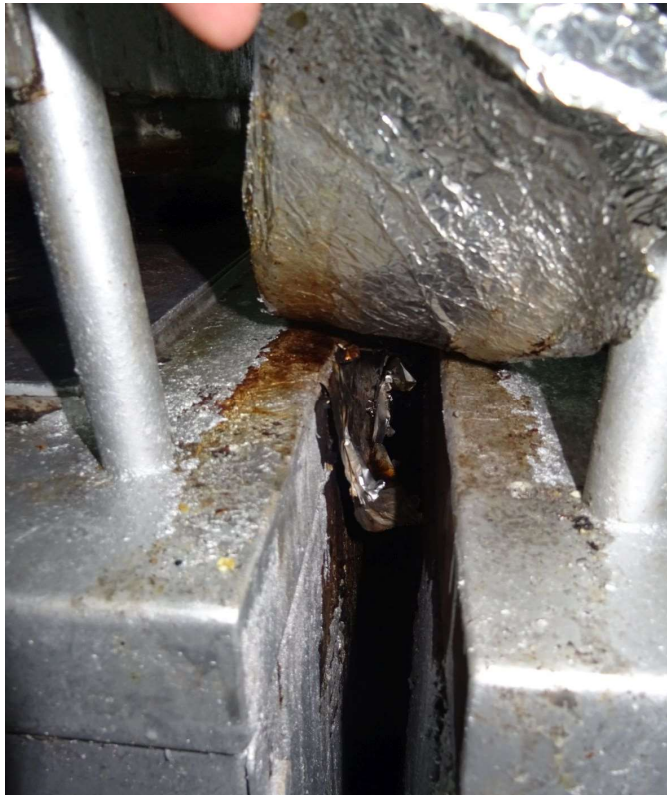
Picture 31 – self made construction on stove

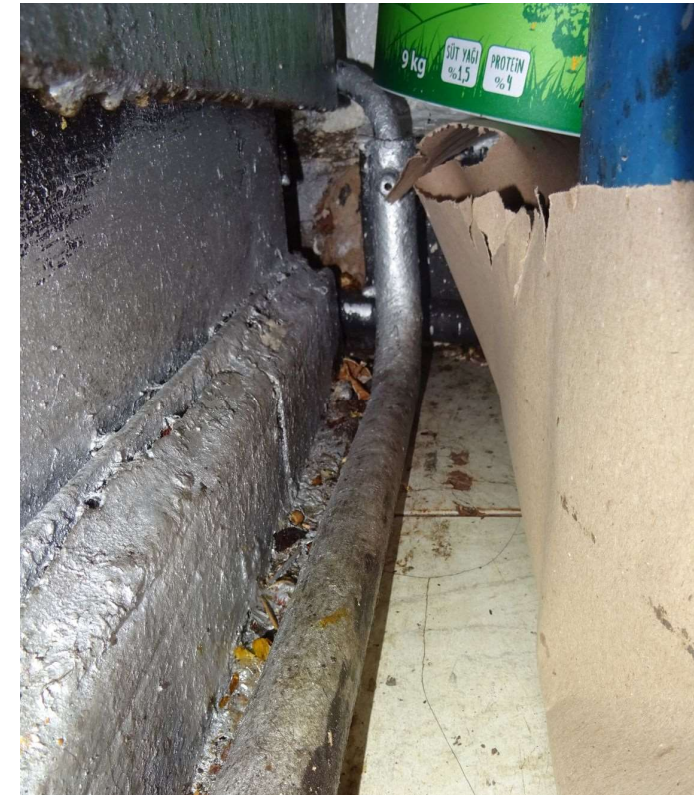
Picture 32 – home of cockroaches beneath the stove

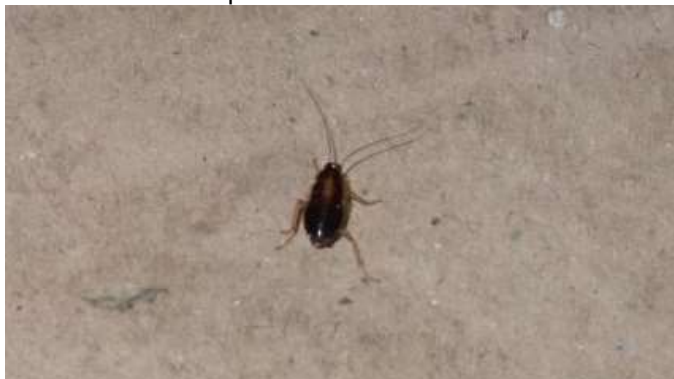
Picture 33 – cockroaches in galley

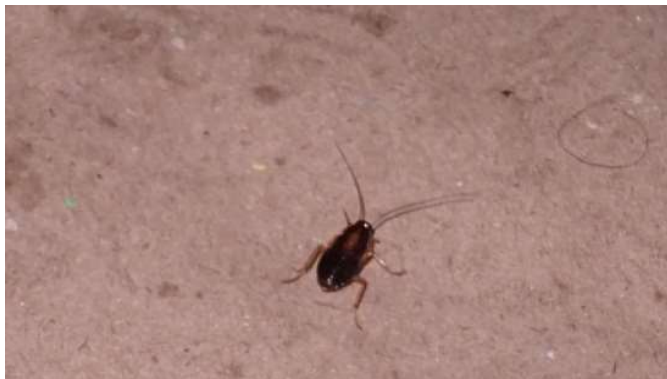
Picture 34 – cockroaches in galley

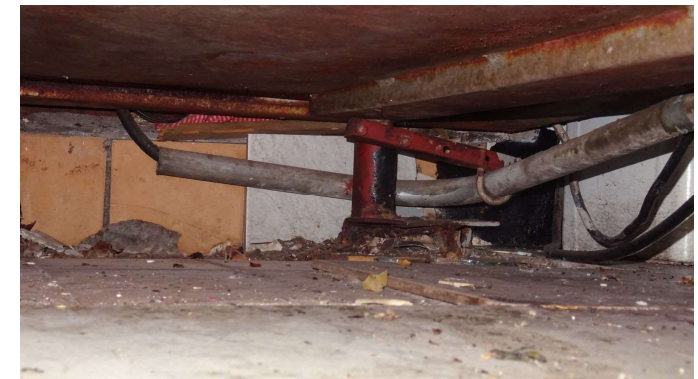
Picture 35 – below the galley cabinets

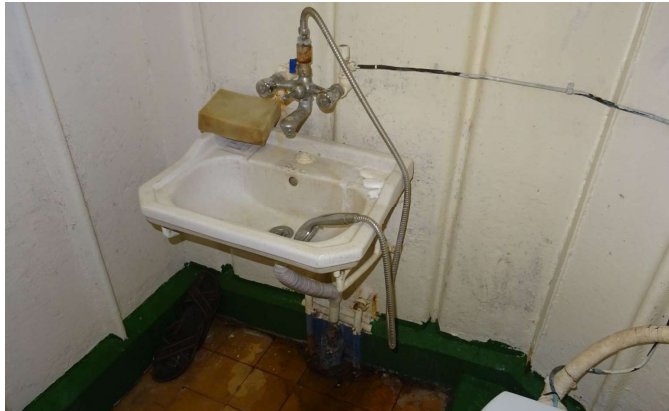
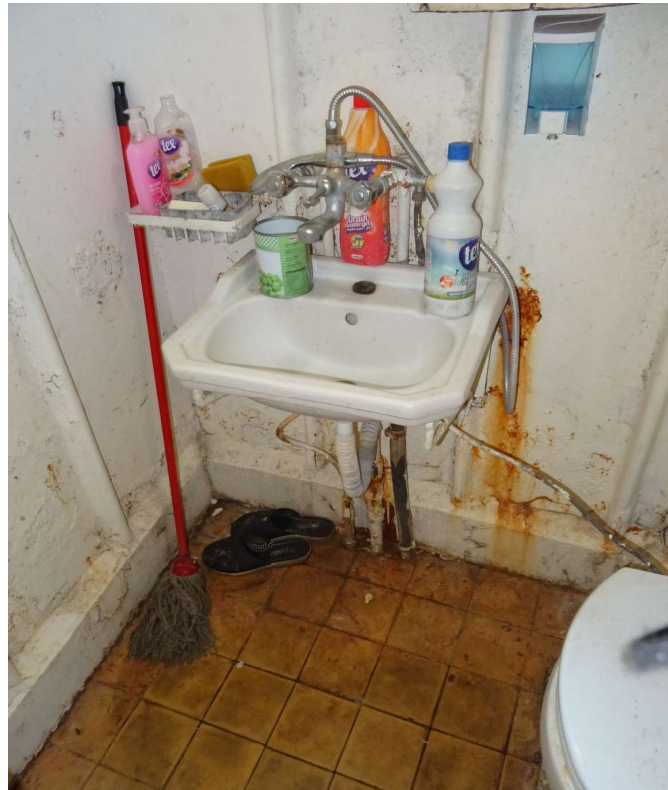
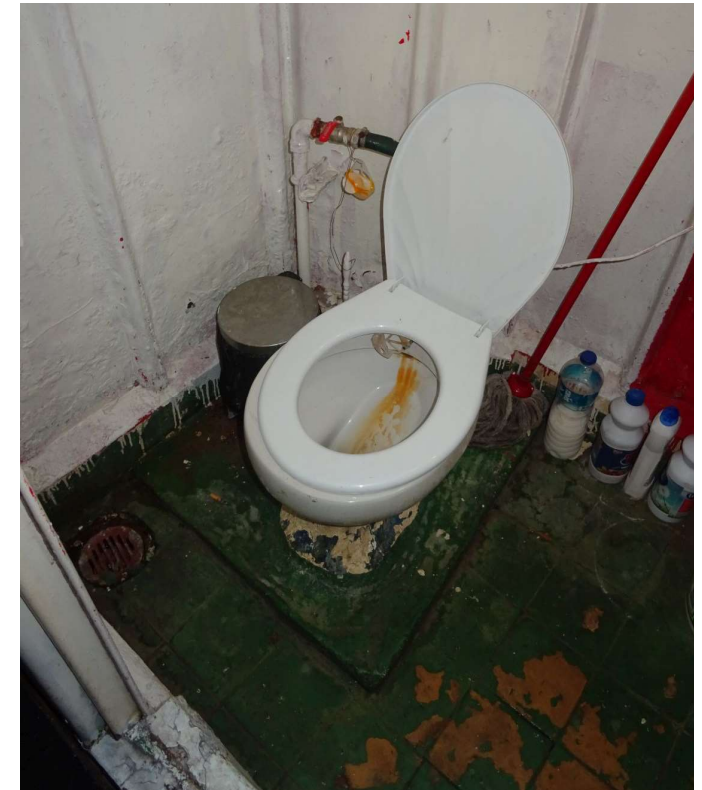
Picture 36 – The condition of the sanitary...

Picture 37 – ...rooms in the crew cabins was found...

Picture 38 – ...below standard

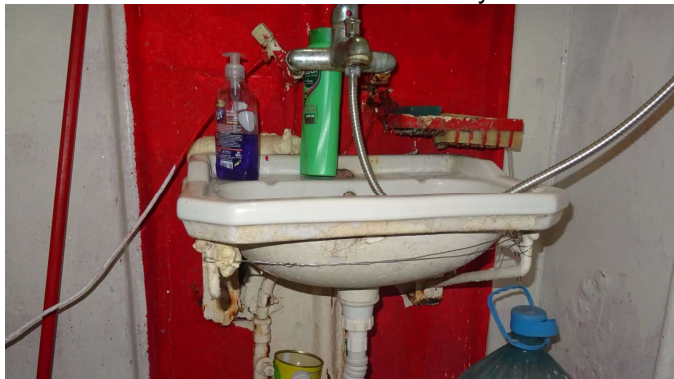
Picture 39 – self made repair by building foam and wires

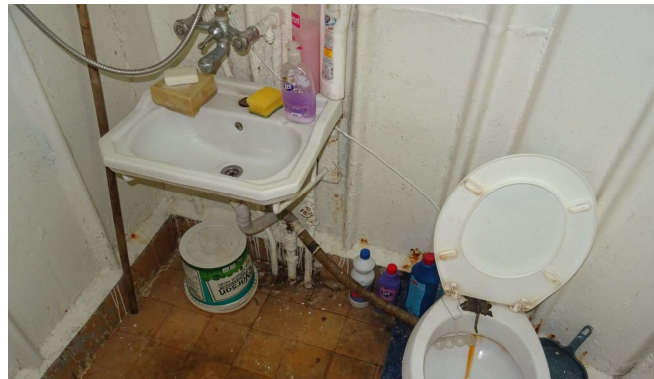
Picture 40 – all installations found dirty and outworn

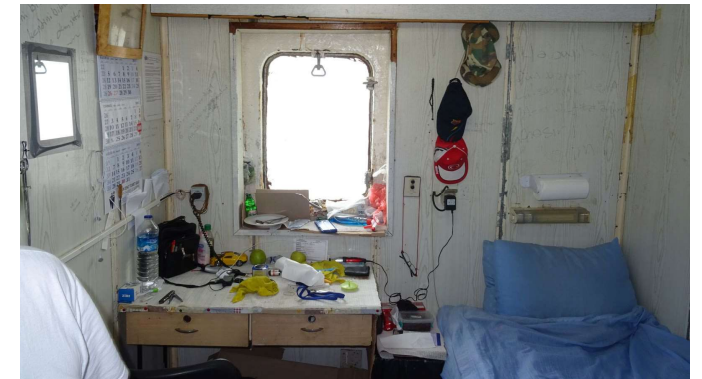
Picture 41 – also the crew cabins found outworn

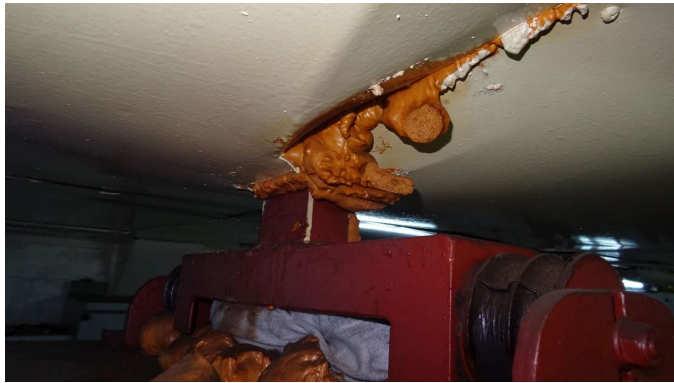
Picture 42 – ceiling in engine control room (ECR)

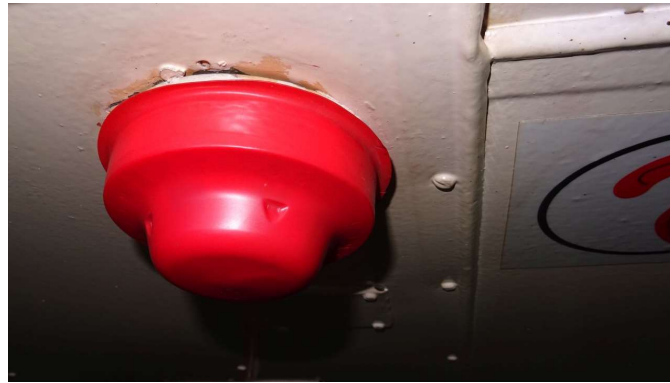
Picture 43 – disabled smoke detector in ECR

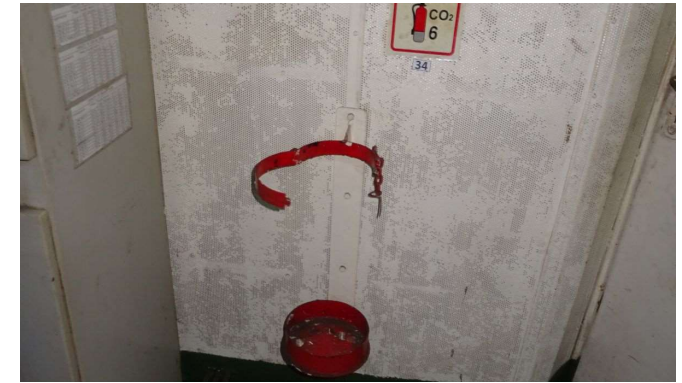
Picture 44 – missing fire extinguisher in ECR
