SHIP SAFETY DIVISION International Safety Management (ISM)

ISM-Circular 02-2009
Date: 31.03.2009

Sub.: Rate-of-Turn Indicators / SOLAS regulation V/19.2.9.1

Application: Ships of 50,000 GT and upwards

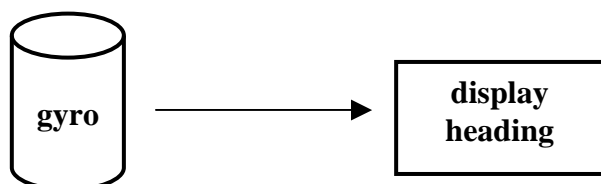
(Picture 1)

SOLAS Reg. V/19.2.5.1 requires that ships of 500 GT and upwards shall have a gyro-compass, or other means, to determine and display their heading.

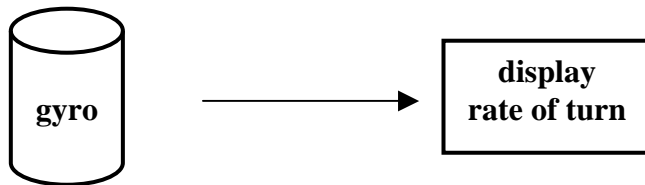
(Picture 3)

- Determine and display rate of turn by other means, e.g. gyro

- A second gyro-compass as 'other means' to determine and display the rate of turn. Remark: This second gyro-compass cannot be credited to fulfil the regulation V/19.2.5.1 and has to be approved in accordance with IMO resolution A.526(13). (picture 3)

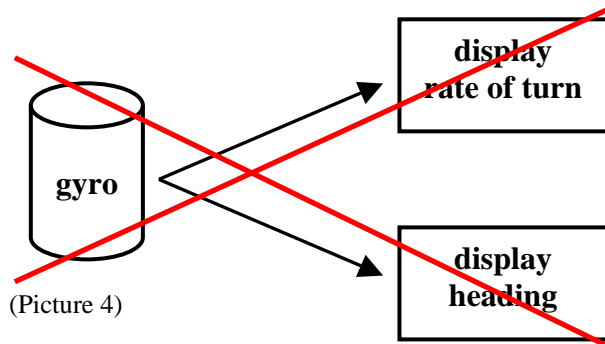
Navigational equipment installed to determine and display the heading of the ship cannot be accepted at the same time as equipment to determine and display the rate of turn (Picture 4), as this is not in compliance with:

➤ SOLAS Reg.V/19.2.9

*'All ships of 50,000 gross tonnage and upwards shall, **in addition** to meeting the requirements of paragraph 2.8 (2.7; 2.5)*

➤ SOLAS Reg.V/19.6

'.....in case of failure in one part of an integrated navigational system, it shall be possible to operate each other individual item of equipment or part of the system separately'
