Sub-Standard vessels in German ports 2014

ships name: M/V HUDSON LEADER
IMO number: 8607749
Call Sign: H9JS
MMSI number: 355123000
Ship type: Car Carrier
Gross Tonnage: 47307
Keel laying date: 20.03.1987

Detention port: Bremerhaven
Detention date: 29.08.2014
Detention Duration: 8 days

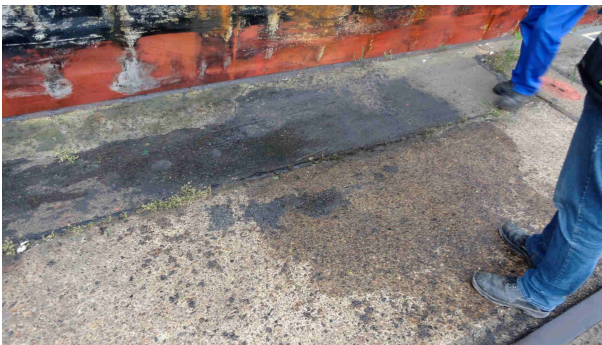
picture 1: vessel made oil spill on berth

When the PSCOs arrived at the berth two crew members were found cleaning the quay. When opening the flange for connecting the hose for sludge delivery the crew had found out there was still some pressure on the line so sludge had come out, splashing on the berth.

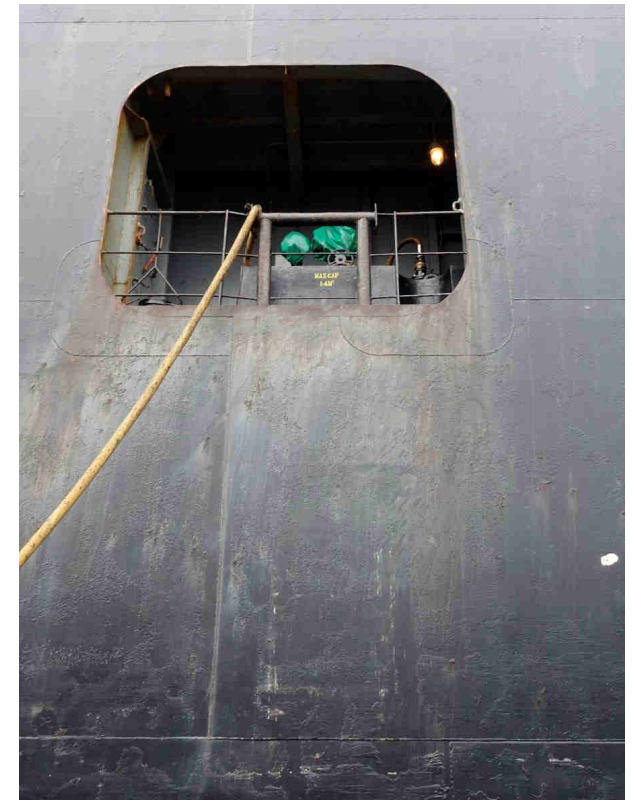
picture 2: bunker station where oil spill starts from

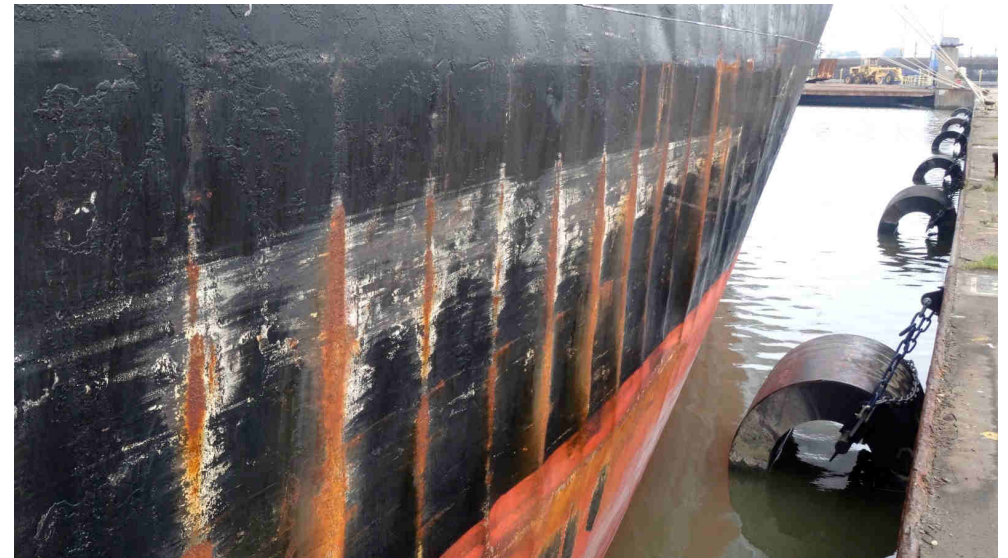
Still outside on the vessel the inspectors found several dents and bending on the outside hull, included dent frames.

After getting managed the oil spill the captain was asked for survey reports of the damages. These did not exist because nobody informed RO about the "minor" damages.

picture 4: some "minor" dents on starboard side middle

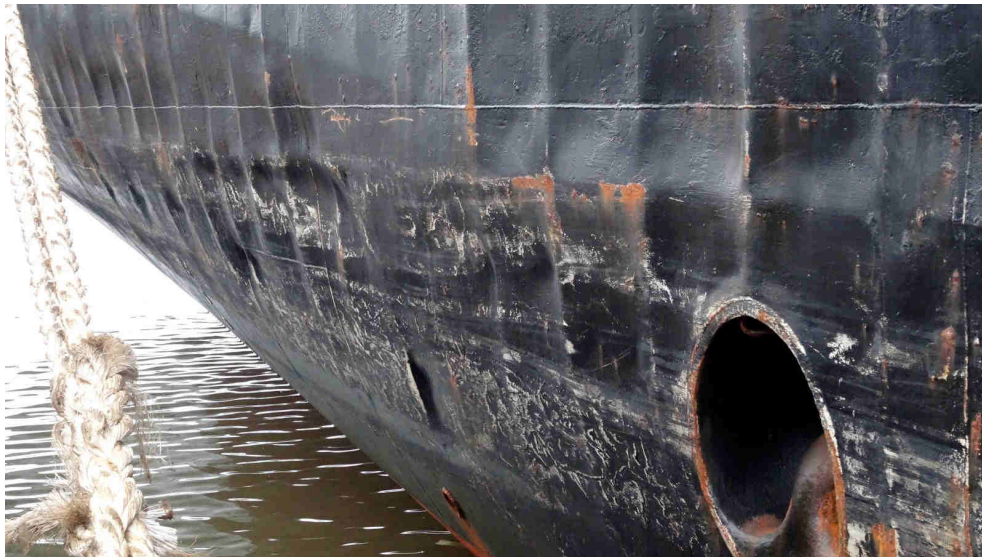
picture 3: some "smaller" dents on starboard aft

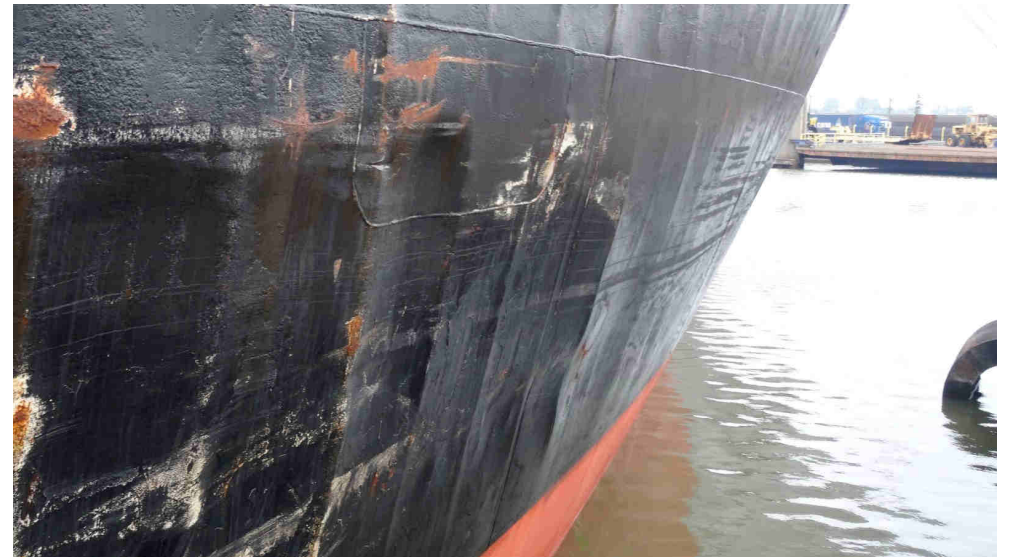
picture 5: an some other marginal dents on forward

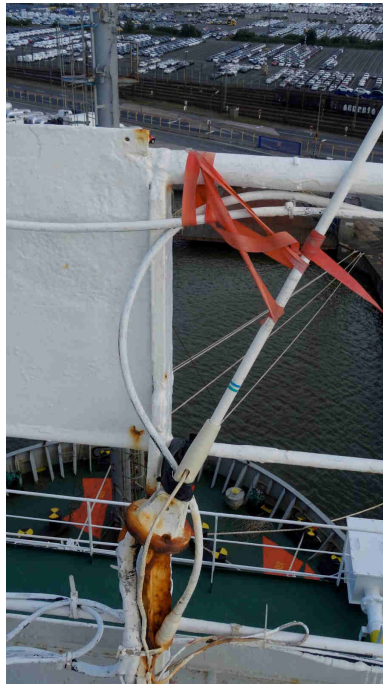
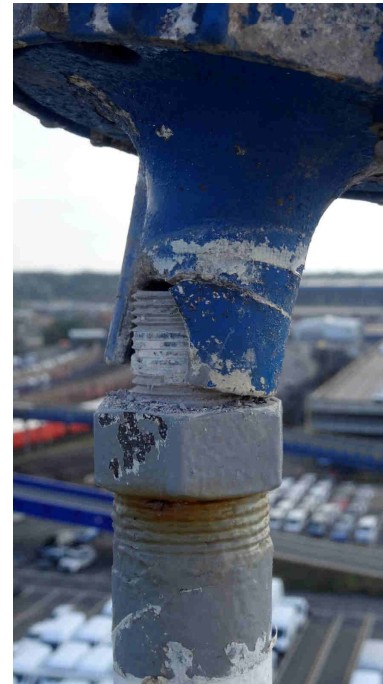
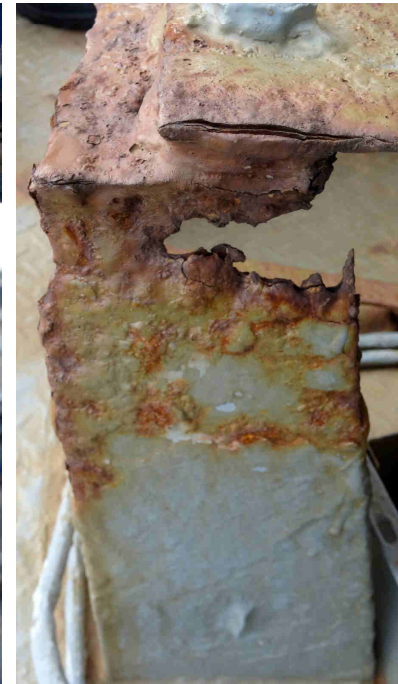
- VHF antenna fixed by tape only
- RADAR basement holed by rust
- SAT C antenna foundation broken
- MF antenna: broken grounding cable, base corroded, connection box fixed by spanner

picture 6-8: VHF antenna, basement of Sat C antenna and Radar basement

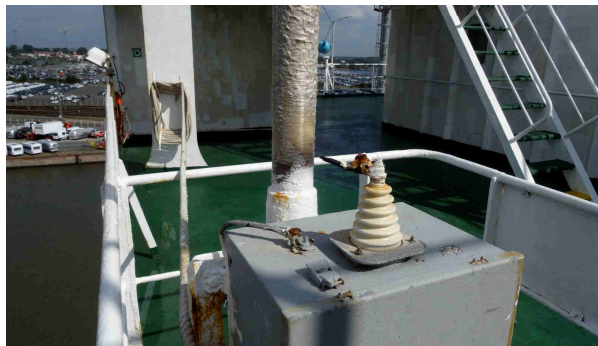
picture 9: MF Antenna with destroyed cable

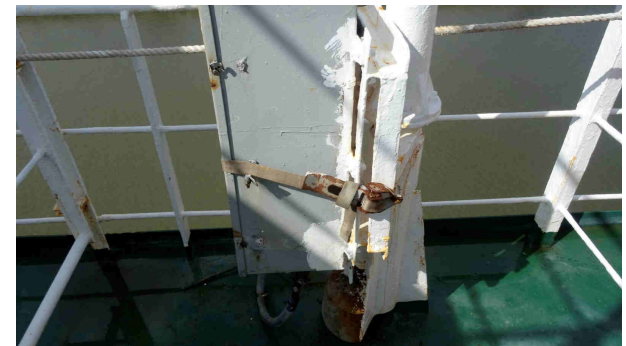
picture 10: connection box kept in place by spanners

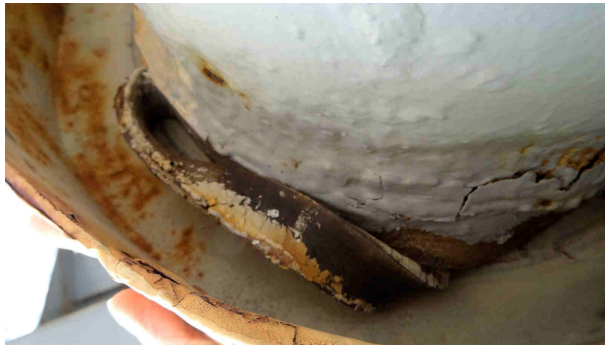
picture 11: damaged rubber on fire damper

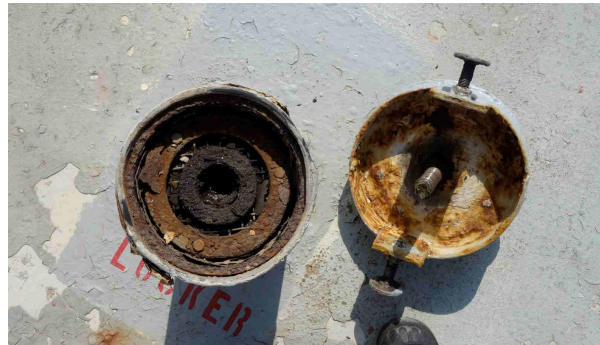
picture 14: from inside not looking better

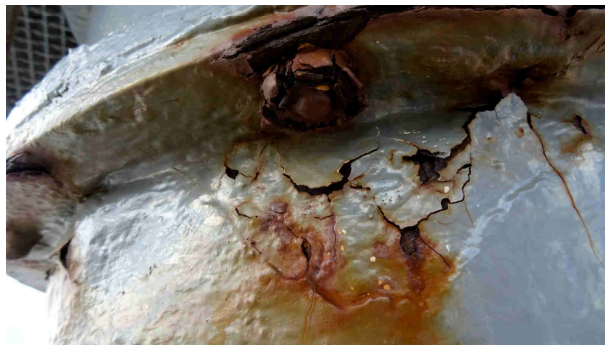
picture 12: corroded flange on fire damper

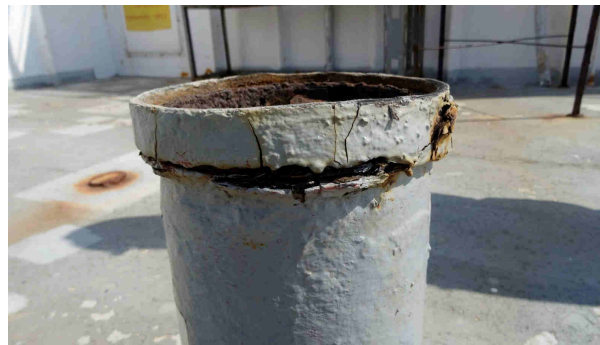
picture 15: next fire damper, same story

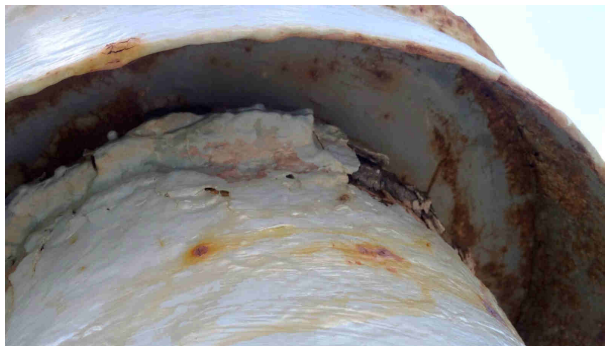
picture 13: another corroded fire damper

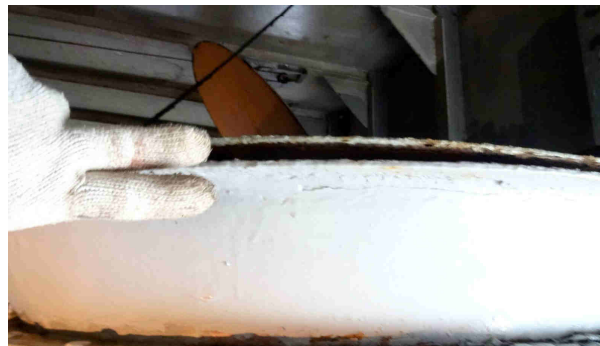
picture 16 ventilation flaps for car decks are not closing properly

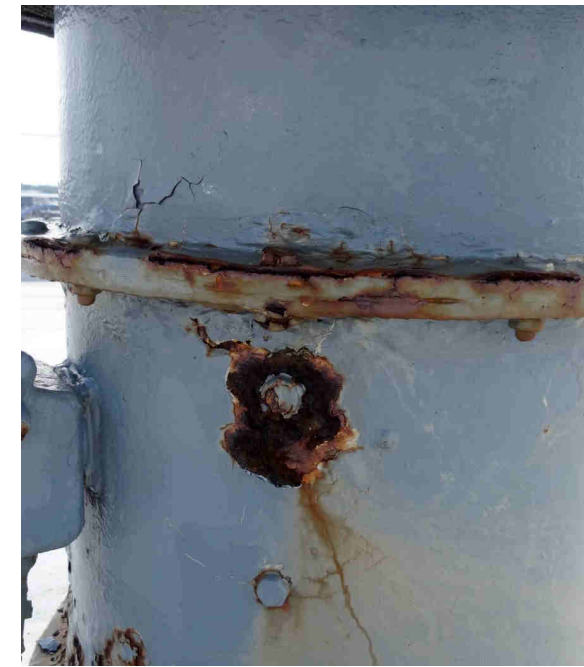
picture 17: not only flange but complete structure rusted

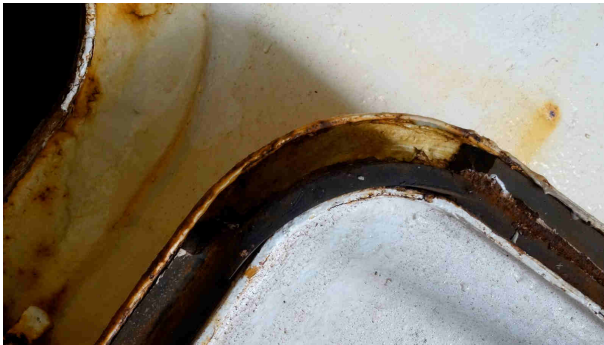
picture 18: parts of rubber insulations were missing

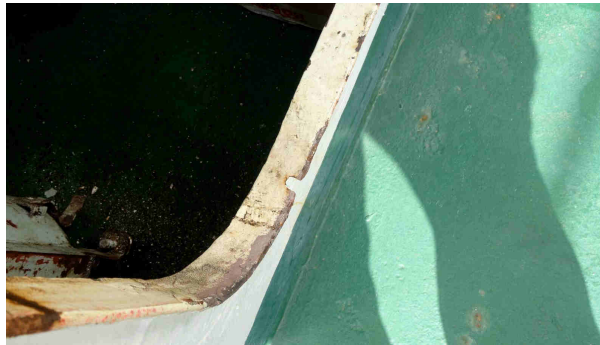
picture 21: door frames were rusted and holed

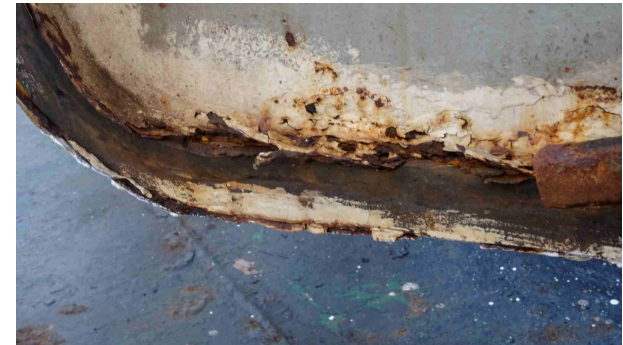
picture 24: corrosion on inner frame on door

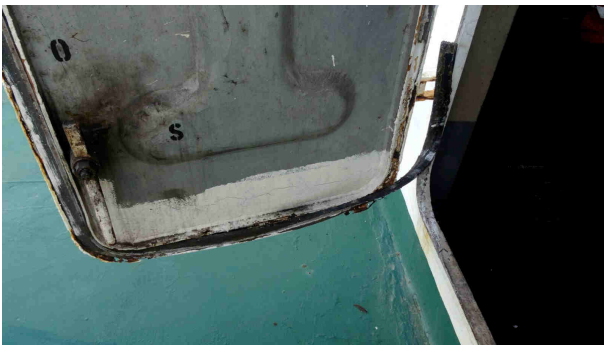
picture 19: or if not completely missing, not in place

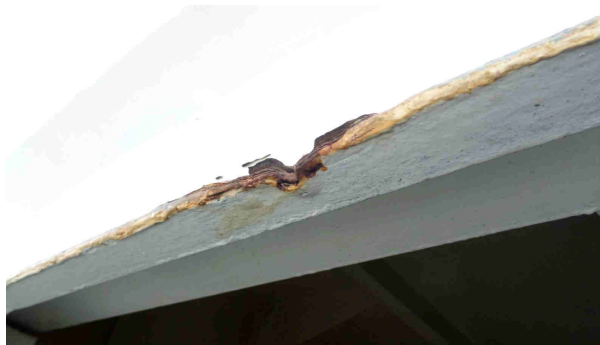
picture 22: tight closing not possible with this frame

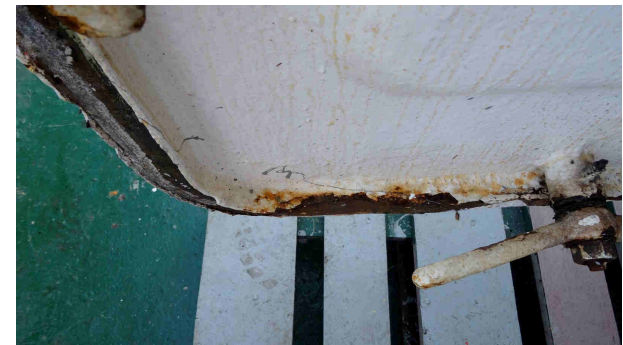
picture 25: net door, same problem

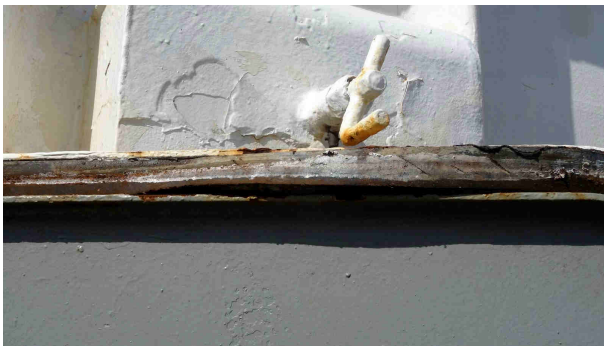
picture 20: in best case just not fitting

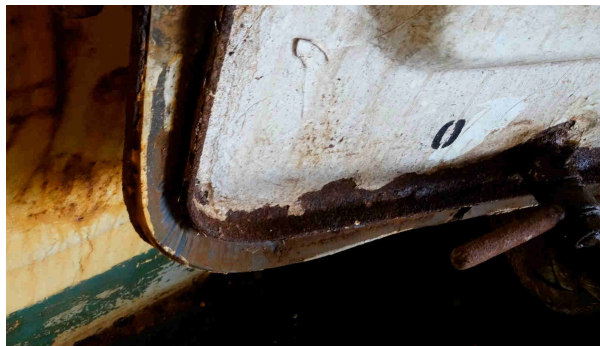
picture 23: doors itself were found bent

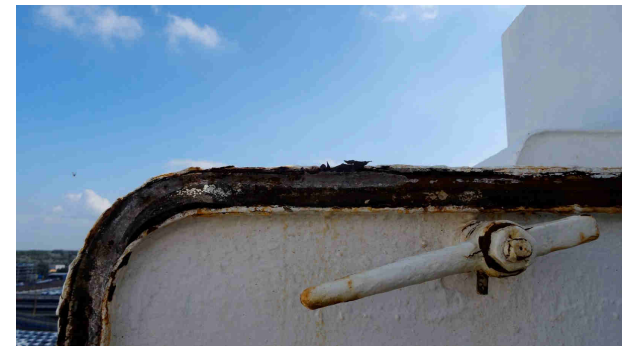
picture 26: additional rusted parts on outer door frame

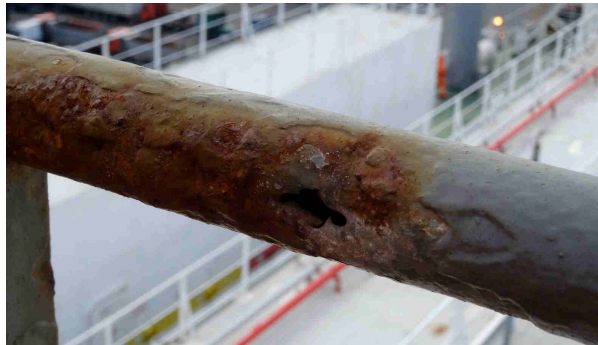
picture 29: rusted railing

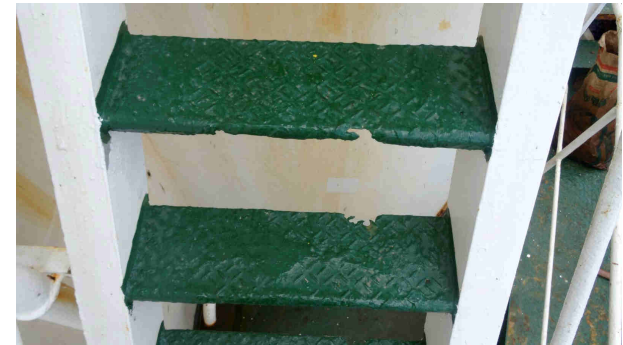
picture 32: in general outside staircase in bad condition

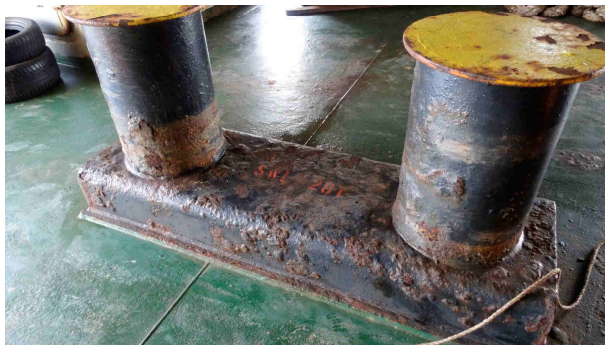
picture 27: bollards with some rust

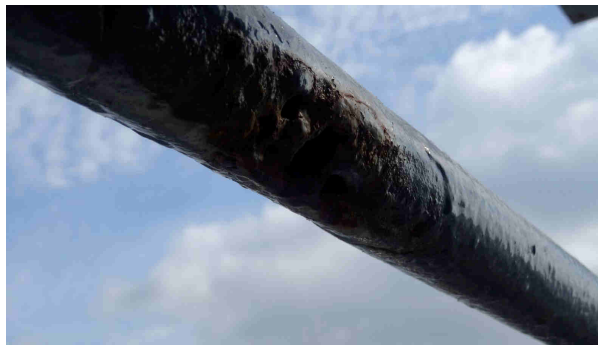
picture 30: holed railing

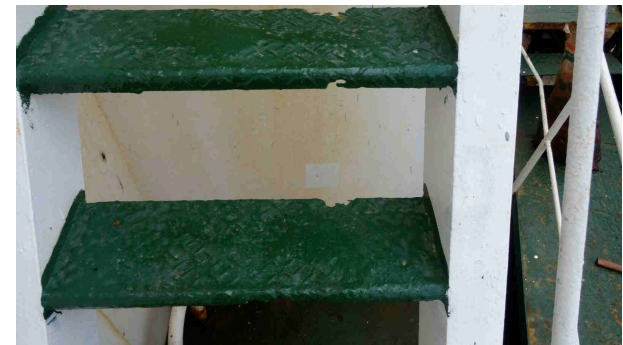
picture 33: the steps are particularly destroyed by rust

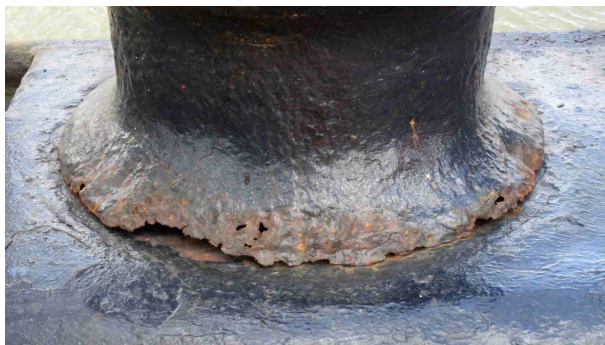
picture 28: capstan damaged by rust

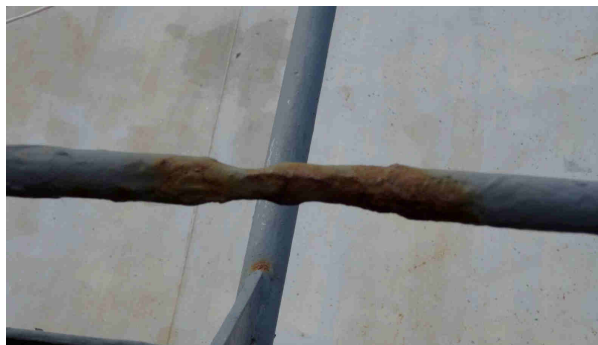
picture 31: what is the name for this condition?

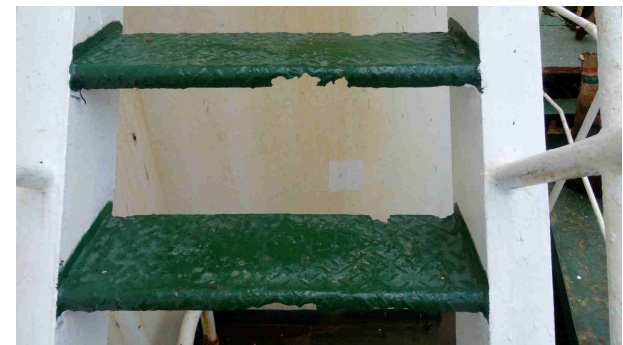
picture 34: remaining stability unknown

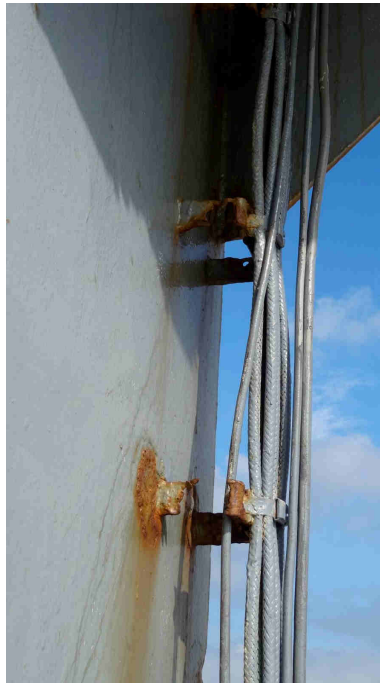
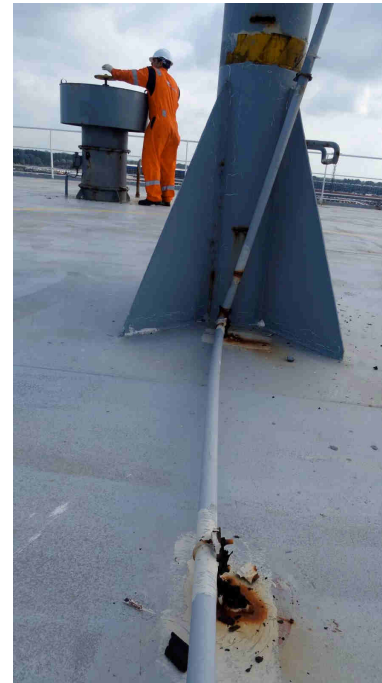
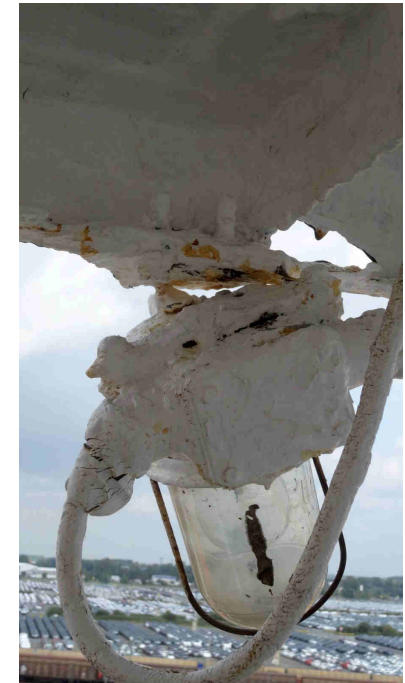
picture 35-37: rusted holders, broken basements and damaged lights all over the vessel

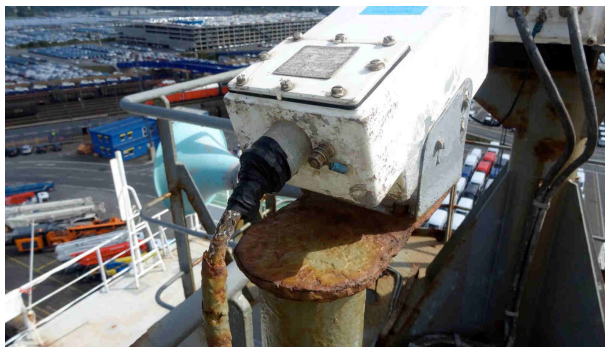
picture 38: destroyed insulations were...

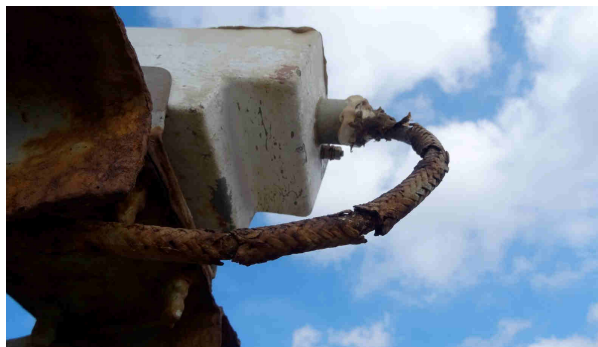
picture 39:..found on different installations

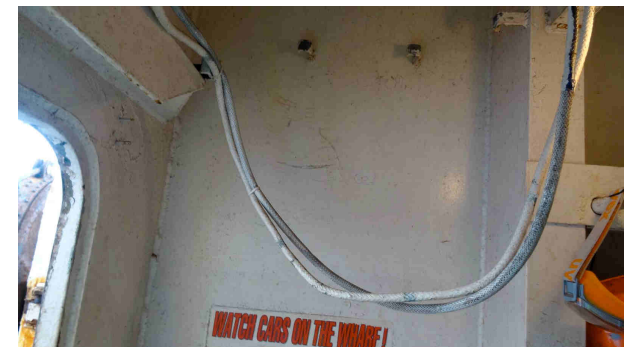
picture 40:nice trap when entering the room

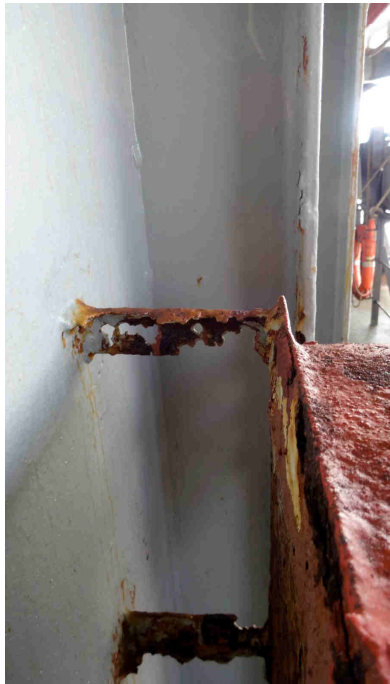
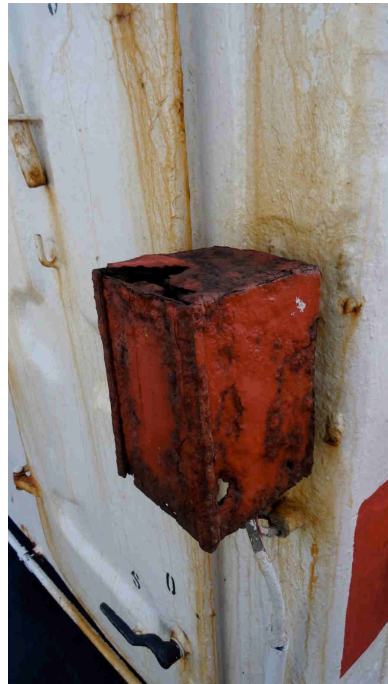
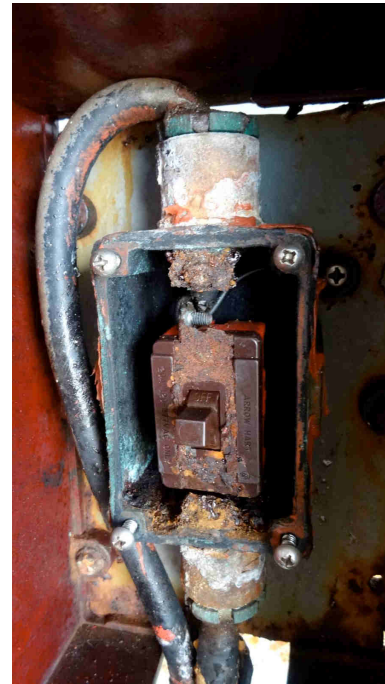
picture 41-43: fluent passage from poor external structure, rusted cover and poor condition of switch

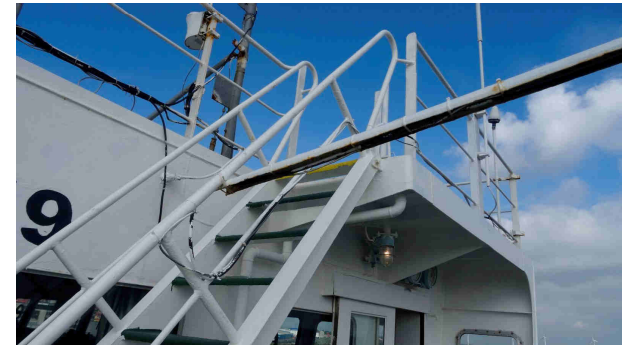
picture 44: Historically evolved electrical...

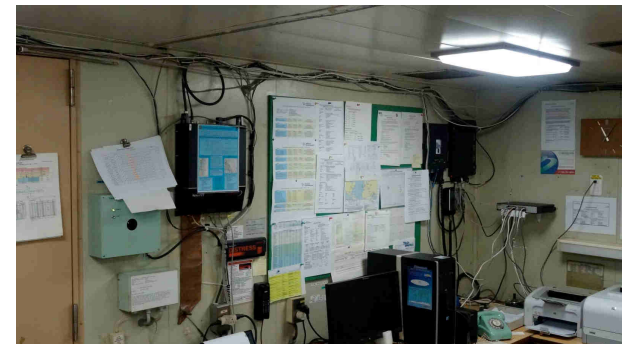
picture 45: ...installations found inside and outside

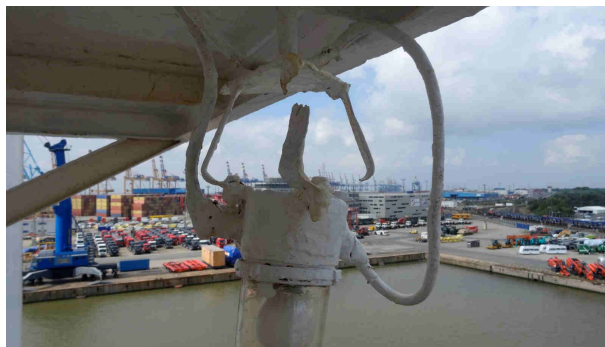
picture 46: unsafe installations outside

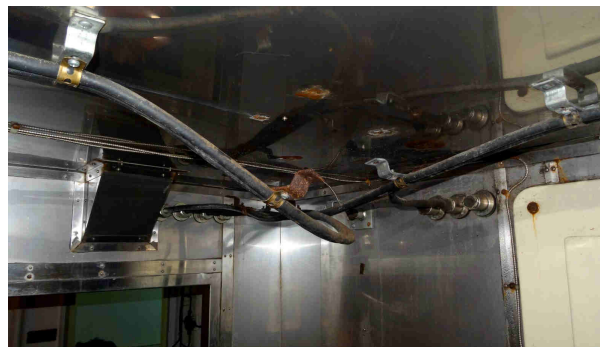
picture 47: unsafe installations inside

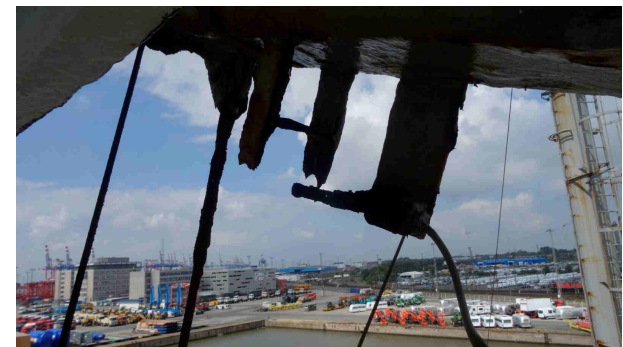
picture 48: destroyed limit switch on crane

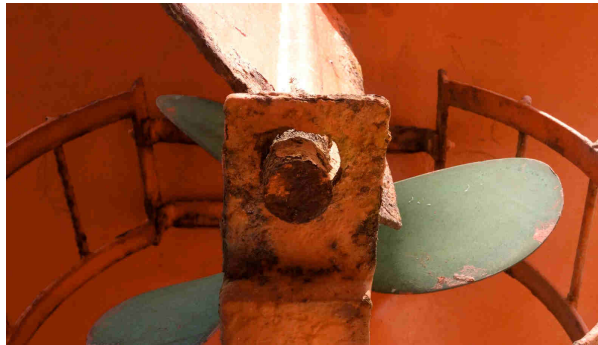
picture 49: worn out rudder shaft of life boat

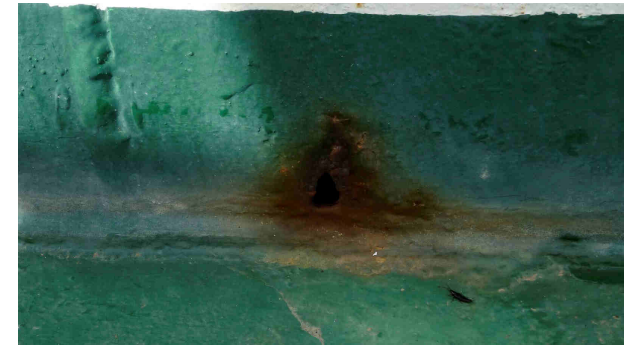
picture 52: several rust-made holes on deck, ...

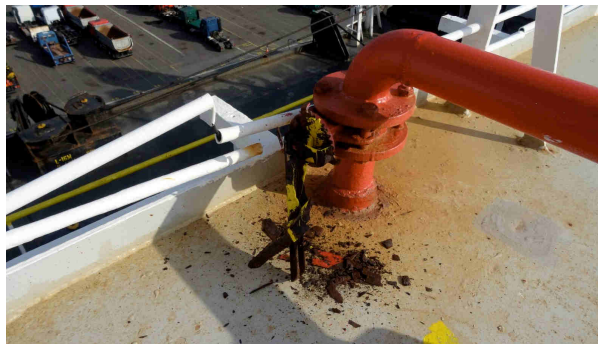
picture 50: fire line section valve after testing

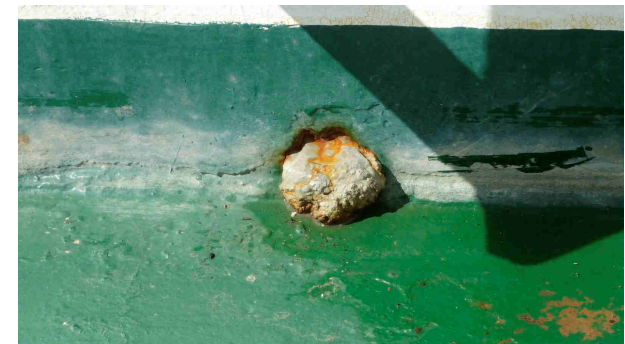
picture 53: ...some of them filled by concrete

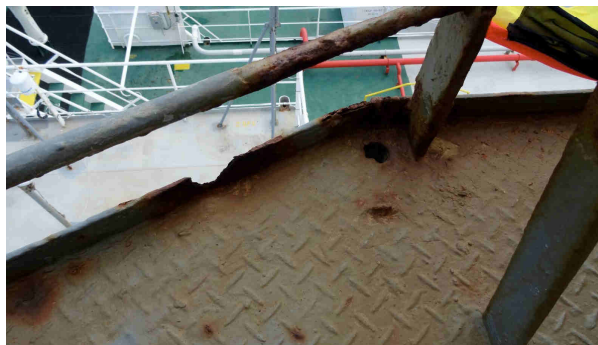
picture 51: general poor condition on platforms

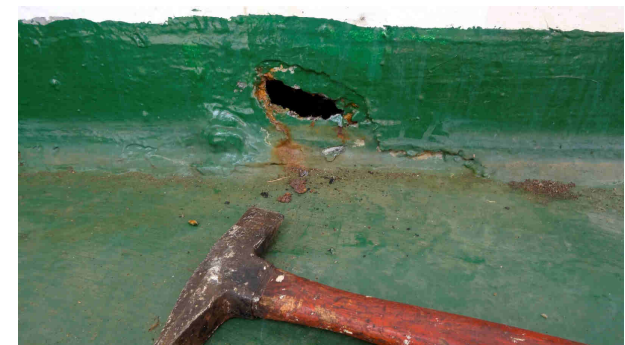
picture 54: additional holes could be made easily

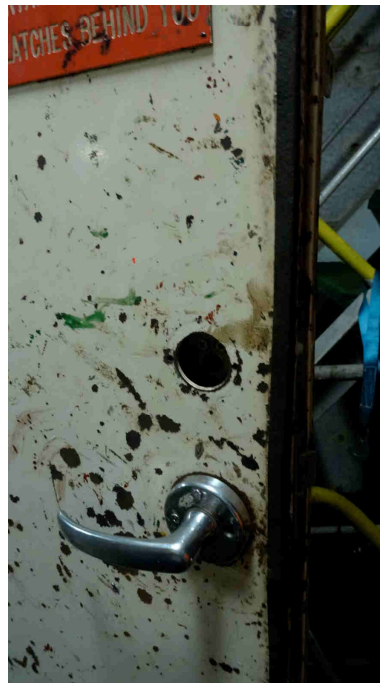
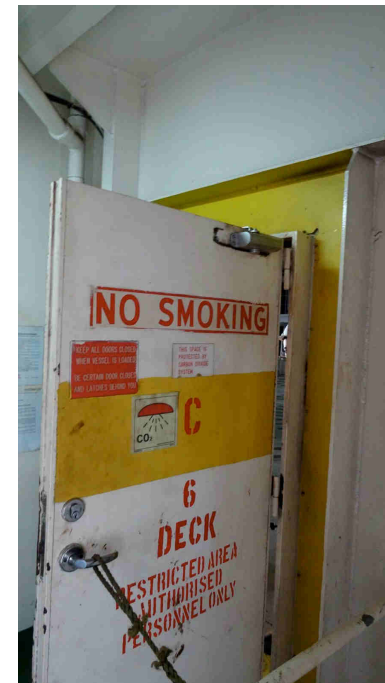
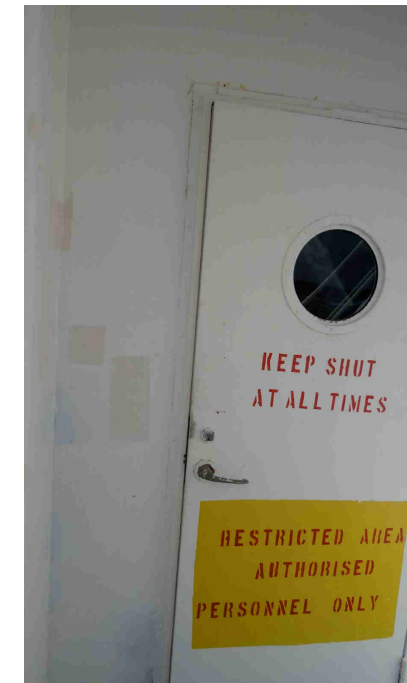
picture 55-57: fire doors were found damaged, bent, kept open by ropes, not more self closing or not tight closing

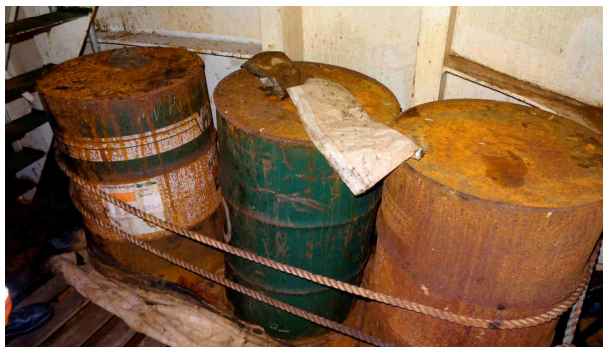
picture 58: nobody knows what is inside these drums

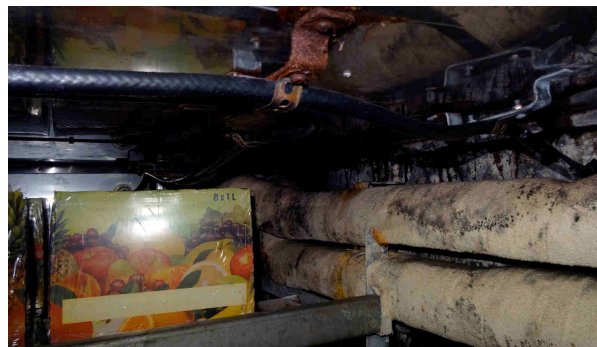
picture 59: cold rooms in unhygienic state

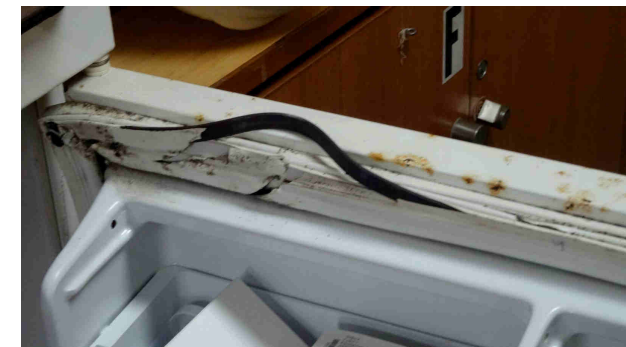
picture 60: refrigerators on board showing damaged gaskets and mould

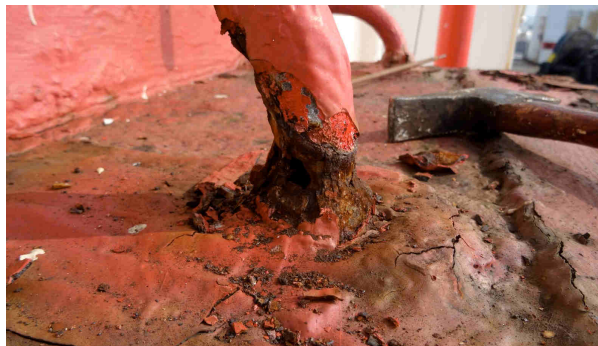
picture 61: holed CO₂ pipe to emergency generator

Ongoing the suspended inspection three more deficiencies were found. Worst of them was the CO₂-pipe for emergency generator room. When touching the rust on the pipe big pieces of the pipe disappear and a big hole was getting visible.

The workgangs on board immediately took action and have been able to repair this pipes before the inspection was finished.
