# Paris MoU

## on Port State Control

Name:	HUANGHAI DEVELOPER
IMO:	9458444
Flag:	Hong Kong, China
Type:	General Cargo
GT:	20682
Class:	Bureau Veritas
RO:	Bureau Veritas
IMO Company:	Tianjin Xinhai Intl Ship Management
Date keel laid:	17/12/2008
Delivery date:	10/03/2013

MV "HUANGHAI DEVELOPER" IMO: 9458444 flying Hong Kong flag, arrived at Hamburg/Germany on 09/08/2016 for cargo operation, no survey or repair work was planned for the port call.

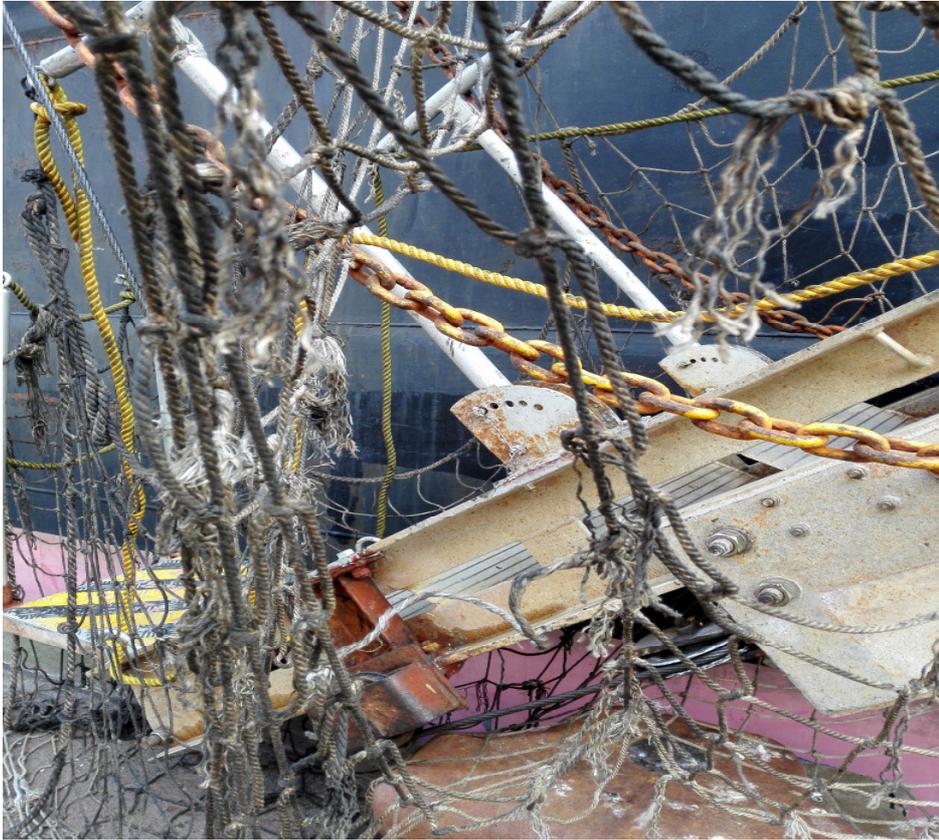
The first deficiency was already recorded when the PSCOs stepped on the gangway. The gangway net was fully worn out, with large gaps, comparable to a patchwork carpet. The picture speaks for itself

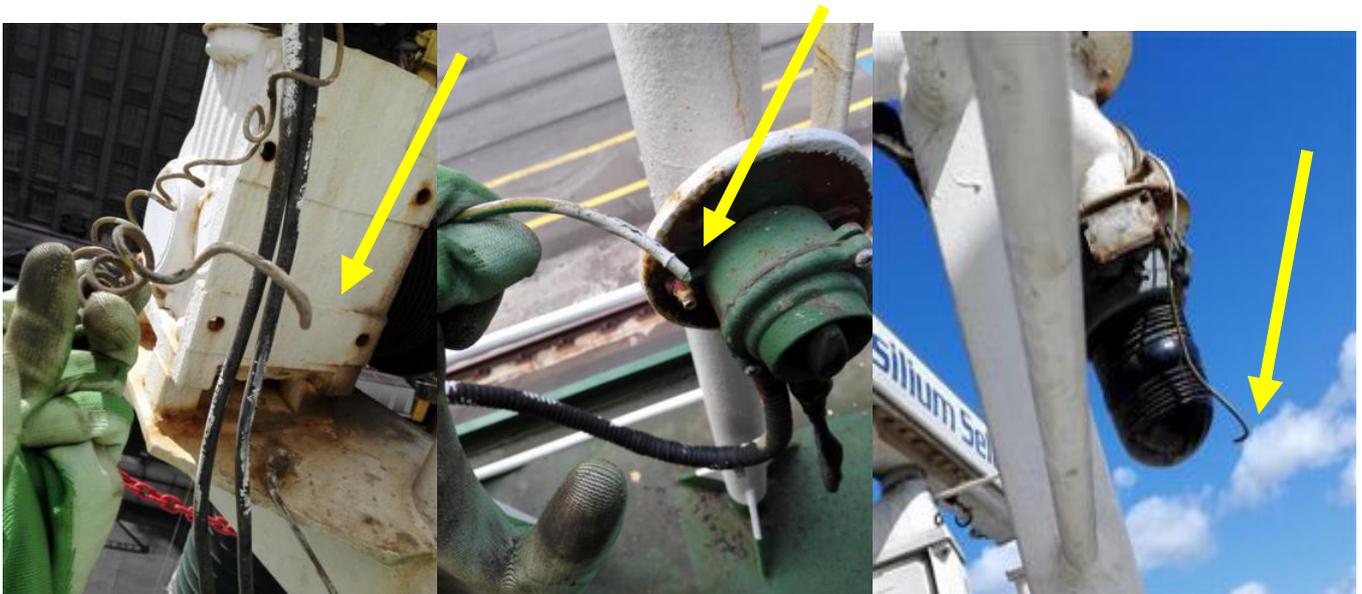
On the way to the ship's office the second deficiency was noted, the protective conductor (earth cable) of the gangway light was rusted away and therefore not connected. Later the PSCOs discovered that this deficiency was found all over the vessel in any possible area. For the sheer amount of damaged conductors this deficiency was noted with "ground for detention".

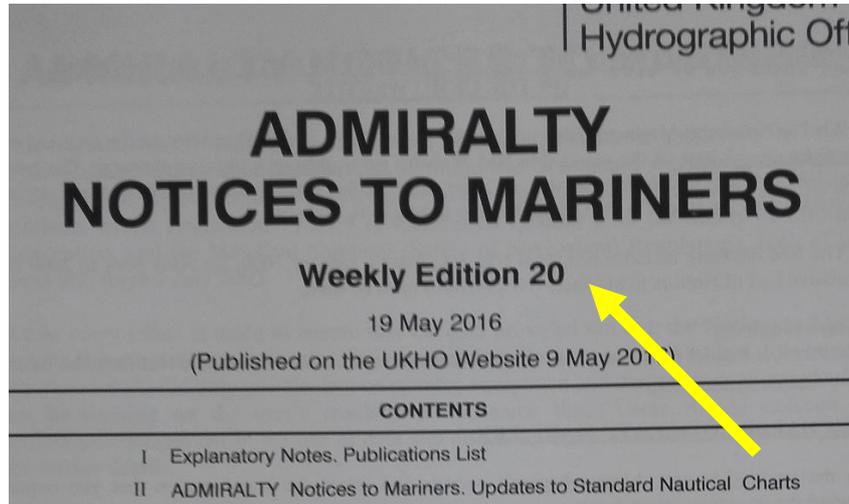
Last NtM available on board was WK 20, the released NtM during the inspection was WK 32. That means that the last 12 (!) weeks no corrections for charts and publications had been done. Additionally, the navigation officer showed a lack of familiarisation with the handling of NtMs, he wasn't able to identify T&P notices on the actual voyage charts. Therefore, the deficiency was marked with ground for detention.

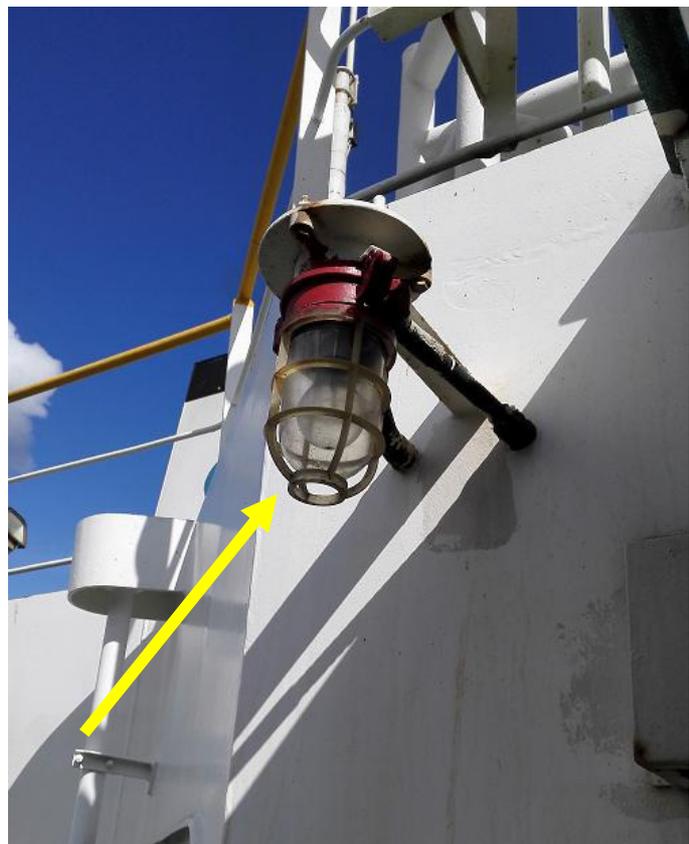
During the inspection on deck, the PSCO recognized numerous emergency lights with burst bulbs. Even a single unlit area could lead to a dangerous situation during emergency but on board this vessel the amount of broken lights was considered as a high risk for the crew and therefore the deficiency was marked as ground for detention.

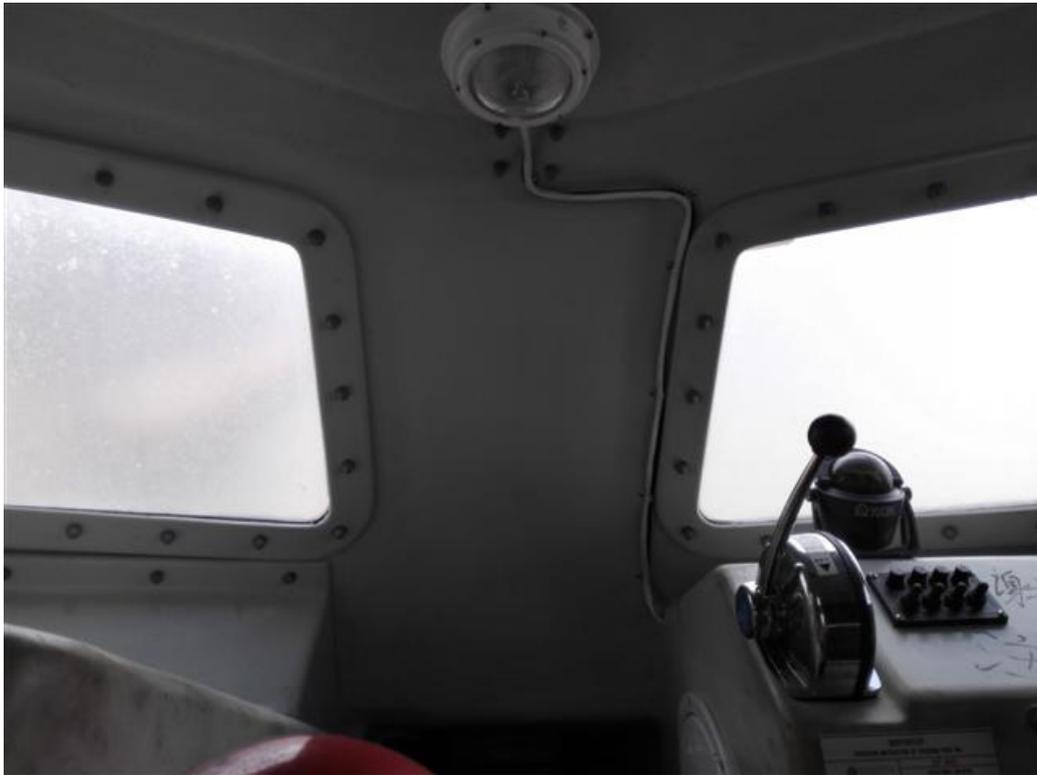
The windows of the free-fall boat, were so dirty that no view from inside to outside was anymore possible.

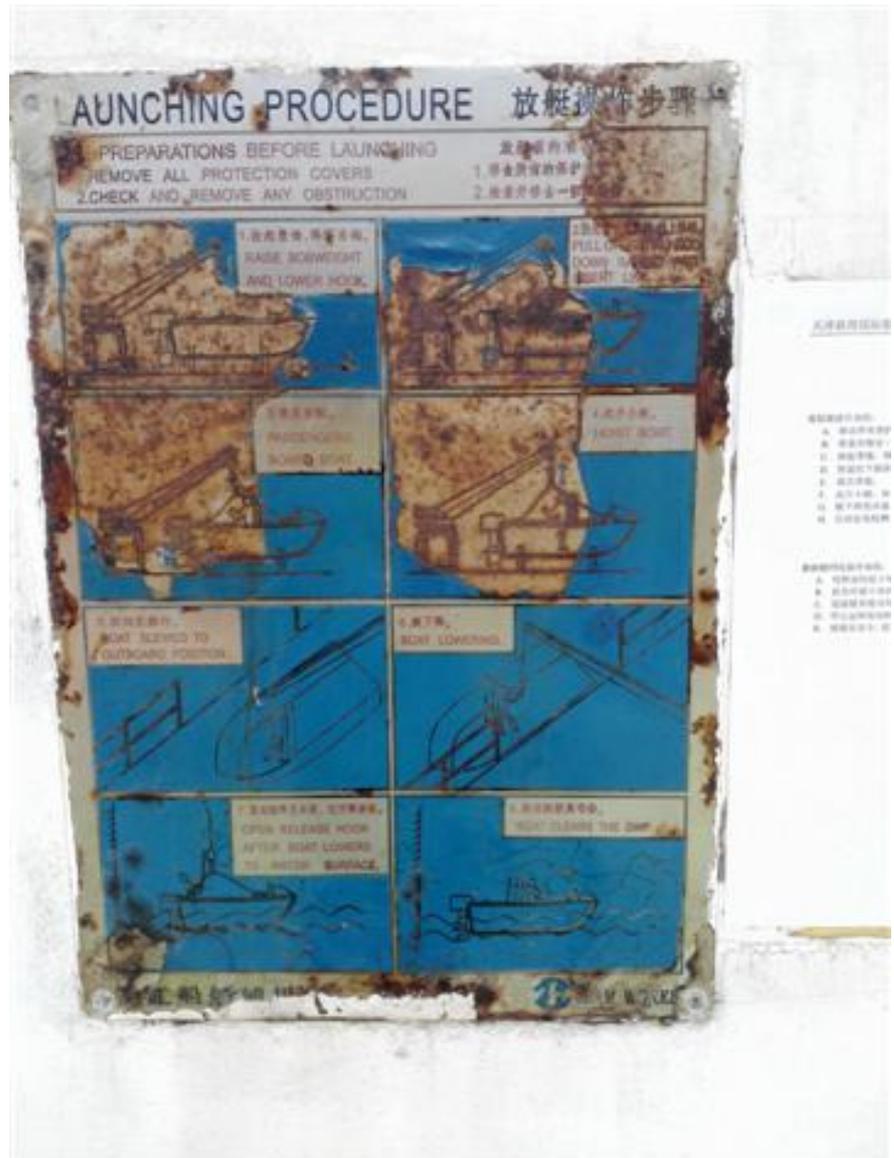
The poster "launching procedures of rescue boat" was so worn out that single steps of the procedures couldn't be identified. Posters for the familiarisation of the crew are a key point for safe operation at sea.

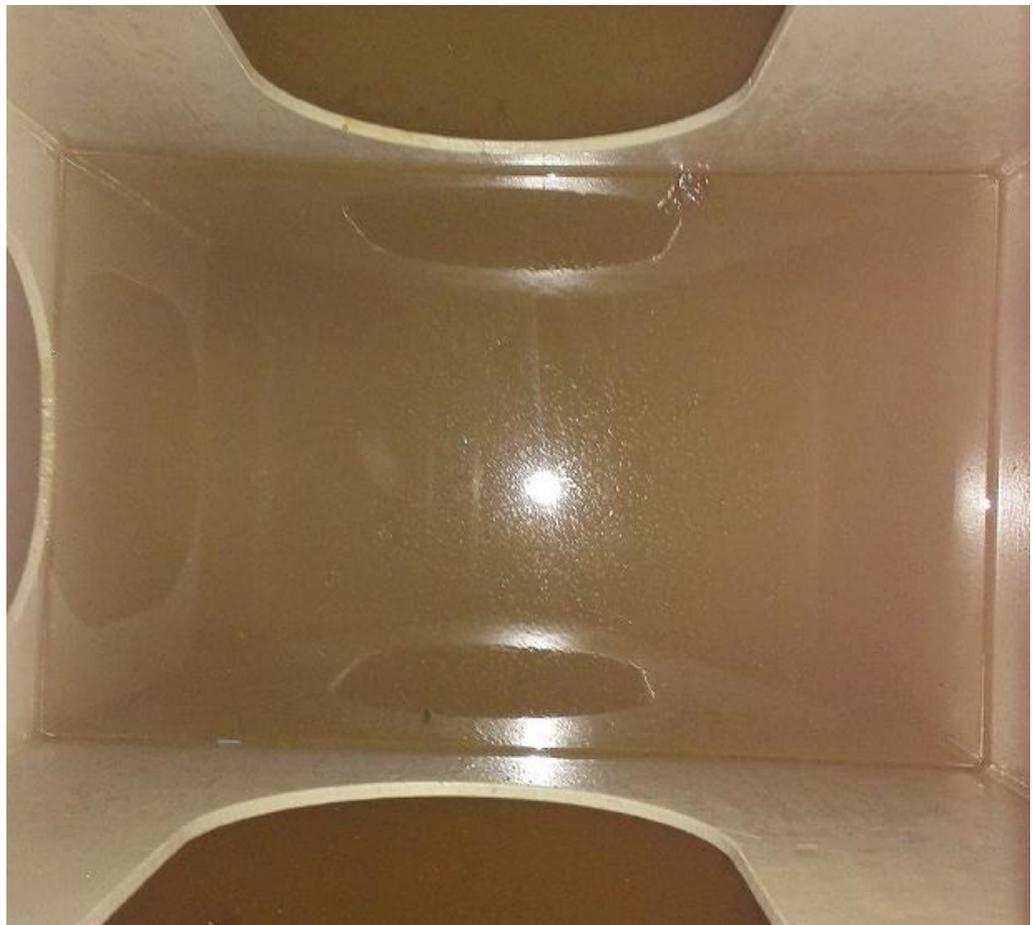
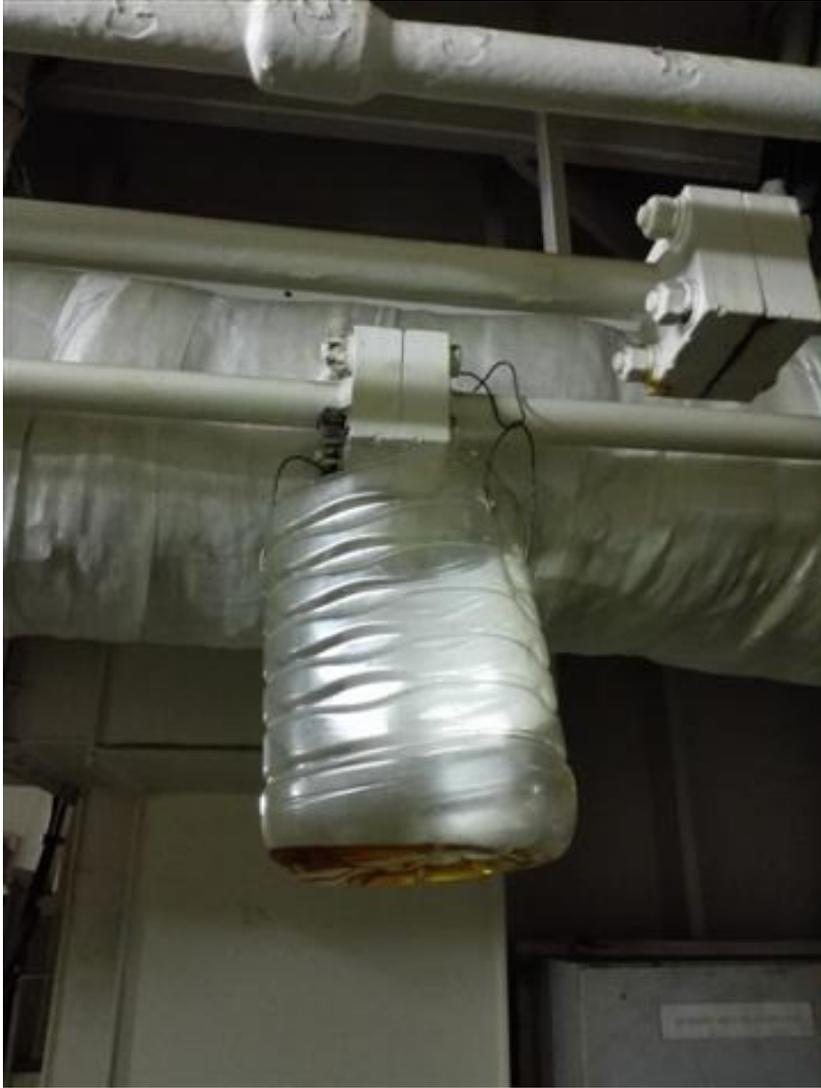
During the inspection of the WATER INGRESS ALARM the EMERGENCY FIRE PUMP ROOM was in alarm. (See pictures below)

An oily water mixture was discovered in the bilge of the emergency fire pump room (about 25cm sounded). According the bilge pumping arrangement a direct discharge to sea was possible. This deficiency was recorded with ground for detention.

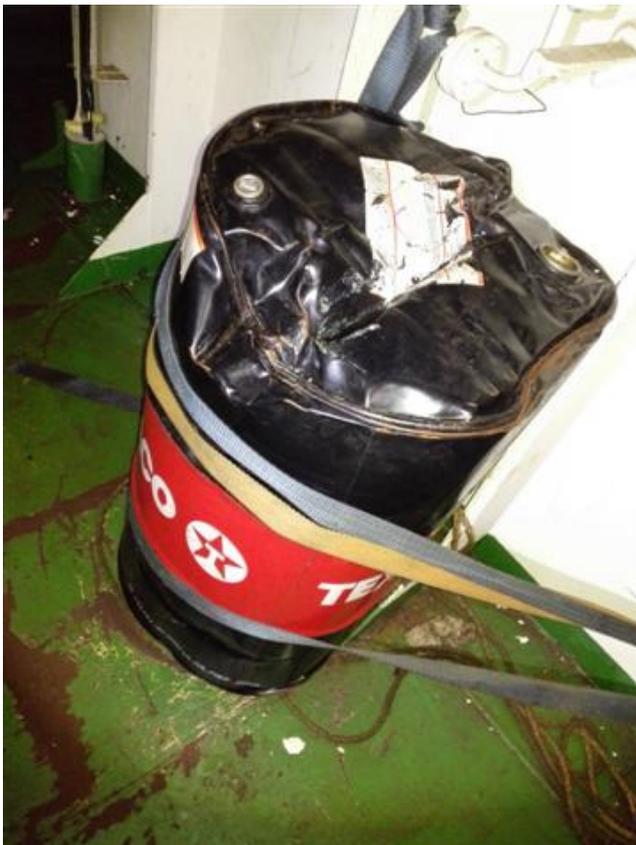
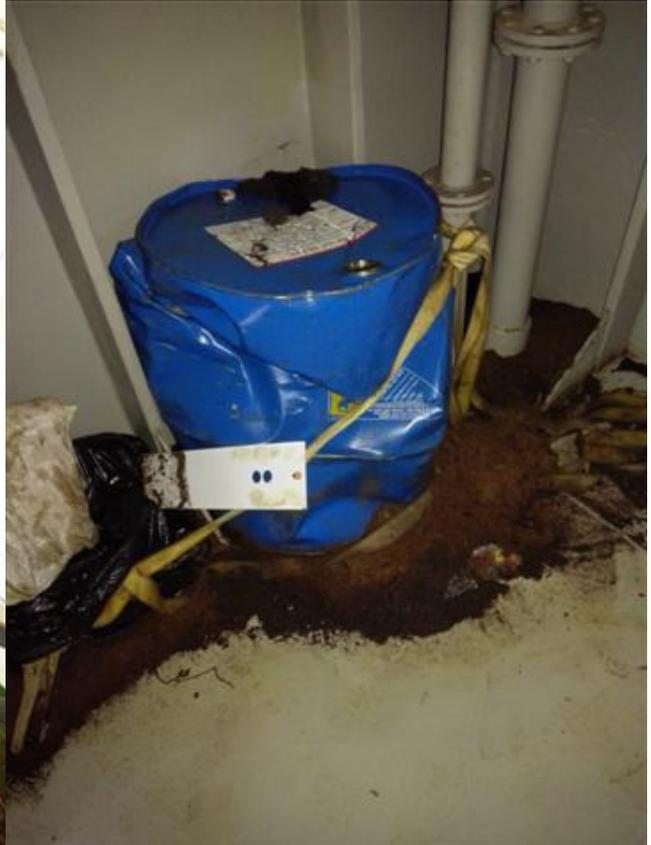
The piping for the hydraulic system of the hatch covers were leaking at every flange. The leaking oil was partly collected in small buckets and partly just dropping to the floor. Therefore, the floors in the bosun store and bow thruster room were fully covered with oil. The crew stated that this leakage had continued for an unknown time already. Inside the bosun store 15+ drums of hydraulic oil were discovered for the constant refilling of the hydraulic hatch cover motor. Also several heavily damaged and leaking drums placed all over the bosun store / bow thruster room, were leading to the extreme oil contaminated walls, floors and bilges. This deficiency was recorded as a ground for detention.

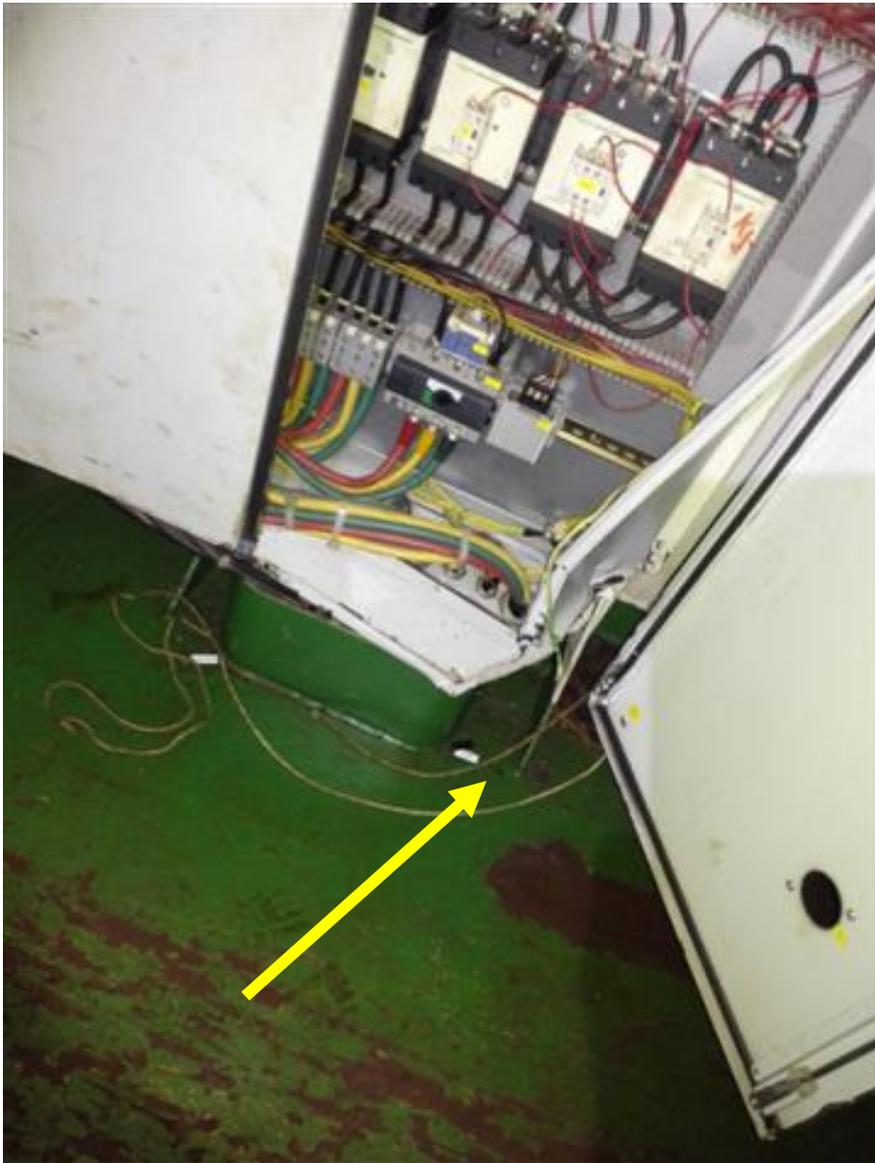
Because of the many unlash drums, both mooring winch control cabinets were heavily damaged. The cabinets were impossible to be closed at all. Crew stated during interview that this had been known for a long time but no spare part orders were forwarded to the company at all. Due to all these facts, this deficiency was recorded with ground for detention.

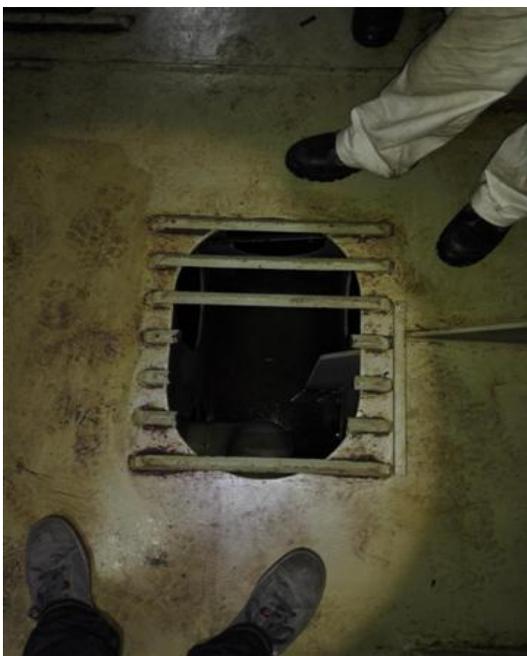
On this picture the fixed steel manhole cover for the bilge is broken. Nobody of the crew could explain why or when this had happened. In this dimly lit area a broken cover like this could lead to serious injuries.

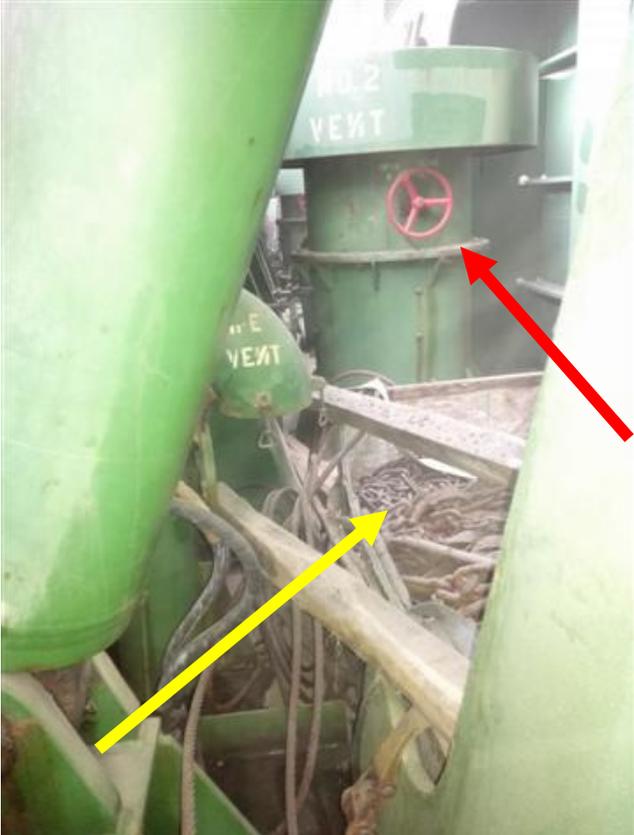
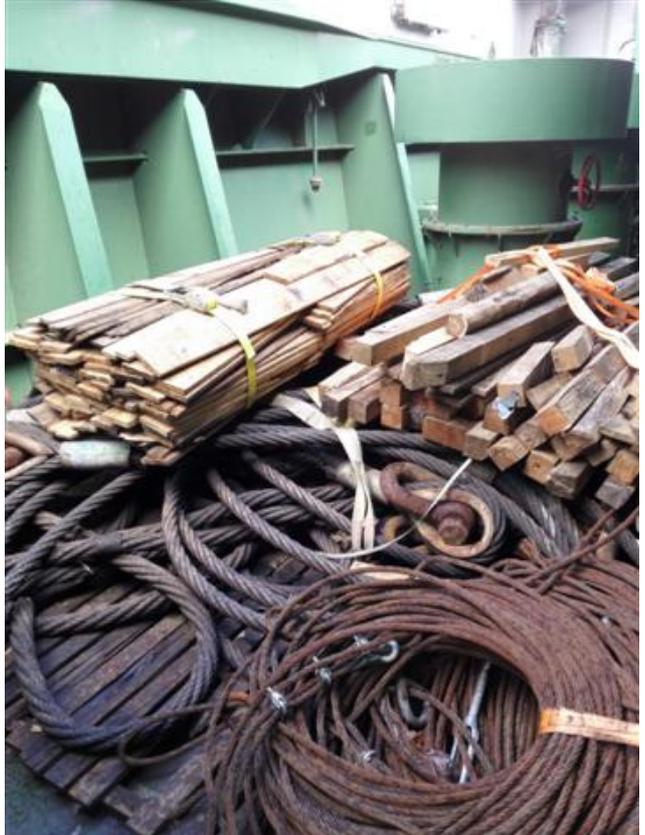
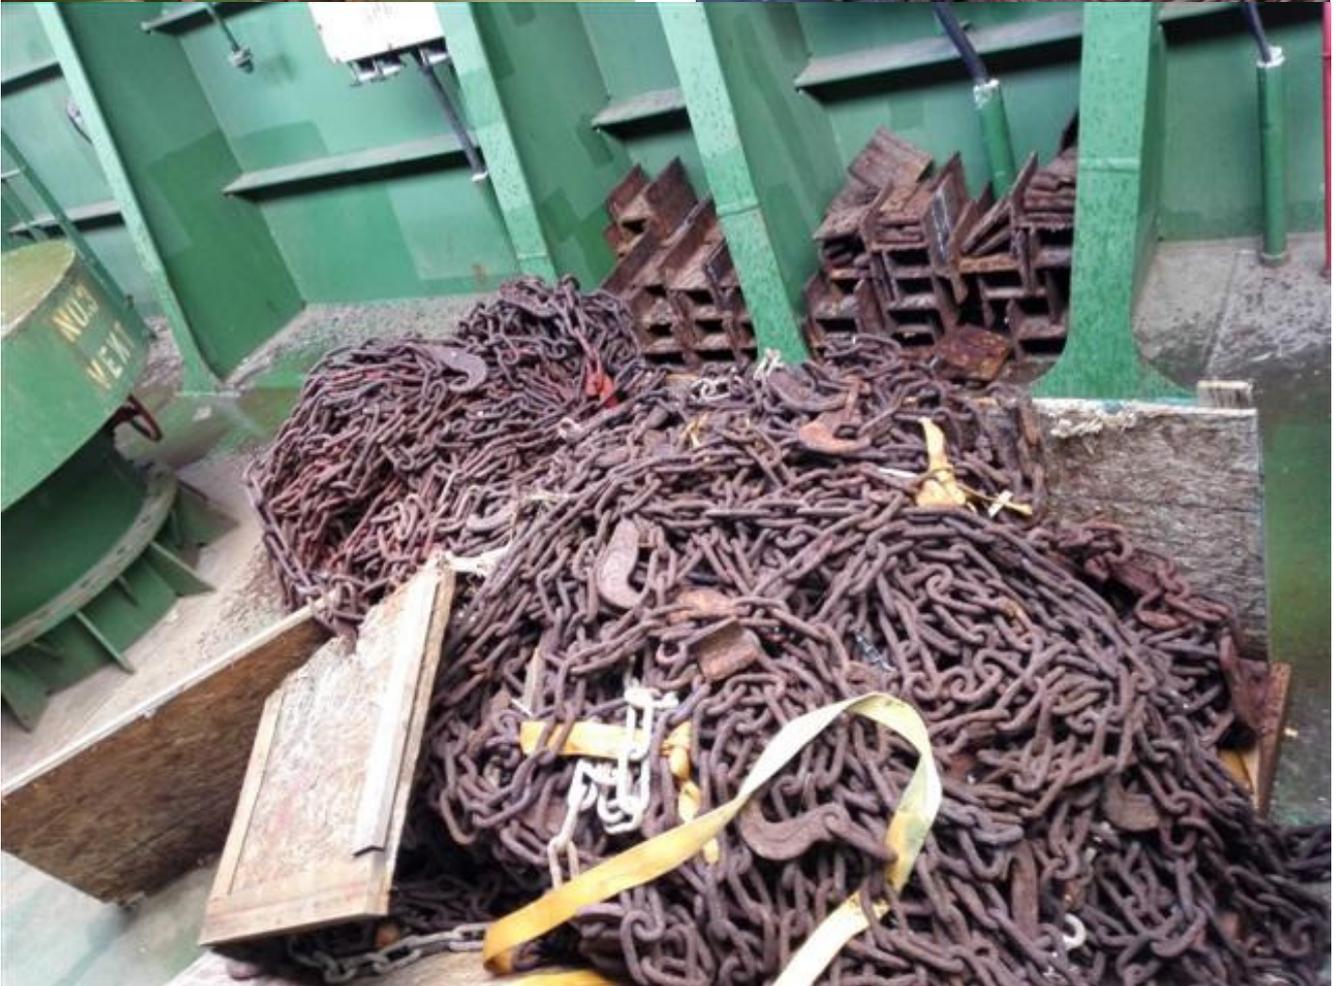
After the inspection of the bosun store, the deck tour continued with an obscure mixture of unlashed deck- and cargo-equipment. Crew confirmed that this equipment remained from previous voyages and had now been "stored" on deck for an unknown time. Ground for detention.

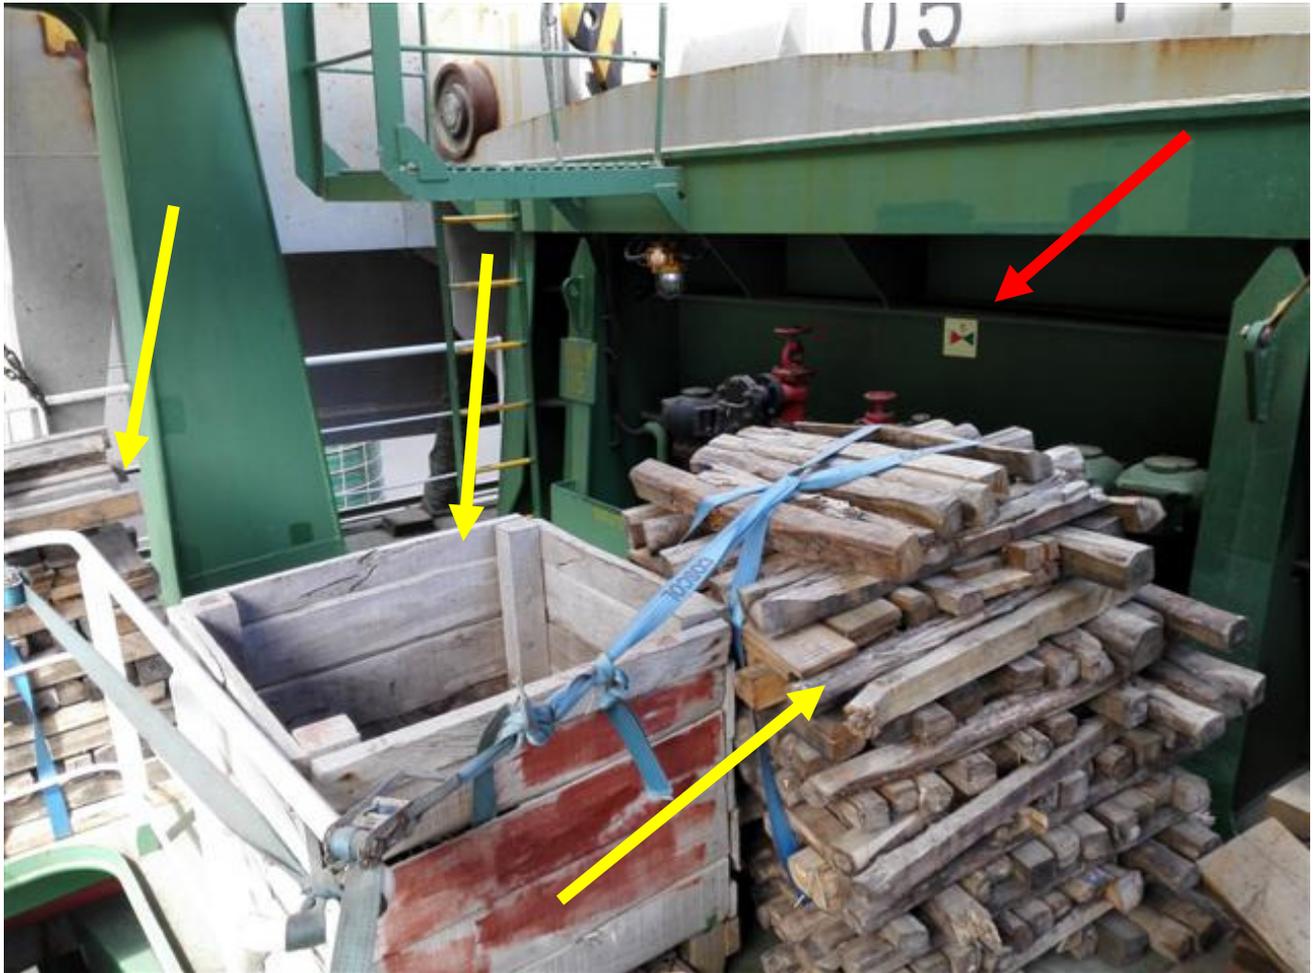
In this picture the fire fighting equipment is totally blocked by dunnage. Hydrants and also fire hose cabinets were not readily accessible at all. This deficiency was recorded with ground for detention.

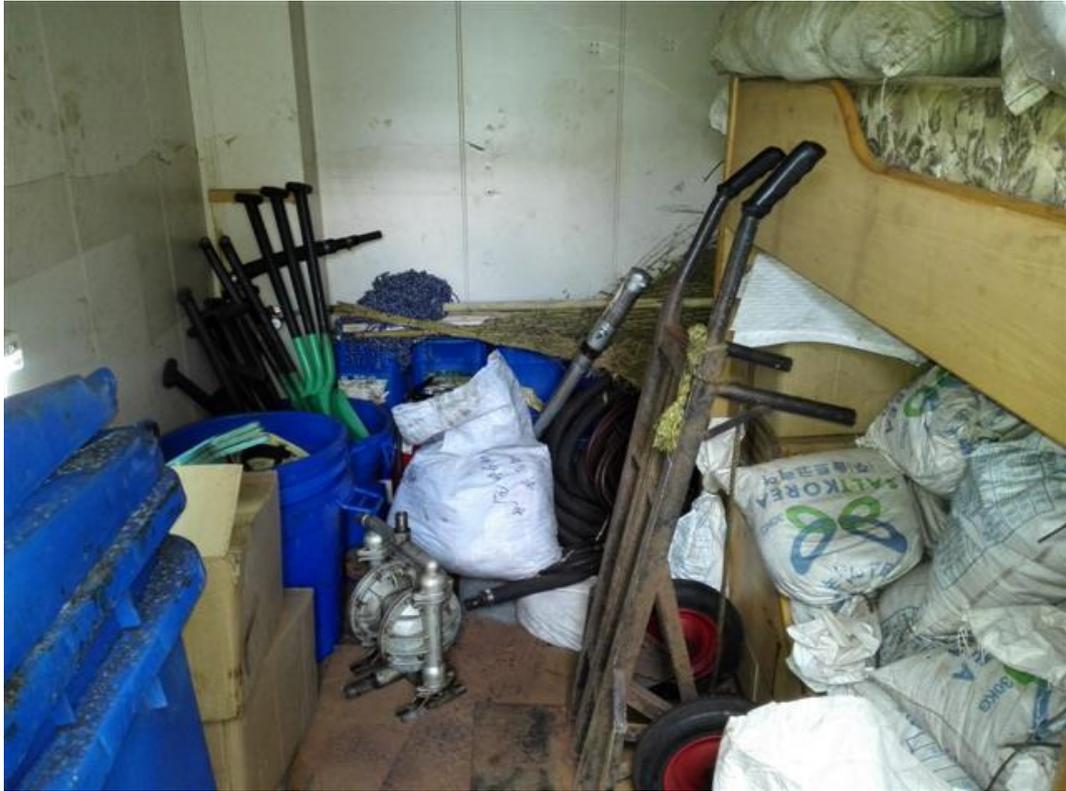
The former Suez crew cabin is used as SOPEP store, still furnished with the bunk beds. Inside the room an unacceptable mess of equipment was discovered. If a quick reaction against an oil spill were necessary, there would be no chance to handle the spill in a professional way.

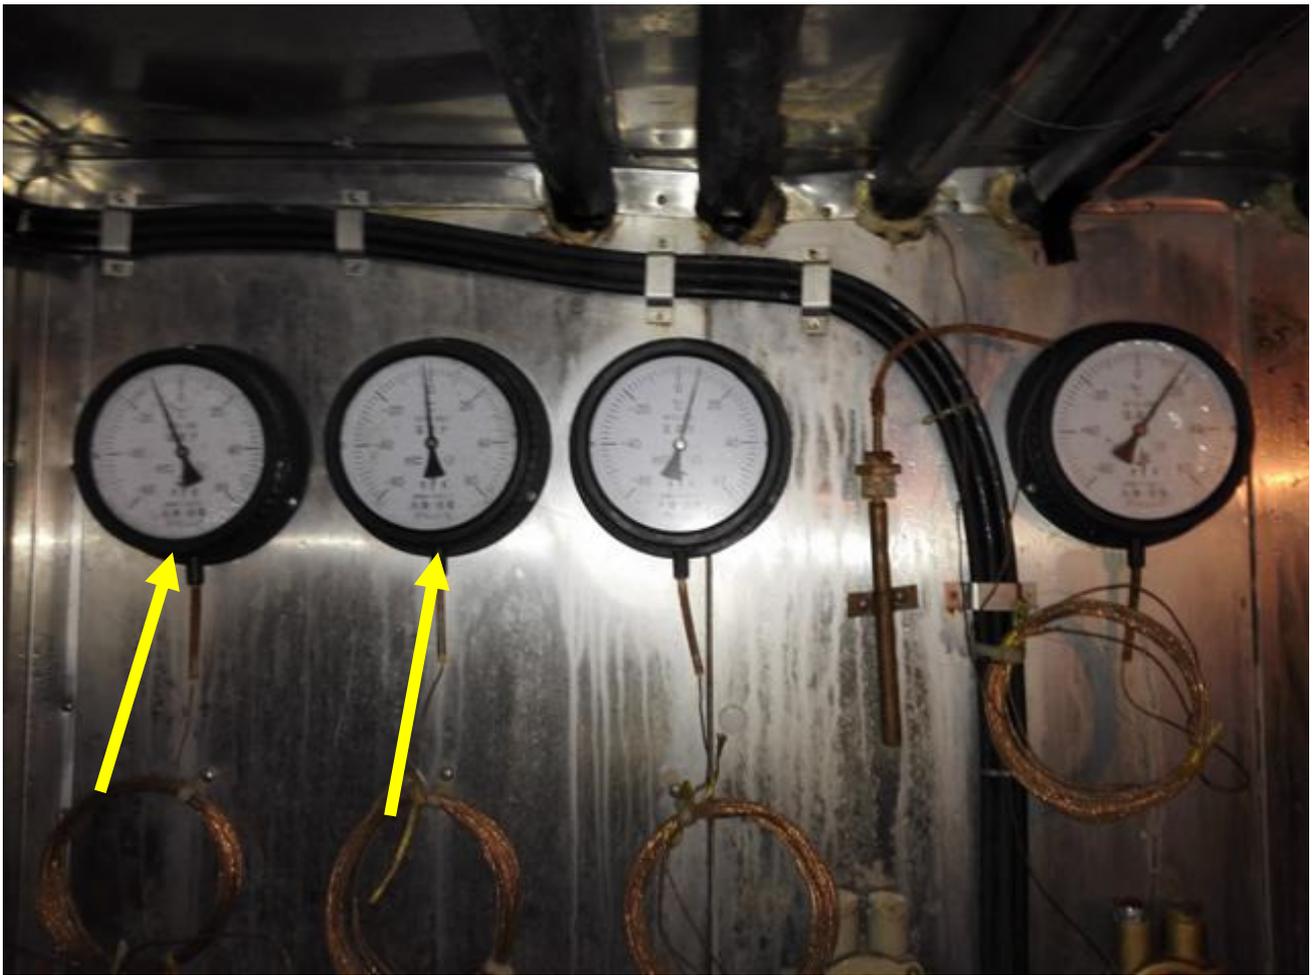
Temperature sensors of freezers fully out of range, resulting in iced meat and rotten food full of mould.

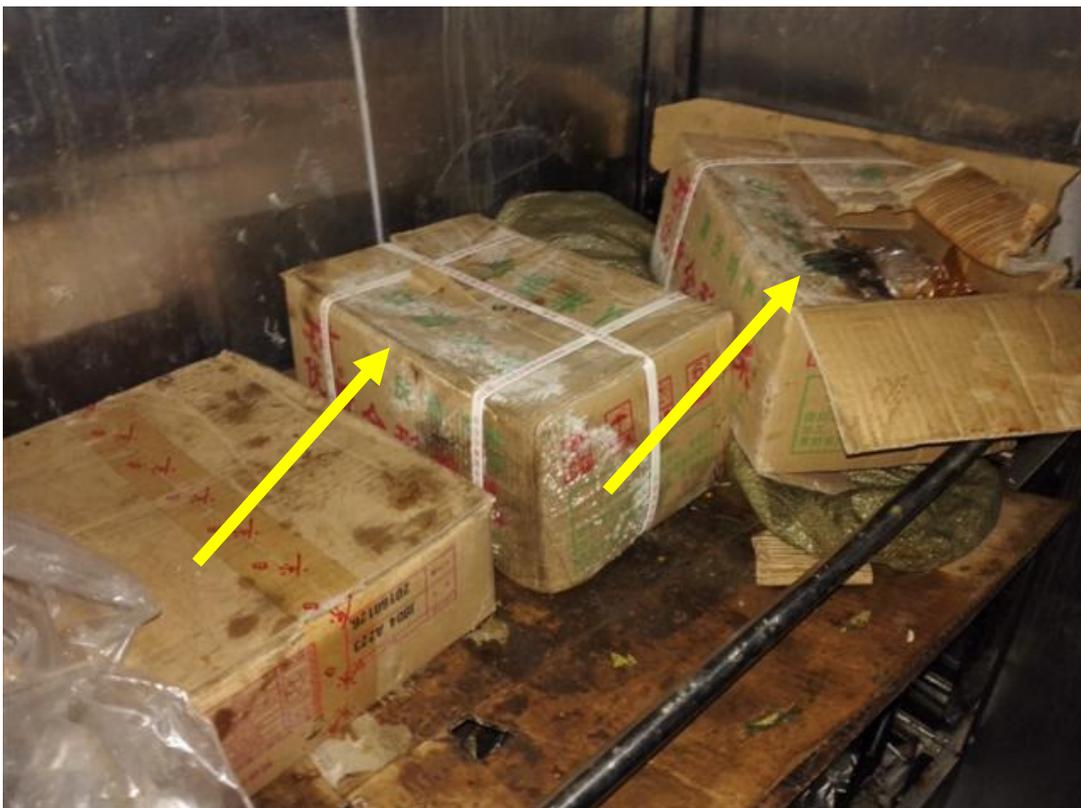
Packed vegetables already fully covered with mould and an awful smell inside all the provision stores.

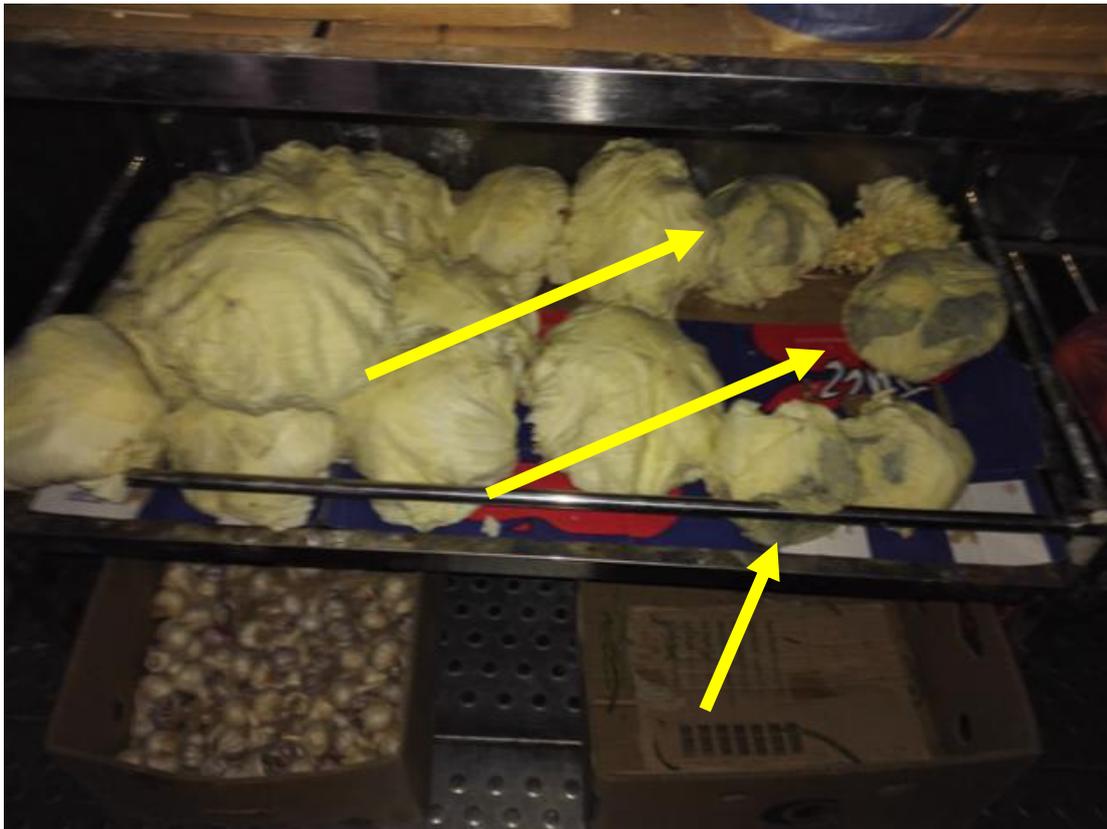
Lettuce heads covered with black mould. This is a high risk of food poisoning for all crew. The mould covered all kinds of vegetables all over the provision store.

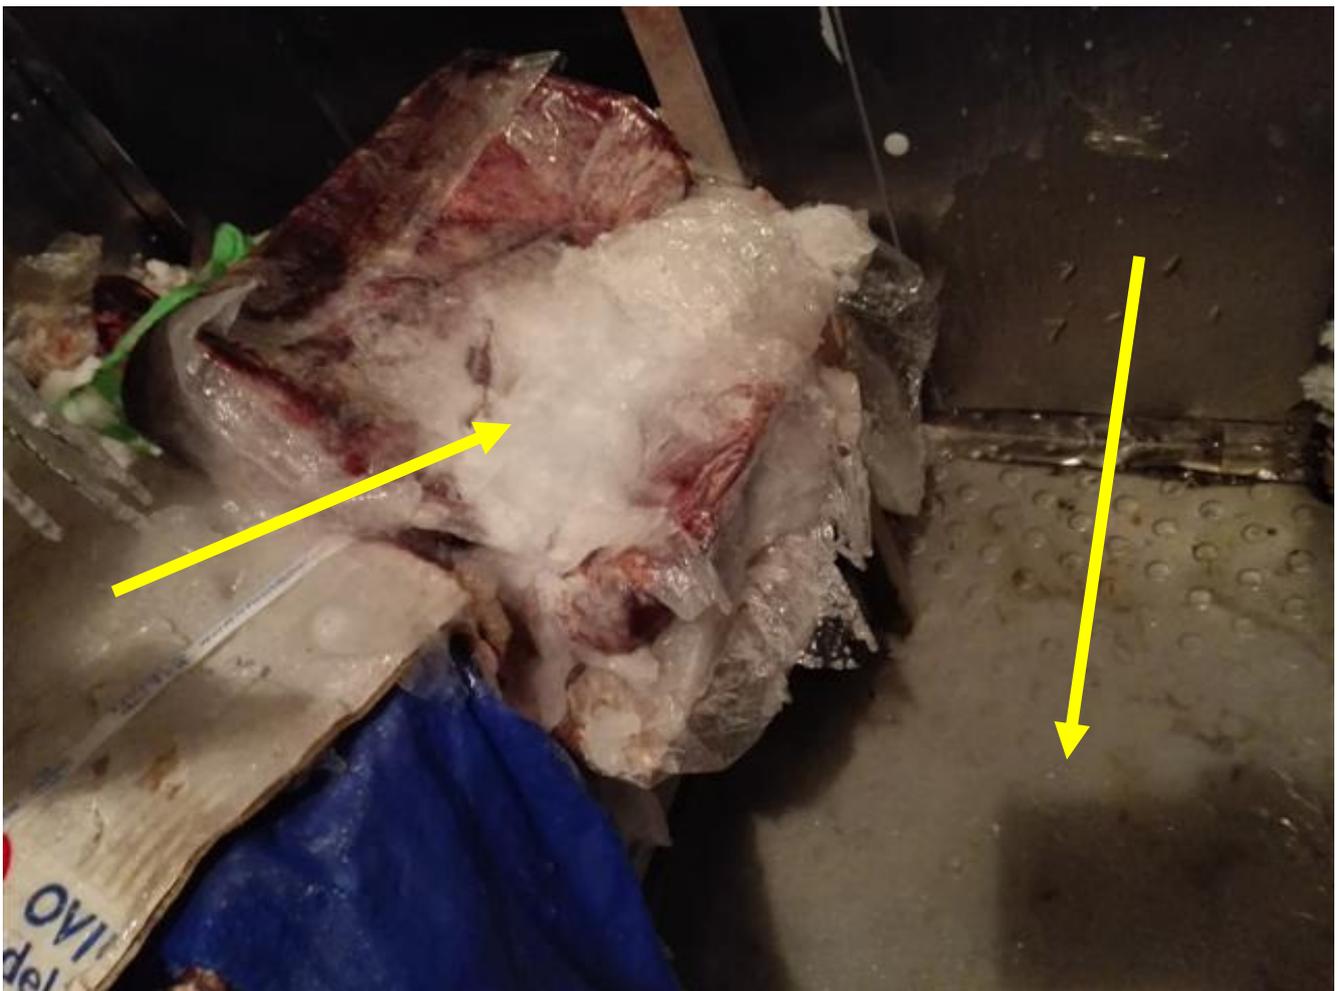
In deep freezer room heavy icing of meat and floor caused by overheating (-10°) and improper gaskets.

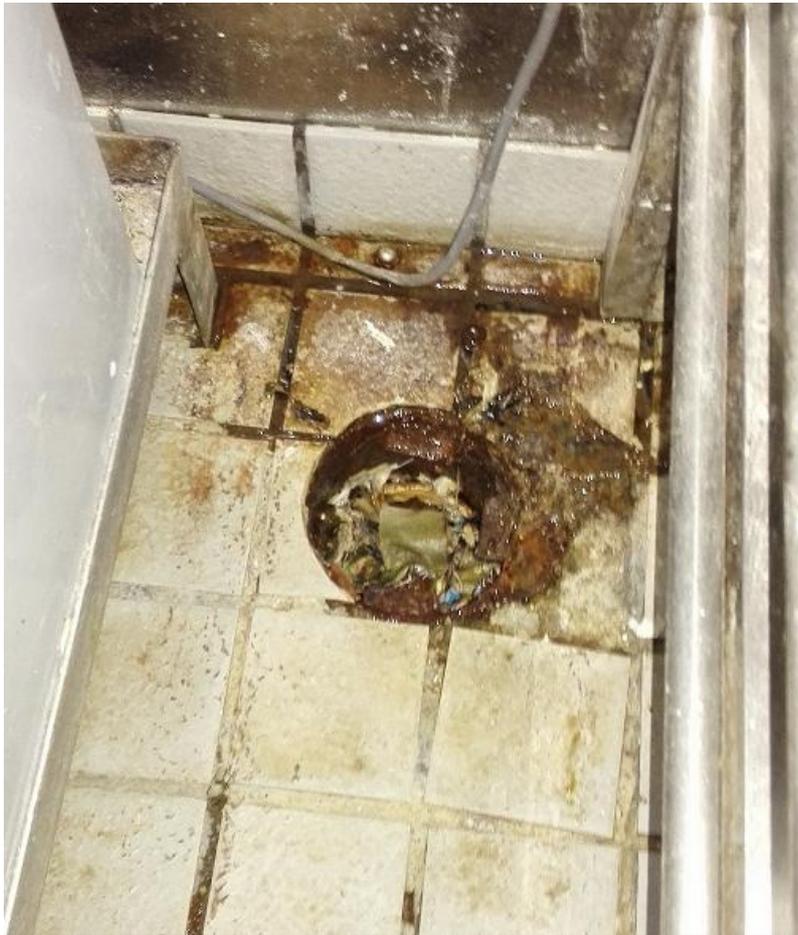
Inside the galley the unhygienic situation continued. Waste, dirt, rotten food and other unknown substances were visible in every corner. The PSCO had the impression, that the galley hadn't been cleaned for months.

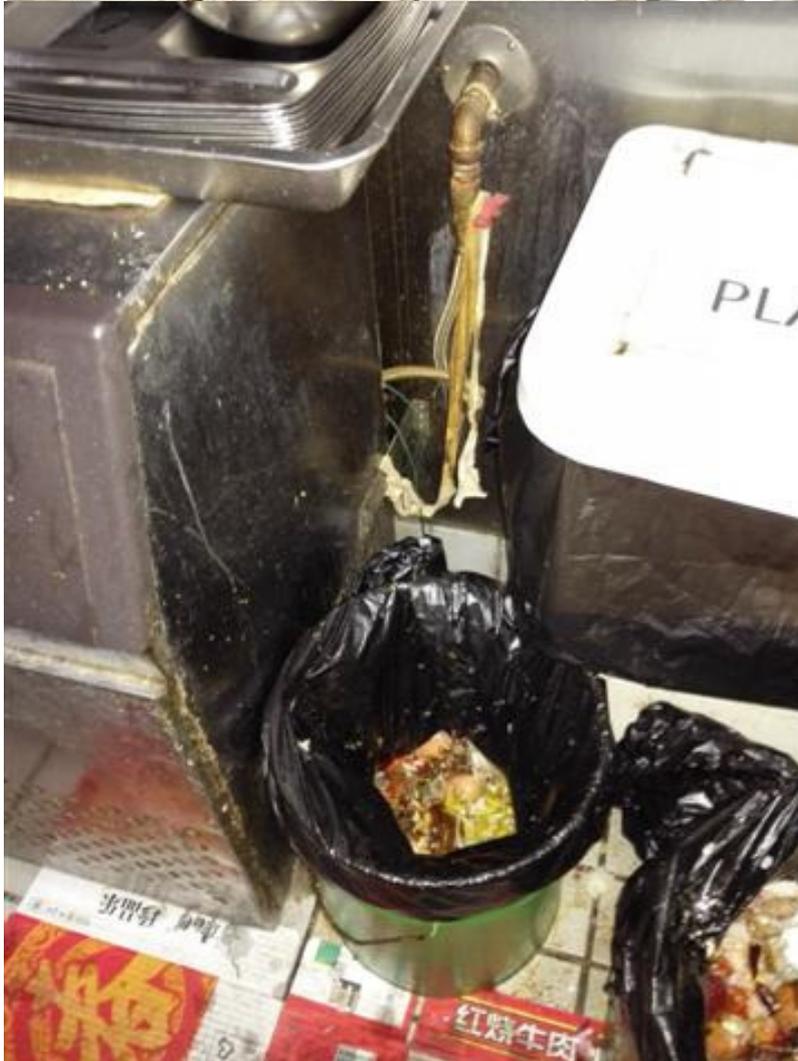
Open waste drums full of old food, walls and floor sticky and a mess of galley equipment was the situation encountered during the first boarding. All these factors combined led to the decision that the absolutely unhygienic situation in galley and provision stores must lead to a deficiency marked with ground for detention.

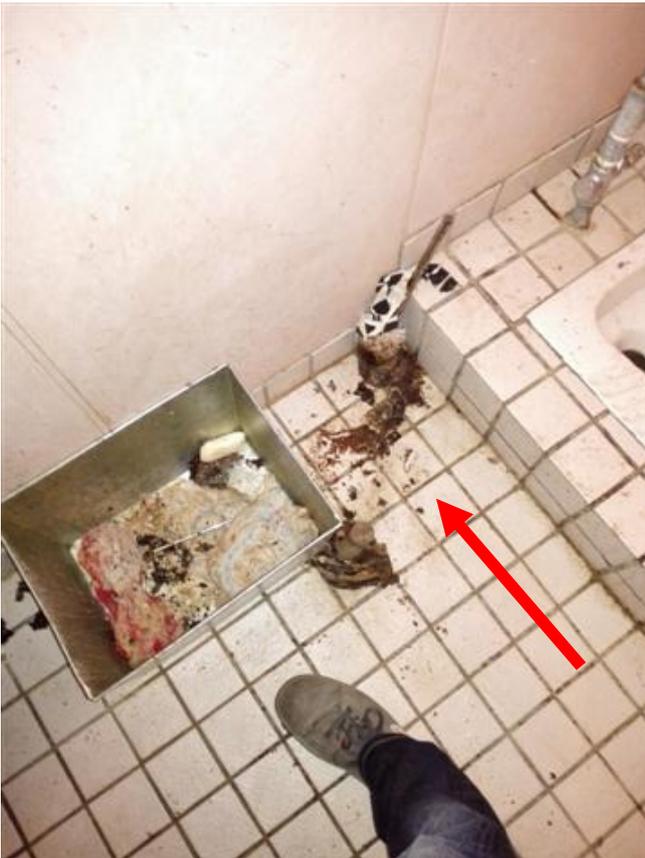
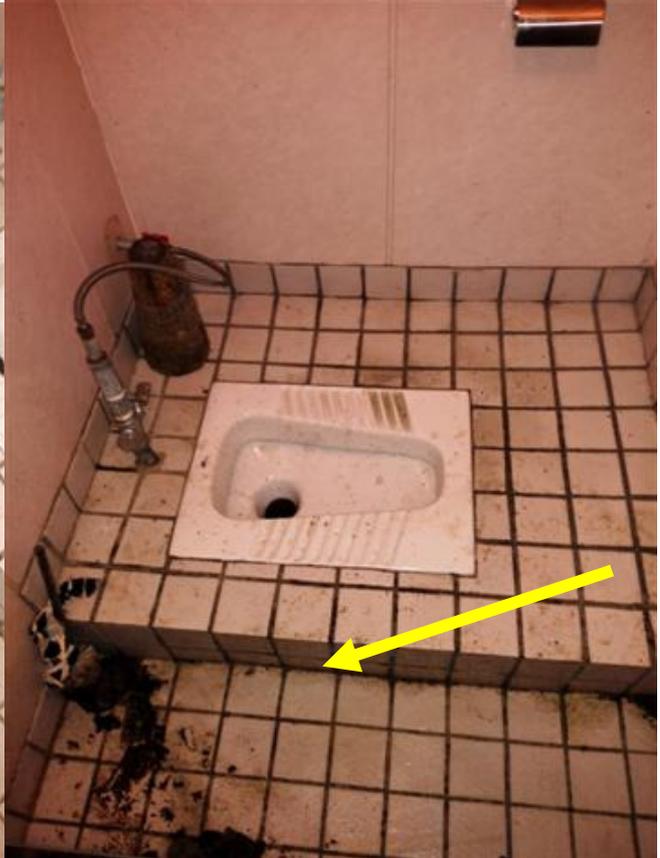
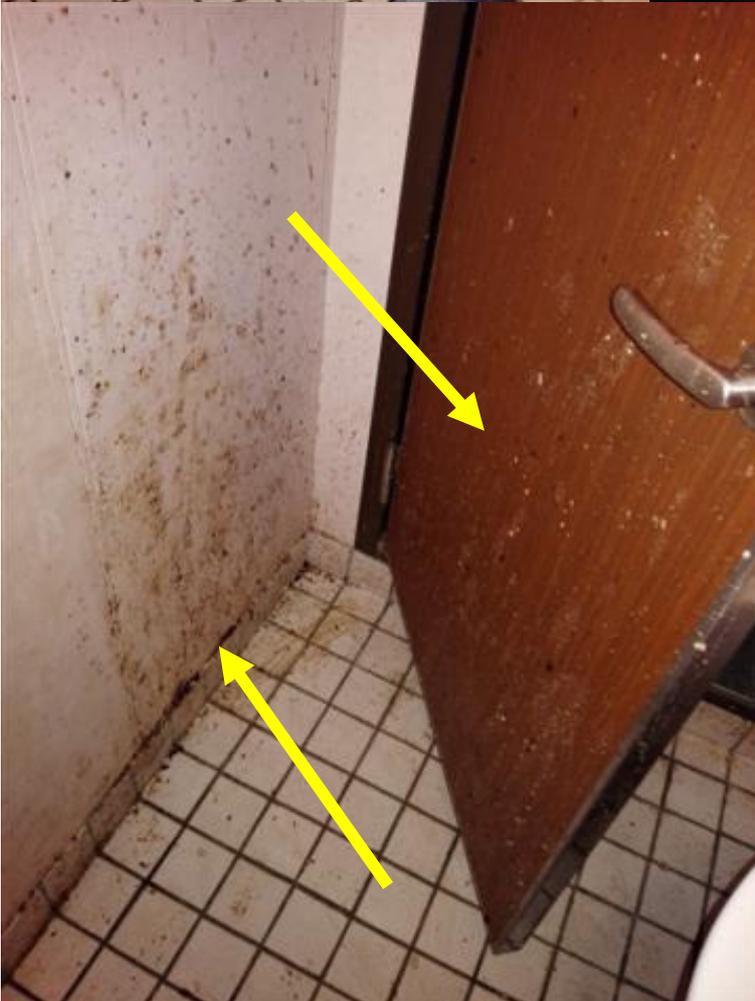
The inspection of the sanitary facilities was the most shocking moment of the PSC, floors and walls were totally contaminated with feces including a disgusting smell. During the whole inspection the PSCOs were under the permanent impression that the crew is fully disinterested and unmotivated. When addressing any of the deficiencies to the crew nobody could explain when or why the specific deficiency occurred. The HUANGHAI DEVELOPER is for sure not the worst ship the PSCOs had ever seen, but she shows what happens to a just 3 years old vessel if the complete ISM system collapses caused by a total lack of maintenance and motivation. At the end of the day, 24 deficiencies were recorded, 11 of them with ground for detention. The vessel was arrested for 3 days before she was allowed to continue her voyage.
