The Hamburg-based Federal Bureau of Maritime Casualty Investigation (BSU) has identified a safety risk in an ongoing investigation, the significance of which extends beyond the individual case. The following lesson learned is therefore being published:

SERIOUS MARINE CASUALTY: crash of a rescue boat

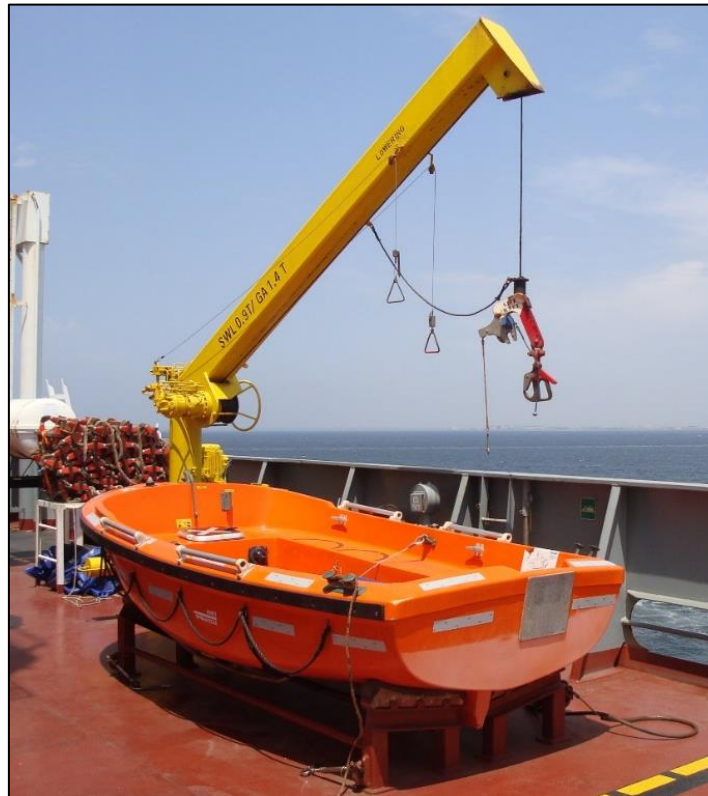
In the course of launching a rescue boat manned by three crew members, the hydraulic brake of the launching appliance was released by means of a cable remote control located in the boat after the boat was swung over from deck to sea. If the launching device had been functioning correctly, the boat would then have been lowered to the surface of the water slowly. However, immediately after the brake was released, the boat, suspended from the launching appliance on a hook, descended much faster, i.e. more or less unchecked, and struck the water accordingly with considerable force. The three people in the boat suffered serious injuries as a result.

Figure 1: Launching appliance and rescue boat

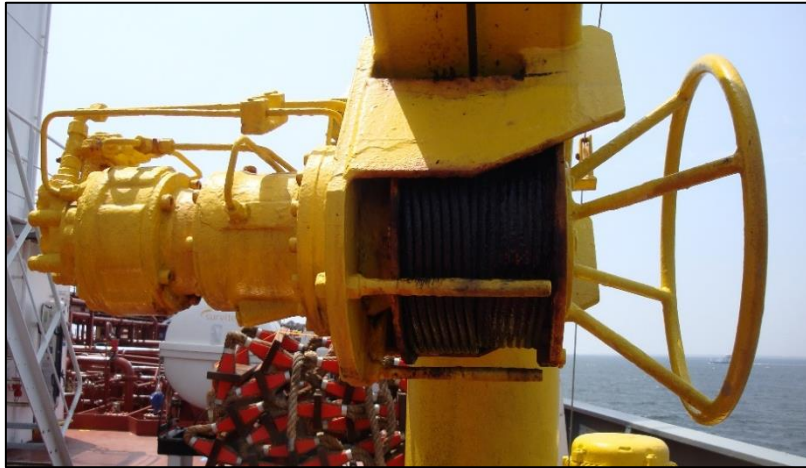
After the accident, various tests and inspections were conducted on board the ship in the presence, inter alia, of the manufacturer of the launching appliance and a technical expert appointed by the BSU, during which the presumed technical fault could neither be reproduced nor its cause initially found. After all possibilities for an operating error or a fault in the hydraulic system could be ruled out during the discussed assessments, the only conceivable error source was a technical problem inside the winch unit mounted on the crane column of the launching appliance. This was therefore disconnected from the crane column on behalf of the BSU and sent to Germany for further assessment.

Figure 2: The launching appliance's winch unit

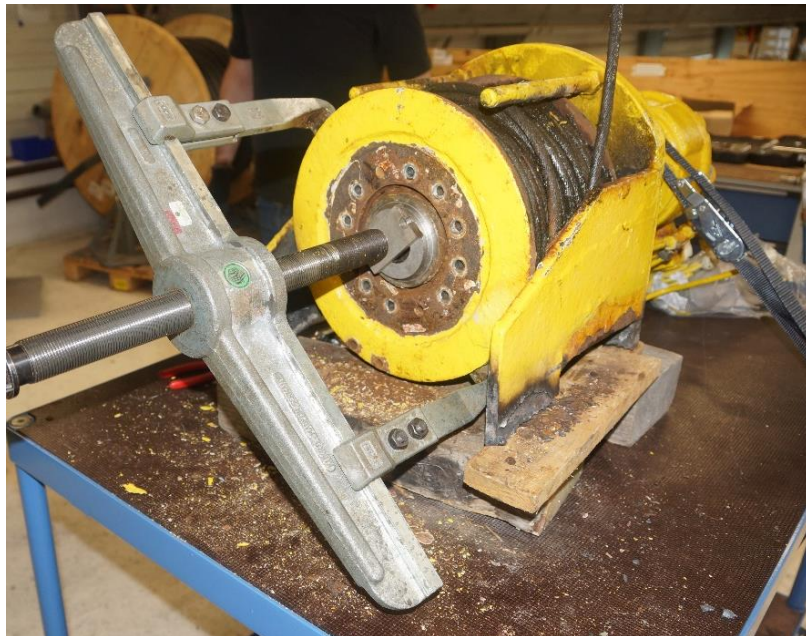
Figure 3: Disassembly of the winch unit

In the course of the inspection of the winch, which was led by the expert commissioned by the BSU and monitored by a representative of the manufacturer, it emerged that the torque transmission between drive and winch drum is ensured by a friction-locking freewheel clutch (a so-called sprag clutch).

The freewheel clutch's function is to enable load-free hoisting of the rope in manual mode. During normal hydraulic operation of the crane, the freewheel is always in the locked position. The freewheel and the surrounding bearings are sealed against environmental influences by radial shaft sealing rings; regular maintenance or inspections are extremely complicated due to the mounting conditions and therefore only possible on board with considerable effort.

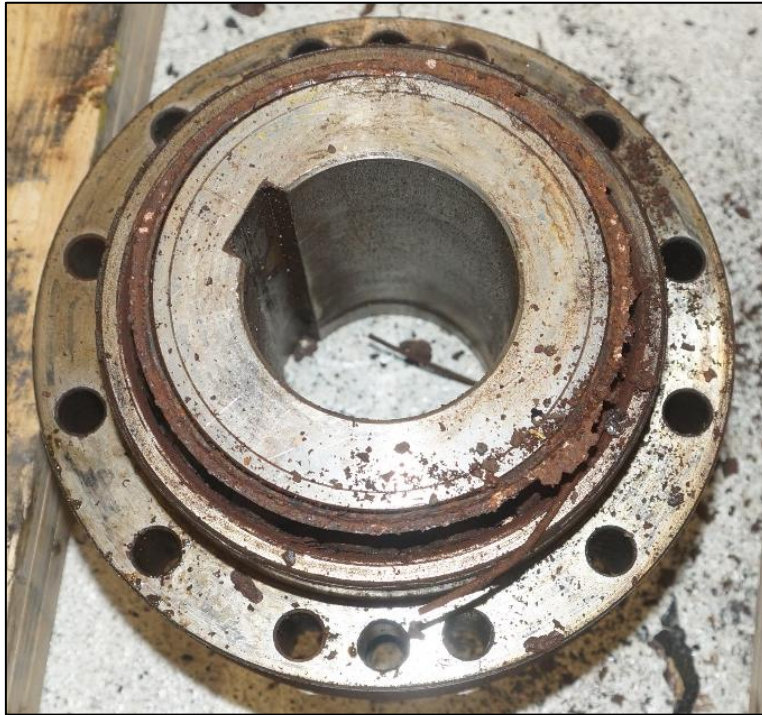
When the freewheel module was disassembled, it became apparent that sea air and moisture had damaged the sealing material over the years. This made it possible for moisture and dirt to penetrate the innermost components of the freewheel and cause considerable corrosion there.

Figure 4: Weather-worn seal of the freewheel module

Accordingly, regular checks as to whether the freewheel of such a system is functioning properly (i.e. locking in the locking direction, releasing in the freewheeling direction) are strongly recommended. If such a performance test delivers evidence of a fault, then qualified personnel should inspect the system immediately and it must not be operated with people in the boat to be launched before that happens.

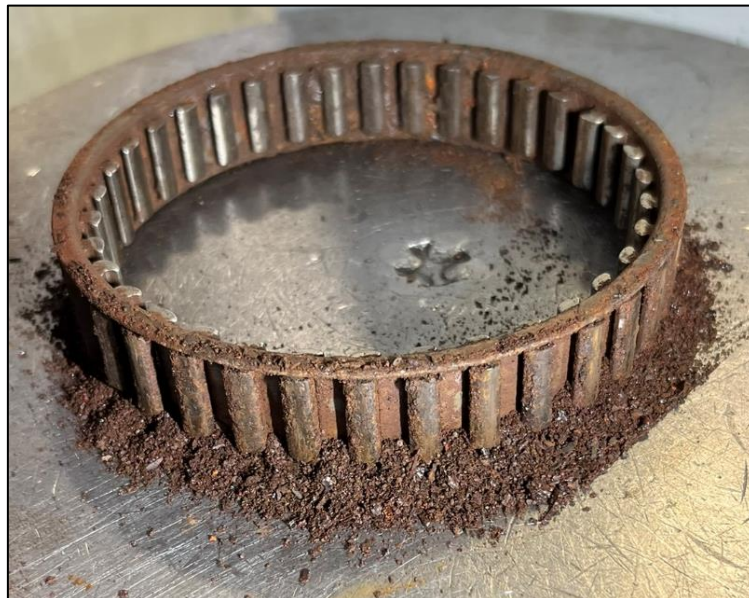
Due to the corrosion and associated rusting of the sprags, the function of the freewheel was restricted to such an extent that torque locking was only ensured by contact rust, but not by the normal clamping effect of the sprags. Accordingly, a failure in the form of slipping against the locking direction was possible at any time. In the present case, this was presumably facilitated or triggered by the jolt of the start-up when the boat was lowered.

Figure 5: Freewheel after disassembly; traces of heavy corrosion on the sprags and sprag cage
