# Paris MoU

## on Port State Control

Name:	HUANGHAI DEVELOPER
IMO:	9458444
Flag:	Hong Kong, China
Type:	General Cargo
GT:	20682
Class:	Bureau Veritas
RO:	Bureau Veritas
IMO Company:	Tianjin Xinhai Intl Ship Management
Date keel laid:	17/12/2008
Delivery date:	10/03/2013

MV "HUANGHAI DEVELOPER" IMO: 9458444 flying Hong Kong flag, arrived at Hamburg/Germany on 09/08/2016 for cargo operation, no survey or repair work was planned for the port call.

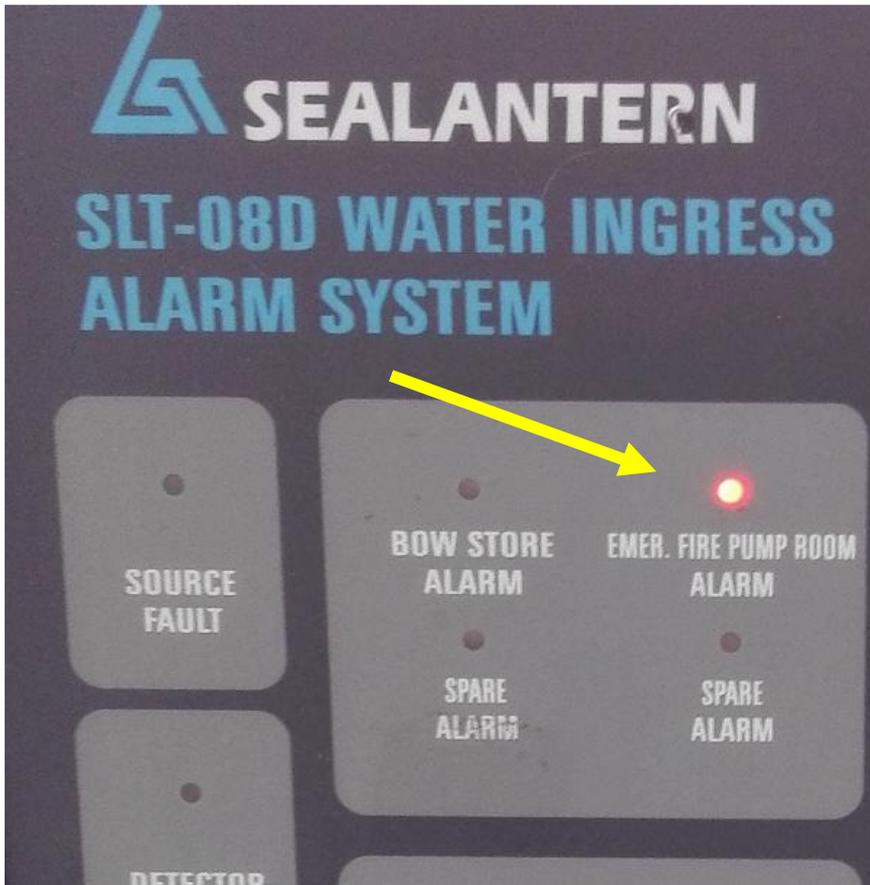
During the inspection of the WATER INGRESS ALARM the EMERGENCY FIRE PUMP ROOM was in alarm. (See pictures below)

An oily water mixture was discovered in the bilge of the emergency fire pump room (about 25cm sounded). According the bilge pumping arrangement a direct discharge to sea was possible. This deficiency was recorded with ground for detention.
